BIKE/WALK AUDIT: Grandin

Date: 14 January 2019

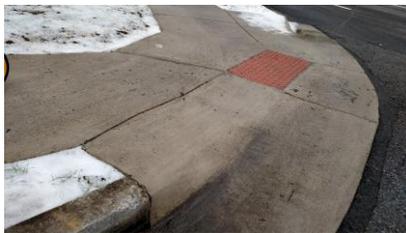
Curb ramps: Curb ramps are smooth. New curb ramps that are sloped radially only have the detectible warnings in one patch and according to the latest guidance should be continuous.

Detectible warning should go all the way around the curve

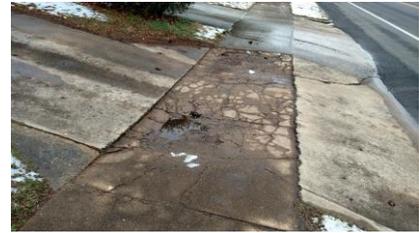
Sidewalks: The sidewalk is five feet wide but the usable sidewalk is as narrow as two feet in places due to debris and vegetation and in some places is completely obscured by mud. There are rough patches of broken sidewalk and panels that have risen or sunk and are offset >1/4 inch.

Cracked sidewalk pavement like this is common on this segment of road

Disability: Remove debris and vegetation from sidewalks. Repair broken sidewalk pavement. Grind down or repair pavement that is offset >1/4 inch.

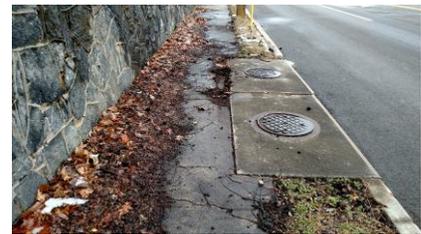
Pavement condition: Road is recently paved and in good condition. Sidewalks have debris, vegetation, broken pavement, lips around storm inlets and drains that have sunk or risen.

Debris and raised lip of storm inlet pose obstacles for wheelchairs

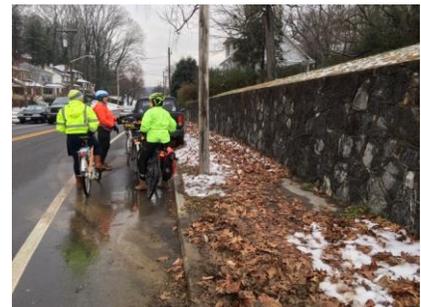
Parking: The parking lane may be underutilized. West of Guilford Ave SW, on the north side of Grandin Rd, there is evidence that cars park with one wheel on the sidewalk or the verge.

Muddy tracks from vehicles that parked with one side on the verge

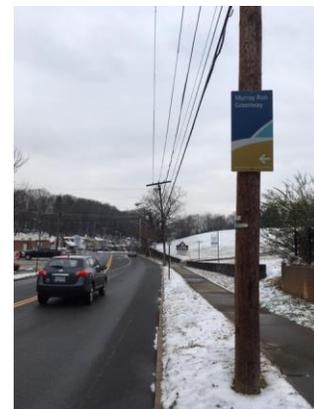
Wayfinding sign

Signs: The wayfinding signage from both directions for Murray Run Greenway is good. A better sign near the tennis courts could help identify the Murray Run Greenway.
