# BUS STOP ACCESSIBILITY STUDY DRAFT REPORT

*Roanoke Valley Area Metropolitan Planning Organization*  
August 2013

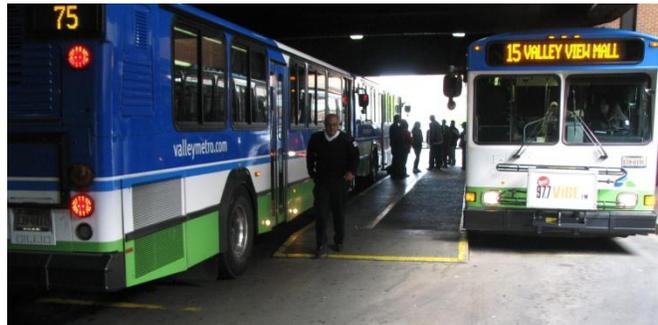
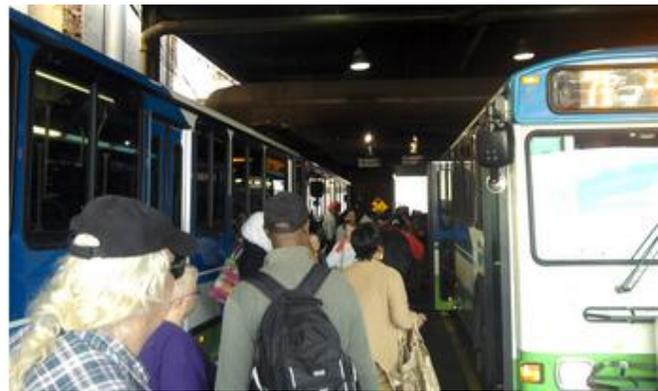
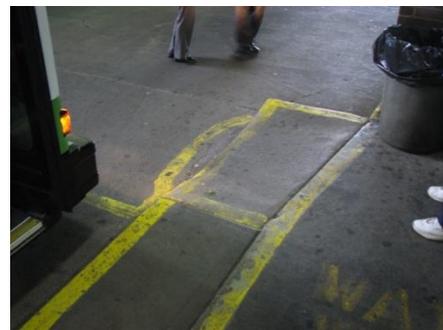
People generally have up to five minutes to transfer buses. Large numbers of people within this time alight one bus and board another bus. ADA accessibility and the resulting ease of transferring at this location is critical; it is a determining factor for people's decision to use the public transit system. If people do not feel they can successfully maneuver from one bus through the station to another bus, they will likely look for another way to get to their destination or not travel at all. The transit system depends on the ability to move easily through Campbell Court. While Campbell Court meets basic accessibility requirements, it is not an easy place to move around.

Landing areas can become very crowded at some times during the day making it a challenge for someone with a disability to maneuver from one bus to another. Signs indicating the drive aisle for buses are not easy to see or understand. Visually impaired riders would have an especially difficult time transferring buses. Announcements over a loudspeaker are made to notify people if a bus is in a different location than usual. However, the announcement may be difficult for some people to hear over the hum of buses. Tactile warning surfaces are not present on curb ramps. Several of the pedestrian walkways around the bus station are too narrow to accommodate a wheelchair. As such, people in wheelchairs must travel through the driveways to enter the station. Any pedestrian activity across the driveways causes potential conflicts and

significant safety concerns as buses enter and leave the station. Handicap push buttons are needed on the doors to enter the waiting area.

<b>Stakeholders</b>	Valley Metro, City of Roanoke, Downtown Roanoke Inc.
<b>Recommendations</b>	As part of the Downtown Roanoke Multimodal Transportation Study, develop options for reallocating space within Campbell Court to improve the ability for pedestrians to more easily transfer between buses including options for more clearly arranging buses within the station, better signage, ADA landings and ramps, and minimizing the need for pedestrians to walk in front of buses.
<b>Estimated Costs</b>	\$300,000 for the study

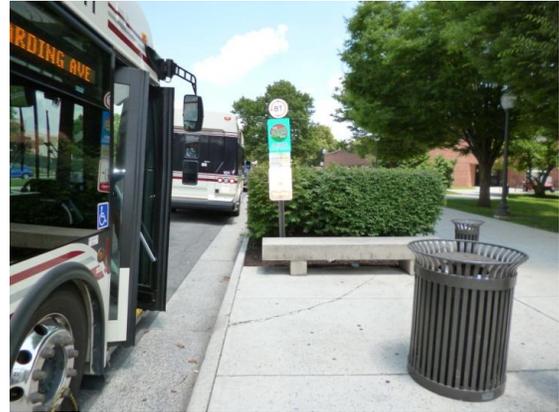
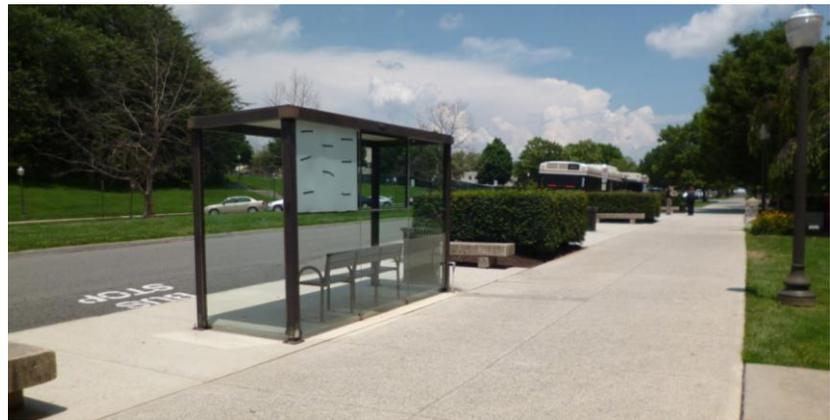
The Virginia Tech Squires Student Center is the main pick-up/drop-off location in Blacksburg. The bus stop is located next to a wide sidewalk, which is easily accessible and allows enough room to deploy the lift. The bus stop features a bench and a trash can. Nearby the Squires Student Center provides refuge during inclement weather. More often people stand under the nearby trees in the grass (which has worn away) for shade. Just before the bus stop, there is a shelter though it is not intended for Smartway users. Installing a bus shelter at the current stop location or relocating the stop to the shown bus shelter should be considered.

<b>Stakeholders</b>	Valley Metro, Blacksburg Transit, Virginia Tech
<b>Recommendations</b>	Install a bus shelter at the current stop or consider relocating the Smartway stop to the existing bus shelter.
<b>Estimated Costs</b>	Varies depending on the recommendation pursued.

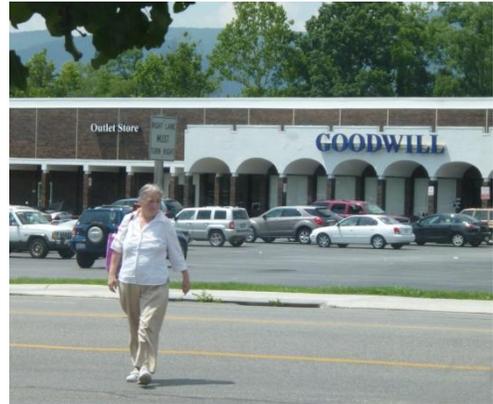
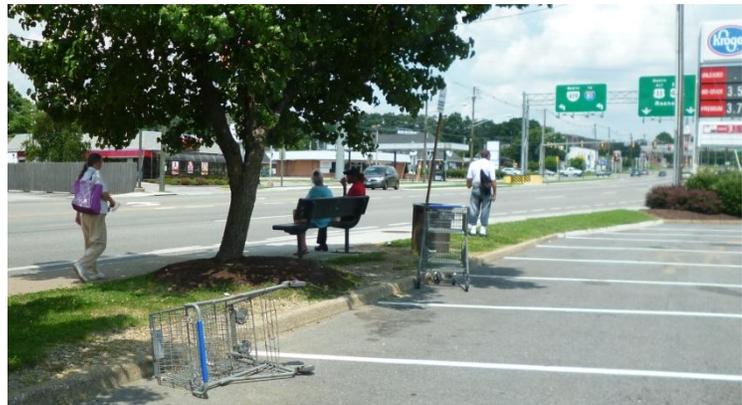
The NTD survey data showed the East Main at Goodwill Transfer Center stop as the second most used stop in the system. Similar in function to Campbell Court, this stop required people traveling between Salem and Roanoke to alight one bus and board another in order to continue their trip which was inconvenient for most travelers and an inefficient use of valuable minutes in the transit schedule. As a result of this realization, and in combination with other factors, the two bus routes were combined in December 2012. This streamlining of the transit line has eliminated the need for people to unnecessarily board and alight at this stop.

As a result, the bus stop at this location has been shifted to the street and is now East Main WB at Lakeside Plaza (Goodwill). Some activity will

continue because of the commercial trip generators, including the Kroger grocery store. In order for passengers to access Lakeside Plaza, they must cross East Main Street, a 5-lane heavily traveled roadway. Although the nearby intersection of East Main Street and Electric Road features pedestrian signals and curb ramps, it is has been frequently observed that people choose to avoid this roundabout path to crossing the street. Favoring a direct path and a few minutes saved, people often cross the five lanes at the driveway entrance to the shopping center.

<b>Stakeholders</b>	Valley Metro, City of Salem, VDOT, Goodwill Industries
<b>Recommendations</b>	Construct a pedestrian refuge island with a crosswalk, signage, and flashing lights in ground and above ground that can be activated by a pedestrian. Close the eastern driveway at Goodwill to enable the crossing and to reduce vehicle turning movement conflicts.
<b>Estimated Costs</b>	Pedestrian Median, Crosswalk, and Signal with flashing lights and signage = \$120,000 Reconstruct driveway with curb, grass and sidewalk = \$4,000

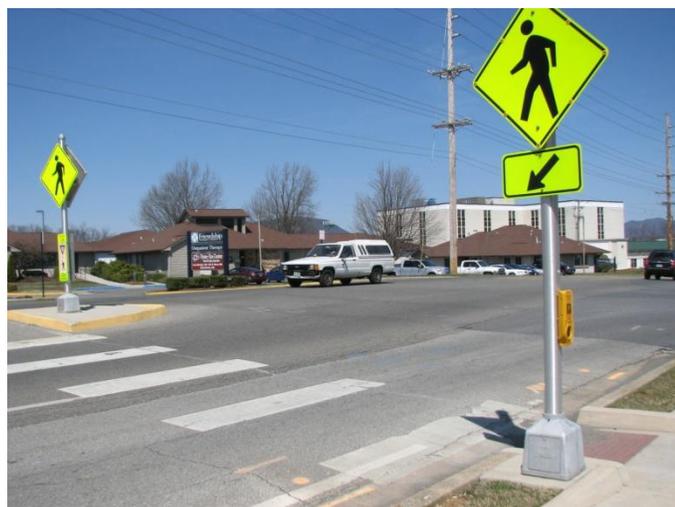
A safe pedestrian crossing at this location is needed. The diagram on the following page shows an option for reducing vehicle turning movement conflicts and creating a safer pedestrian crossing. The picture to the right shows an example of a similar crossing on a smaller scale on Hershberger Road at Friendship Manor.

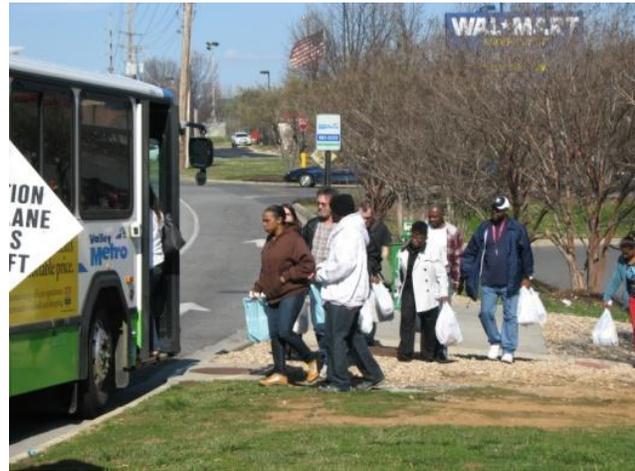
The Valley View Walmart stop has long been a location that has been recognized as needing accessibility improvements. Had it been simply a matter of installing a sidewalk and a bus shelter, conditions at this stop would have been improved years ago. The stop is located on private property at the boundary where the Walmart property meets the Sears property. Concerns from some of the private owners have kept officials struggling to find an adequate solution. The current stop location takes advantage of a concrete pad over a convergence of utilities. Improvements at the current location are limited due to the location of the utilities. The most recent concepts involve moving the bus stop slightly north, away from the utilities and completely on the Walmart property. Such a location requires a sidewalk ramp accessible for a wheelchair to accommodate the change in grade from the Walmart parking lot and Valley View Ring Road.

<b>Stakeholders</b>	Valley Metro, Valley View Mall management, Walmart
<b>Recommendations</b>	Construct a bus shelter with lighting and a pedestrian connection to the Walmart parking lot.
<b>Estimated Costs</b>	\$100,000

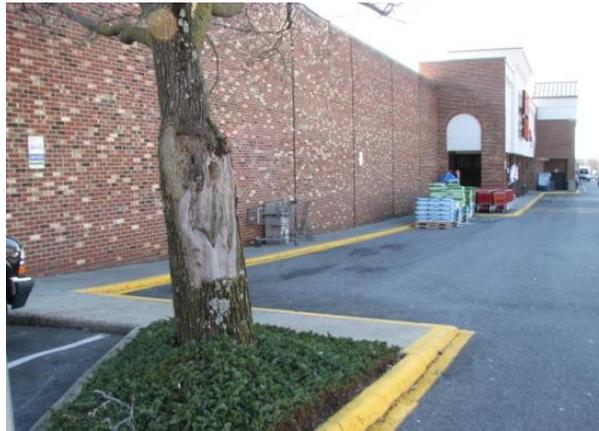
The Kroger grocery store is the main attraction of trips at this location. Route 35 stops here on its way to Downtown Vinton and Orange Avenue. In order for people to travel back towards Campbell Court they must catch the bus at this stop and ride first through Vinton and Orange Avenue or cross Hardy Road and catch route 36 towards Downtown Roanoke.

The current stop location is convenient in that it is right next to the building, though, if needed to save time and provide a more efficient service, the stop could be moved to Hardy Road and still serve the shopping center well. A pair of stops in which one bus stop is opposite the other along a road is sometimes easier for riders to understand where to get on/off to get to/from their destination. In either location, the stop needs a bus shelter and lighting.

<b>Stakeholders</b>	Valley Metro, Lake Drive Plaza management
<b>Recommendations</b>	Construct a bus shelter with lighting at the current location.
<b>Estimated Costs</b>	Large Shelter = \$9,450 Labor/Installation = \$3,395 Permits/Site Plans = \$895

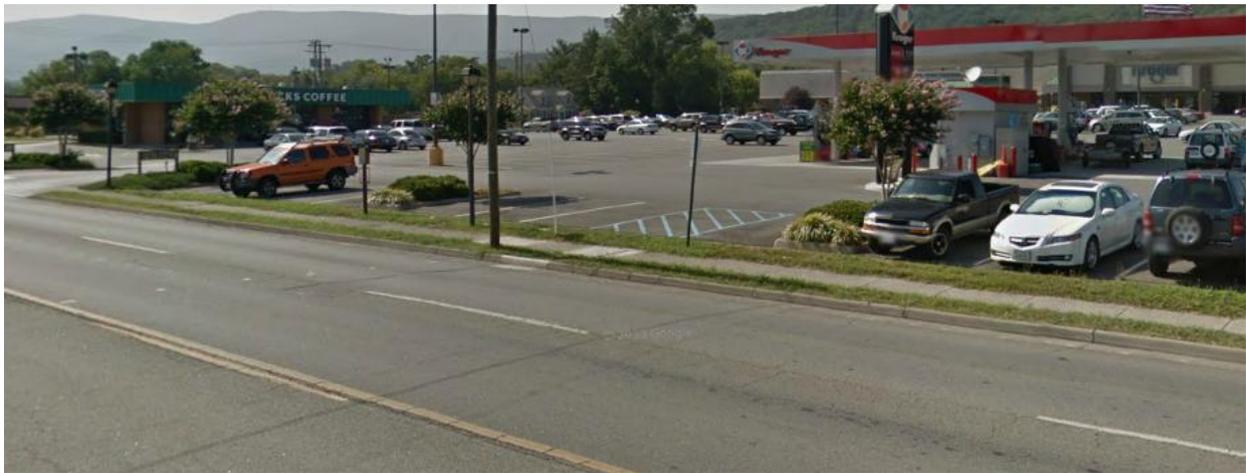
Since the NTD survey, route 91 has been modified in that it no longer stops in the Spartan Square shopping center. Instead the bus stop at Spartan Square Kroger is along the street. The level of bus stop activity may have decreased because this stop, at the time of the survey, was the furthest stop west on East Main Street and now there is one stop further west at Walmart. Regardless, it is recommended that the new bus stop location be improved because of the high activity generators located in the shopping center.

<b>Stakeholders</b>	Valley Metro, City of Salem, Spartan Square management, Kroger
<b>Recommendations</b>	Pave a landing pad from the curb to the parking lot and construct a bus shelter with lighting and a trash can.
<b>Estimated Costs</b>	Large Shelter = \$9,450 Labor/Installation = \$3,395 Permits/Site Plans = \$895

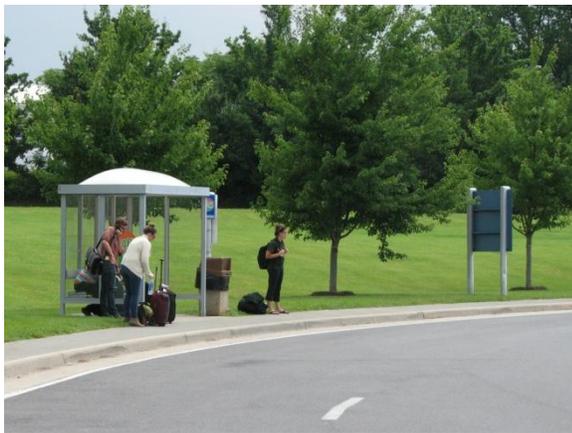
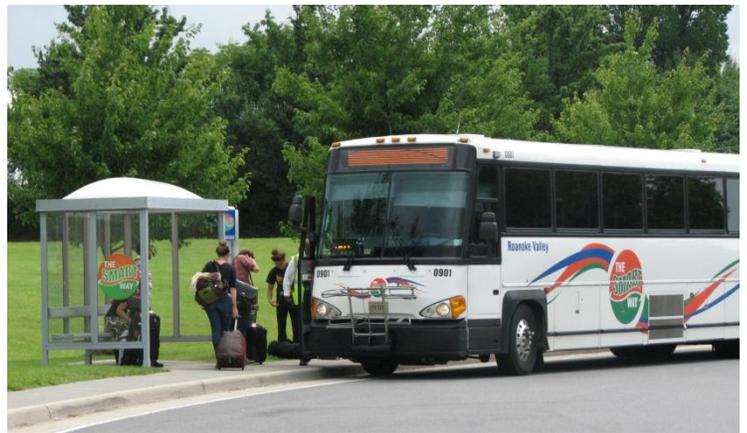
The Roanoke Regional Airport is currently served only by the Smartway Bus, which travels between Campbell Court and Virginia Tech Squires Student Center. The bus stop and shelter are overall in good condition and accessible. While a wheelchair could physically fit within the shelter, there is no specific location for wheelchairs as the bench spans the width of the shelter. The shelter appears undersized for the location since it can only hold only a few people. On the day of the field visit, several people were observed waiting outside the shelter. Fortunately the weather was pleasing to be outside, but on other days, when weather is not as pleasant, more covered space is recommended for this location. A posted bus schedule is also needed.

<b>Stakeholders</b>	Valley Metro, Roanoke Regional Airport
<b>Recommendations</b>	Upgrade the existing shelter to the current Valley Metro standard and add a second bus shelter, an additional concrete pad, and post the bus schedule.
<b>Estimated Costs</b>	Two Large Shelters = \$18,900 Labor/Installation = \$6,790 Permits/Site Plans = \$895

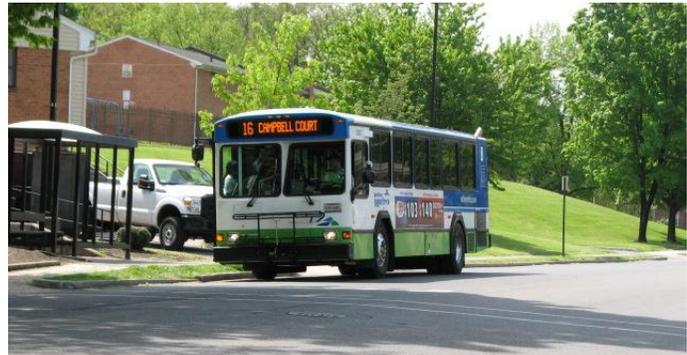
This is an inbound bus stop to Campbell Court that serves Hunt Manor and Afton Apartments. The existing bus shelter is in great disrepair with broken glass below missing windows. There is a crosswalk and ramps at the stop, but improvements are needed.

<b>Stakeholders</b>	Valley Metro, City of Roanoke
<b>Recommendations</b>	Install a new shelter and pave the landing pad between the sidewalk and curb, reconstruct two ramps with tactile surfaces on the north side of Hunt Avenue.
<b>Estimated Costs</b>	2 ramps = \$8,000 Small Shelter = \$6,620 Labor/Installation = \$3,395 Permits/Site Plans = \$895

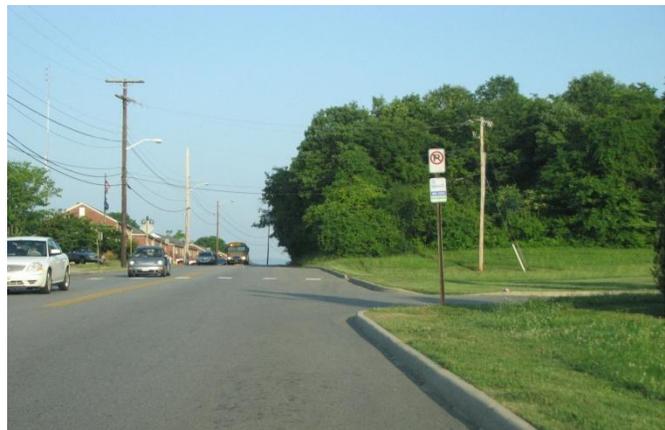
Horton Park, Melrose Library and Lansdowne Park public housing are the activity generators at this bus stop. During the NTD survey, more than 90% of the activity at this stop was from passengers being dropped off. There is no sidewalk at the bus stop, so riders are most likely let off in the street at the driveway entrance to the library. There is a crosswalk as seen in the picture west of the bus stop. Given the activity at this stop, several improvements are needed.

<b>Stakeholders</b>	Valley Metro, City of Roanoke
<b>Recommendations</b>	Construct a landing pad, sidewalk between the bus stop and the crosswalk, curb ramps at each corner of the library driveway and at the crosswalk.
<b>Estimated Costs</b>	3 ramps = \$12,000 125' x 5' sidewalk = \$4,375 Labor/Installation = \$3,395 Permits/Site Plans = \$895

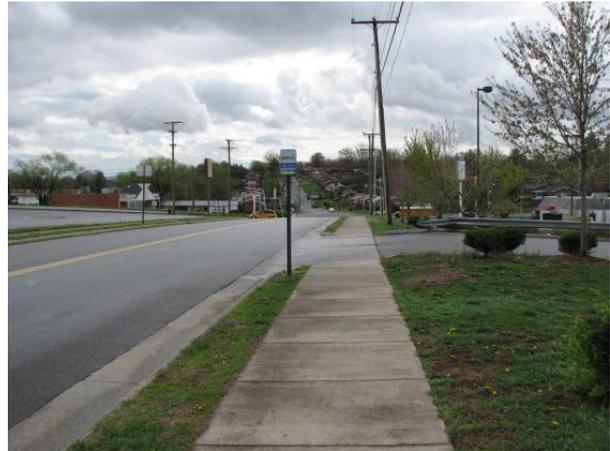
This bus stop is considered an outbound bus stop. It is located near several large retail stores and heads towards Valley View Mall. During the NTD survey, twice as many passengers alighted at the stop than boarded. As such, a small shelter is recommended at this location. Given that there are shopping destinations on both sides of the street, a crosswalk with ADA ramps in between the companion bus stops should be striped.

<b>Stakeholders</b>	Valley Metro, City of Roanoke
<b>Recommendations</b>	Construct a landing pad, curb ramps at a new crosswalk, and install a bus shelter.
<b>Estimated Costs</b>	2 ramps = \$8,000 Crosswalk striping = \$1,000 Small shelter = \$6,620 Labor/Installation = \$3,395 Permits/Site Plans = \$895

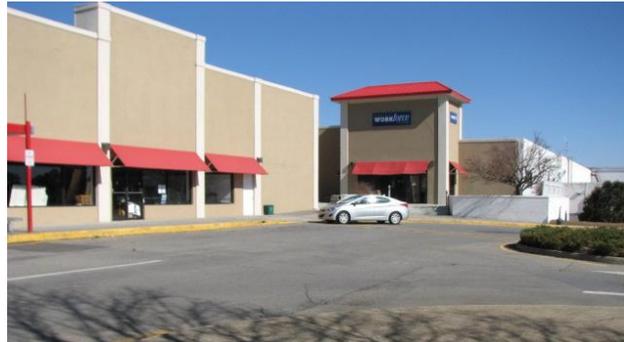
The Virginia Work Force Center is the main attraction for this bus stop's location. The Advance Auto Parts headquarters is also near this stop. The companion stop is on Hershberger Road at Bean Street.

The current location is accessible. It features a bus stop sign that is propped up in a window. Nearby deteriorating benches at Kmart provide riders a place to sit while waiting for the bus. Parking is prohibited at the stop through No Parking-Fire Lane signs. If this stop is moved to Hershberger Road, depending on the route alignment that would serve the stop, a bus shelter, landing pad, and other amenities may be needed.

<b>Stakeholders</b>	Valley Metro, City of Roanoke, Shopping Center management
<b>Recommendations</b>	Evaluate the long-term desired location of the stop. In the current location, relocate the sign on a post.
<b>Estimated Costs</b>	Minimal for the current location.

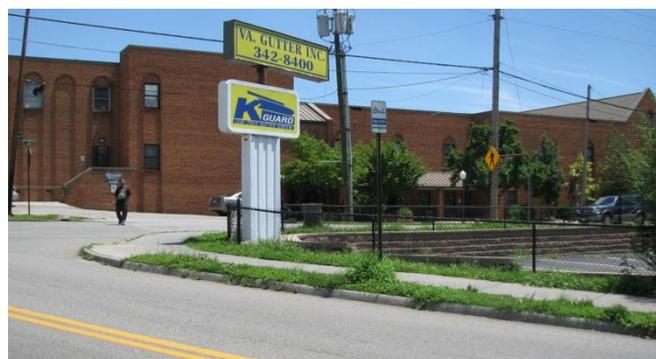
The main activity generator at this stop is the Rescue Mission. The bus at this location has traveled from Campbell Court on its way into Vinton. Most people during the NTD survey used this stop for alighting.

<b>Stakeholders</b>	Valley Metro, City of Roanoke
<b>Recommendations</b>	Pave a landing area 5'x8' wide by widening the sidewalk to the back of curb at the bus stop.
<b>Estimated Costs</b>	Sidewalk extension 40 sf = \$280 Labor/installation = to be done within a larger contract for ongoing maintenance costs.

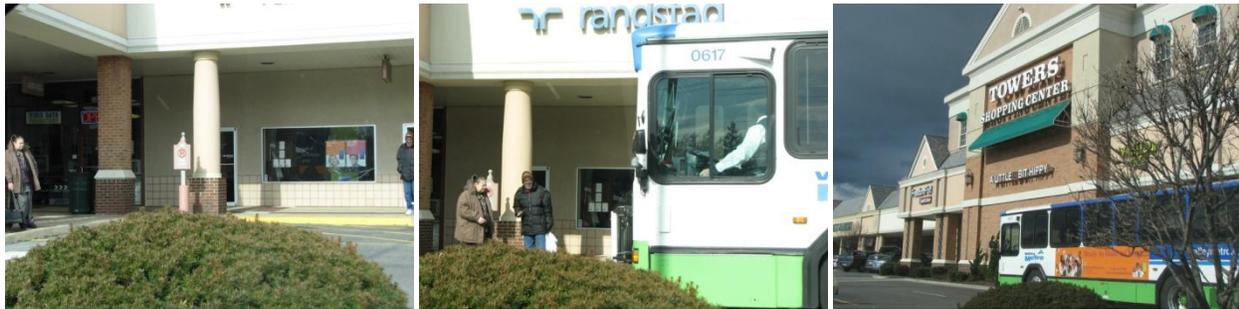
The bus stop in the upper lot of Towers Shopping Center is not currently signed though people who use the bus regularly know it will pick them up at the main entrance next to Randstad and McCallister's Deli. The building itself provides shelter. There are benches and a trash can available to riders. A person in a wheelchair would need to wait in the fire lane, which is unsheltered and accessible by using the ramp leading to the parking lot. In order to access the stop, the bus must use the drive aisles where at any moment a vehicle may attempt to back out, potentially causing a conflict with an oncoming bus. When one bus is at the stop, it blocks four parked vehicles from backing out of their spaces. If two buses arrive at the same time, many more parking spaces are blocked. The parking lot gets very crowded and driving to the current stop location can often be delayed by the congestion.

If the current stop remains, a sign is needed along with a ramp directly from the hatched area to the building entrance. However, it is preferable that this bus stop be moved to Colonial Avenue in order to avoid vehicle conflicts and delay in the parking lot. In order to accomplish this bus stop shift, the route would need to be modified. Additionally, because there are no elevators in Towers Shopping Center, and no safe pedestrian walkway to get from the upper and lower levels, each side of the shopping center must each have a bus stop. It is recommended that any bus route that includes Towers Shopping Center provide service to both levels.

<b>Stakeholders</b>	Valley Metro, Towers Shopping Center management
<b>Recommendations</b>	Relocate the bus stop to Colonial Avenue, potentially on the end near Chipotle, and install a shelter, landing pad, trash can, and pedestrian ramps, and sidewalk connections to the shopping center and to the existing sidewalk front of CVS.
<b>Estimated Costs</b>	Large Shelter = \$9,450 Labor/Installation = \$10,185 Permits/Site Plans = \$895 250' x 5' sidewalk connection = \$8,750 Five ADA ramps = \$20,000 Total = \$49,280

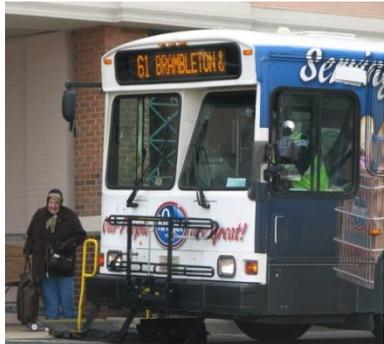
*Existing Lower Level Stop Location*

The current bus stop at Towers Shopping Center Kroger is conveniently located next to the building so that people can take advantage of the covered space, bench and trash can. The main concern with this location is that the back door of the bus opens up against a row of bushes next to the building, causing people to walk through the bushes. It is desirable to keep the stop next to the building to eliminate pedestrian/vehicle interaction in the parking lot. A possible location to relocate the stop would be in front of the Tuesday Morning store. The area in front of this store does not have parking as indicated by yellow striped lines. There is a blue marked handicap ramp to the sidewalk, a nearby bench and covered area for people to wait. If the stop were relocated here, because the sidewalk does not wrap around the building, pedestrians would need to walk through the building to access Kroger. This stop needs a bus stop sign.

<b>Stakeholders</b>	Valley Metro, Towers Shopping Center management
<b>Recommendations</b>	Relocate the bus stop to the Tuesday Morning store location.
<b>Estimated Costs</b>	Minimal for the sign installation.

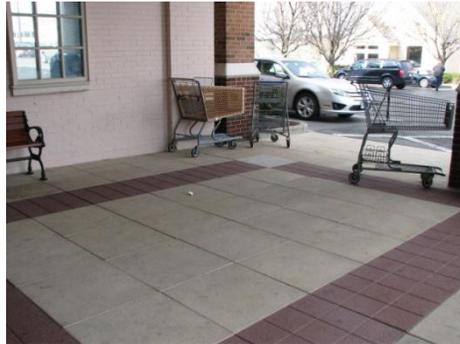
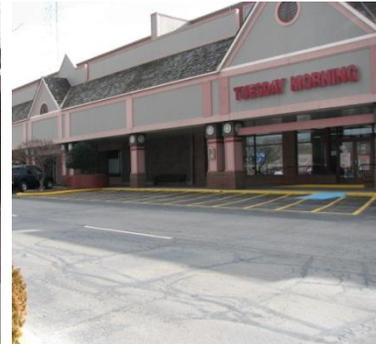
*Proposed Location*

Due to the lack of an elevator within Towers Shopping Center, there is no opportunity for a person in a wheelchair to travel between the upper and lower level shops without going all the way around the building. There are no sidewalks to assist with this travel, so people would need to travel through the parking lots and driveway aisles. Unless conditions change at the Shopping Center, it is recommended that the routes that currently only serve the upper or lower levels be routed to serve both levels of the shopping center.

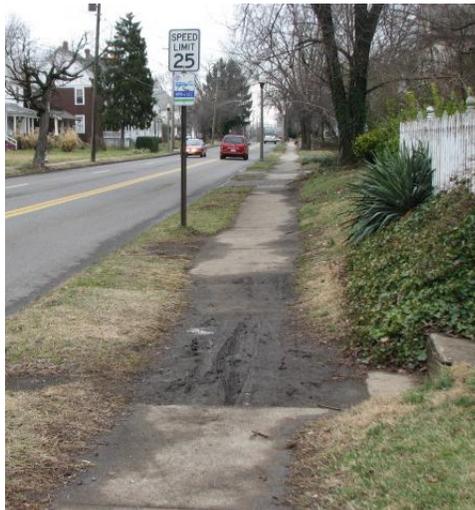
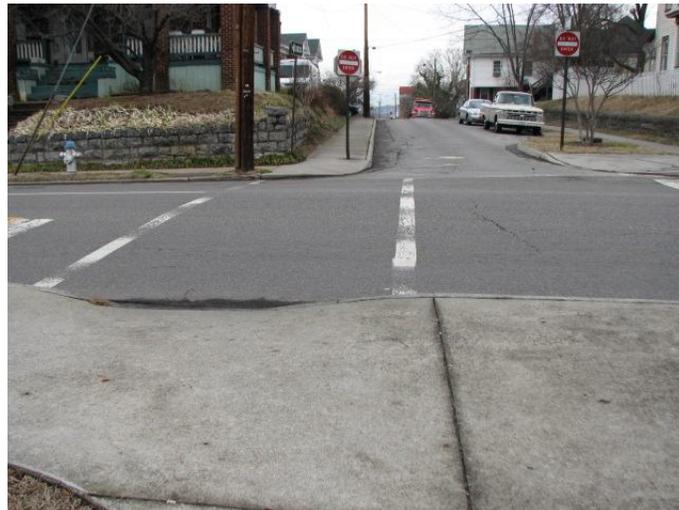
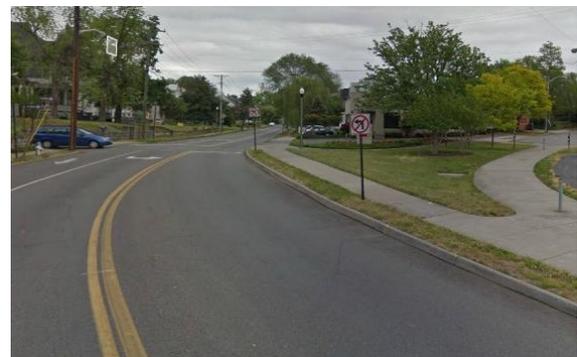
This bus stop travels inbound to Campbell Court. It is located in a residential area with private homes adjacent to the stop. The current bus stop location is limited in space but given its activity level would warrant a bus shelter. Locating a bus shelter at the current location should be explored fully before looking at relocation options. Locating a shelter at the current stop may be difficult because of the adjacent private homes and the potential for a shelter to cause site distance limitations from vehicles emerging from driveways.

Another option to explore would be relocating the stop to the open space on the nearside of the Elm Avenue and 8<sup>th</sup> Street intersection. Due to the proximity to the Main Street and Ferdinand Avenue intersection, and the volume of traffic on this street at some times of the day, it may be desirable to provide a bus pull-off within the green open space. Drainage structures are evident within the open space which may make a bus pull-off more costly. In any location, at a minimum, a bench should be provided facing the sidewalk, a landing area paved between the sidewalk and curb, and a new sign installed.

<b>Stakeholders</b>	Valley Metro, City of Roanoke, adjacent property owners, Old Southwest
<b>Recommendations</b>	Explore amenity improvement options at the current location. Explore a bus pull-off design and cost within the green open space between Ferdinand and 8 <sup>th</sup> Streets.
<b>Estimated Costs</b>	Varies depending on the option selected.

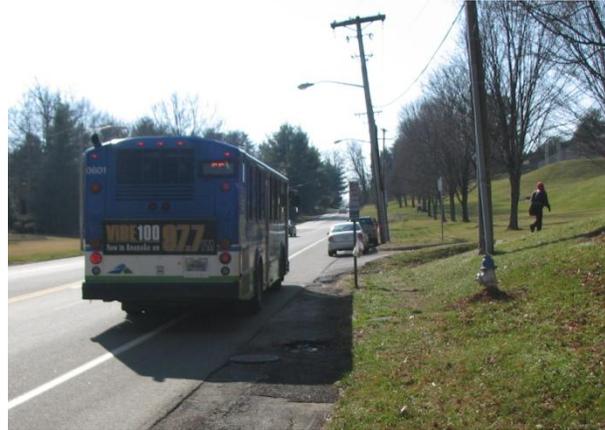
Virginia Western Community College is the attraction for this bus stop. The stop currently has no infrastructure or amenities. Able-bodied students walk up a nearby driveway to enter a side door to the building. Students cross the street using the overhead pedestrian walkway. Recently, a new building was constructed nearby. New sidewalks associated with the project did not extend to the bus stop. Additionally, it appears the sidewalk is higher than the roadway, but no curbs were constructed with the sidewalks. This bus stop is mainly used for dropping off people coming from Campbell Court. However, a small shelter would still be appropriate for people waiting for the southbound bus.

<b>Stakeholders</b>	Valley Metro, City of Roanoke, VWCC
<b>Recommendations</b>	A small bus shelter, trash can, and paved landing area with connections to existing pedestrian facilities are recommended. Coordination with the College is necessary to determine the best location for the bus stop, and if it could be incorporated into the new section of sidewalk.
<b>Estimated Costs</b>	Small bus shelter = \$6,620 Labor/Installation = \$3,395 Permits/Site plans = \$895 Curb and sidewalk connections depending on the final location.

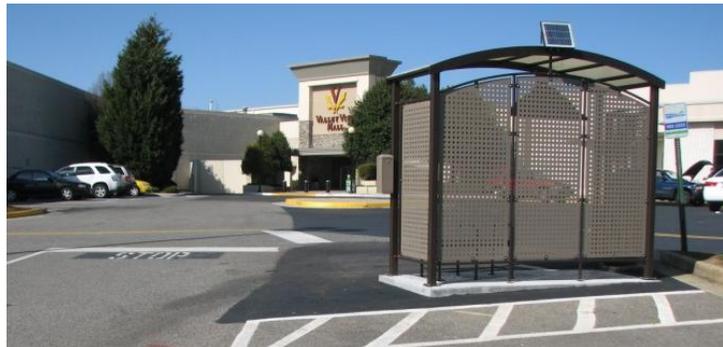
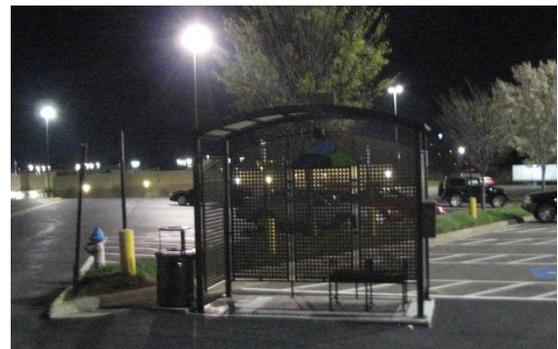
Over the years, the main bus stop at Valley View Mall has been moved around due to concerns from nearby businesses. The current location places the bus stop in a parking lot near a main entrance of the mall. Functionally, the location works well. The buses have easy access into the lot through main drive aisles; as such, potential conflicts with vehicles are minimized.

The stop itself however is undersized given that it is the primary mall stop. There are seats for only two people and space for one wheelchair under the shelter. Additional riders would be waiting on the pavement next to the drive aisle intersection. At nighttime, the light inside the shelter does not work because of the lights in the surrounding parking lot. This makes the shelter itself dark.

Recommendations include creating a raised curb extension to separate the driving aisle from the passenger waiting space. This could be done by extending the median through some of the handicap parking spaces as shown in the adjacent concept. This concept would add an ADA ramp and an adequately sized ADA landing pad, as well as provide one additional large bus shelters. Pavement striping of stop bars would also be adjusted.

<b>Stakeholders</b>	Valley View Mall management, Valley Metro
<b>Recommendations</b>	Raise the bus stop to the sidewalk level, in line with the adjacent grass median. Enlarge the bus facility landing area to provide one more large bus shelter and one lamppost.
<b>Estimated Costs</b>	400 sq. ft. reinforced pedestrian area = \$5,600 Large shelter = \$9,450 Lighting/Lamppost = \$5,000 ADA ramp = \$4,000 Reuse existing small shelter and trashcan. Additional costs for demolition of existing curb/sidewalk.

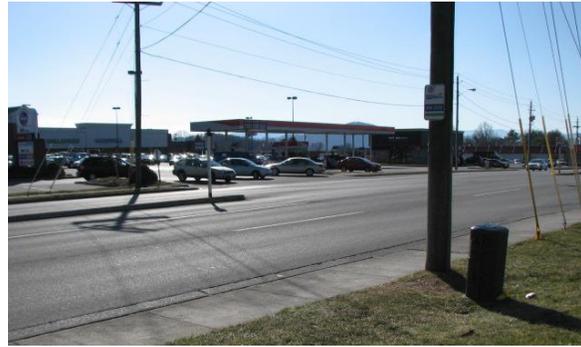
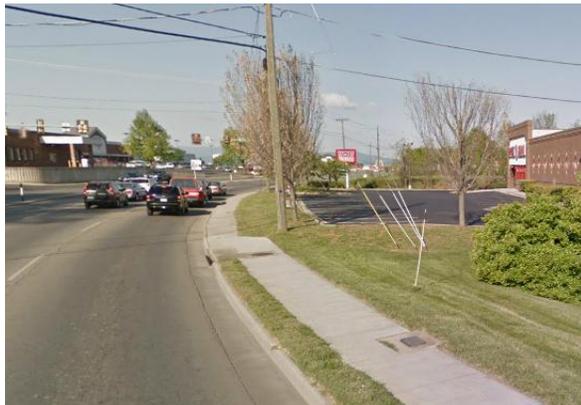
This bus stop is the companion to the Lake Drive Plaza Big Lots (Hardy Road) stop across the street. Without pedestrian crossing facilities across Hardy Road at Bedford Road, it is not safe to cross the street at this location and instead pedestrians must walk to the nearest signalized intersection (Clearview Drive or Vinyard Road) in order to safely cross the street. However, the most direct path from Kroger to this bus stop is at the Hardy Road/Bedford intersection so it is likely that many riders choose to take their chances and cross at this intersection. Instead of building a pedestrian crossing at the current location, it is recommended that the bus stop be moved to the nearside of the Hardy Road/Clearview Drive intersection near the Family Dollar as shown in the adjacent picture.

<b>Stakeholders</b>	Valley Metro, Town of Vinton, Adjacent property owners
<b>Recommendations</b>	Move bus stop to nearside Hardy Road/Clearview Drive; install a shelter and landing pad; stripe crosswalks on Hardy Road and Clearview Drive; construct and ADA ramp on the existing sidewalk at the Clearview Drive driveway into the shopping center (behind Subway).
<b>Estimated Costs</b>	Large Shelter = \$9,450 ADA Ramp = \$4,000 Crosswalk Striping = \$800 Labor/Installation = \$3,395 Permits/Site plans = \$895

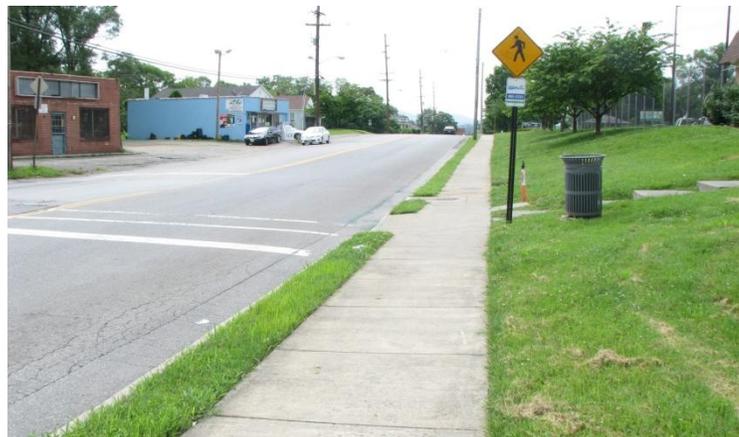
This bus stop serves route 16, which travels from Valley View Mall to Campbell Court. Many lower income residences are located near this stop, contributing to its high activity level. The stop is adjacent to Washington Park pool. The stop needs a small bus shelter and a repainted crosswalk. The trash receptacle should be moved to be more easily accessible from the sidewalk.

<b>Stakeholders</b>	Valley Metro, City of Roanoke Transportation and Parks and Recreation
<b>Recommendations</b>	Install a small shelter and landing pad, extend the sidewalk to the back of the curb at the bus stop, relocate the trash can.
<b>Estimated Costs</b>	Small bus shelter = \$6,620 Crosswalk Striping = \$400 Labor/Installation = \$3,395 Permits/Site plans = \$895

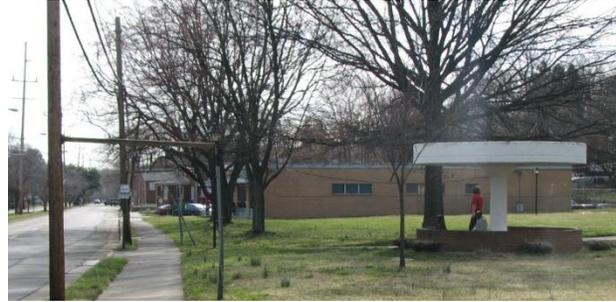
Melrose Towers, a residential building for lower income and elderly people, is the main trip generator at this bus stop. An adequate landing pad exists at the bus stop. Currently, a functional but dated shelter exists in the front lawn and serves as the bus shelter for the stop. The only concern with this shelter is the ability of the bus driver to see people waiting inside the shelter, due to its setback from the street. It is also not well lit at nighttime.

<b>Stakeholders</b>	Valley Metro, City of Roanoke, Melrose Towers management
<b>Recommendations</b>	Install a small shelter at the sidewalk.
<b>Estimated Costs</b>	Large bus shelter = \$6,620 Labor/Installation = \$3,395 Permits/Site plans = \$895

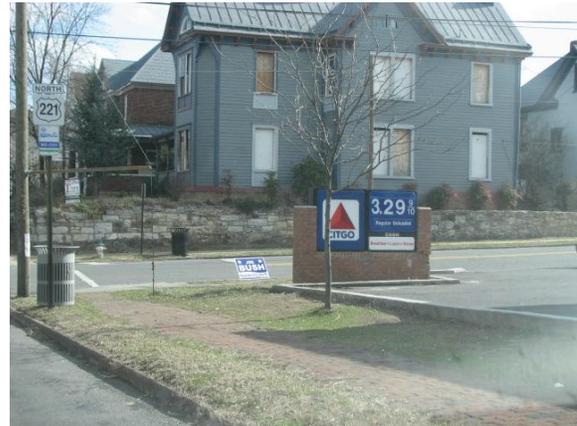
The bus stop at Elm Avenue and 5<sup>th</sup> Street is within the Old Southwest Village Center. While the activity at the stop is generated mostly from the nearby residences, there are some businesses that benefit from having a bus stop nearby. Valley Metro has been working with the Old Southwest Market (Citgo) property owners about installing a bus shelter on their property adjacent to the sidewalk. The sidewalk at the bus stop is brick. The landing pad, when extended from the back of the curb, should match the material and design of the existing sidewalk.

<b>Stakeholders</b>	Valley Metro, City of Roanoke, Citgo property owner
<b>Recommendations</b>	Install a small shelter and landing pad, extend the sidewalk to the back of the curb at the bus stop, relocate the trash can.
<b>Estimated Costs</b>	Small bus shelter = \$6,620 Labor/Installation = \$5,000 Permits/Site plans = \$895

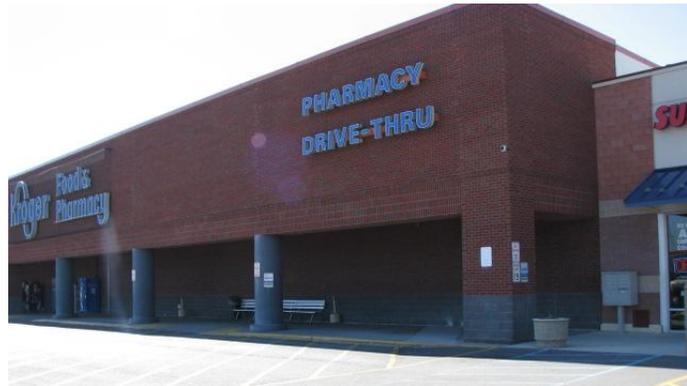
The Town Square Kroger bus stop exists as a place for the bus to turn around. The bus stop was put in place prior to the construction of the Aviation Drive/Towne Square Boulevard intersection. Now that the intersection exists, it opens up new opportunities to connect the Crossroads shopping area to the Valley View Mall shopping area.

The routes serving Valley View and Towne Square Kroger should be reviewed to determine if a connection can be established. If a redesign of the routes is possible, the existing stop at Kroger could be removed. Bus stops, Towne Square EB at Rutgers and Towne Square WB at Rutgers (Golden Corral) exist nearby to accommodate riders traveling to the Kroger shopping center.

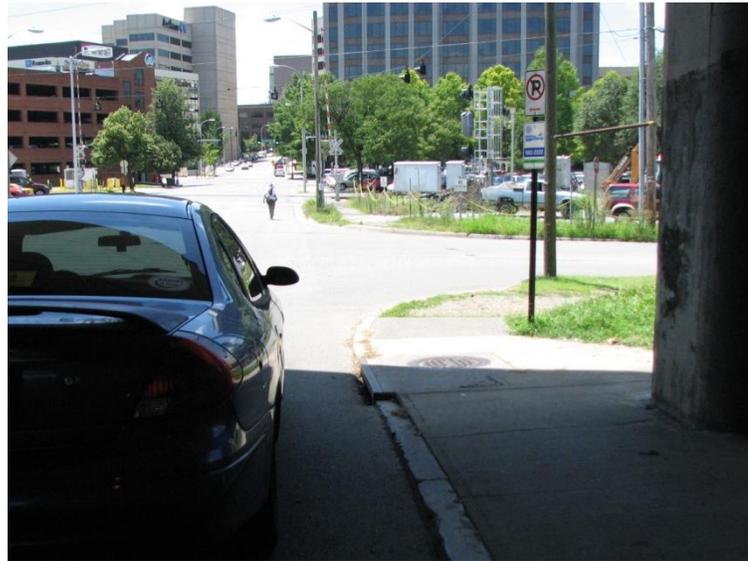
The Rescue Mission is the main generator of activity at this stop. From this stop, the bus travels inbound to Campbell Court. The bus stop is located at a drainage inlet. Currently, the I-581 bridge over Tazewell Avenue provides shelter. Lights mounted under the bridge provide light at night. There is parking adjacent to the bus stop, which prohibits the bus from pulling up to the curb. Lack of a sidewalk and curb ramp at the corner require people in wheelchairs to travel to the bus stop on the street and wait in the street for the bus to arrive. Waiting passengers are hidden from view of the approaching bus due to the parked vehicles.

<b>Stakeholders</b>	Valley Metro, City of Roanoke
<b>Recommendations</b>	Option 1: Construct a curb extension at the bus stop with new sidewalks and a small bus shelter. Curb ramps on three corners of the Tazewell/3 <sup>rd</sup> Street intersection are needed.
<b>Estimated Costs</b>	Curb extension and sidewalk connection = \$10,000 Crosswalk = \$1,000 Storm drain structure = \$5,000 Three curb ramps = \$12,000 Small bus shelter = \$6,620 Labor/Installation = \$3,395 Permits/Site plans = \$895

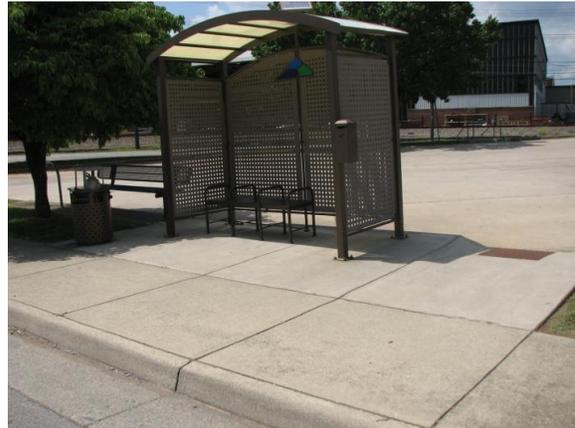
The Campbell WB at Norfolk stop at the Valley Metro Administration Building is a good example of an accessible bus stop. There is an access ramp leading from the stop toward the building. There is room under the shelter for a wheelchair. There is also an additional bench not associated with a shelter, a trash can, and a bike rack. While the stop itself is very accessible, getting to the bus stop could be improved by constructing a sidewalk on Campbell Avenue west of the Administration Building before it changes to Norfolk Avenue.

<b>Stakeholders</b>	Valley Metro, City of Roanoke
<b>Recommendations</b>	Improve the sidewalk and add ADA ramps on Campbell Avenue from 10 <sup>th</sup> Street to 10 ½ Street.
<b>Estimated Costs</b>	Curb, Gutter, Sidewalk for 600' = \$24,000 Three ADA ramps: Campbell/Norfolk, Campbell/10 ½ Street, Campbell/10 <sup>th</sup> Street = \$12,000 Labor/Installation = \$3,395 Permits/Site plans = \$895

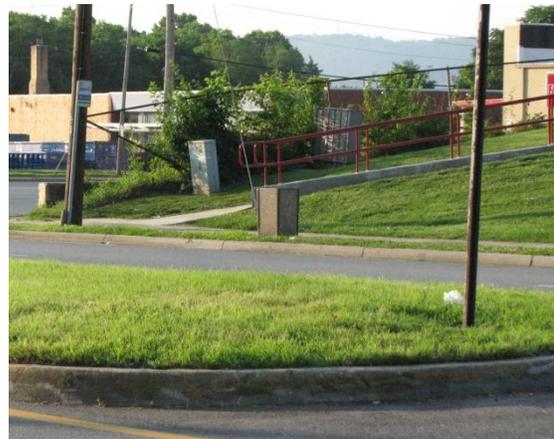
The Lansdowne Park apartments are the main activity generators at this bus stop. The bus route comes from the VA Hospital and heads inbound to Campbell Court. As such, most users are boarding the bus as opposed to alighting. The sidewalk needs to be extended to the curb to create an adequate landing area.

<b>Stakeholders</b>	Valley Metro, City of Roanoke
<b>Recommendations</b>	Extend the sidewalk to the curb at the bus stop to create an adequate landing area (5' wide x 8' deep) and install a bus shelter.
<b>Estimated Costs</b>	Small bus shelter = \$6,620 Labor/Installation = \$3,395 Permits/Site plans = \$895

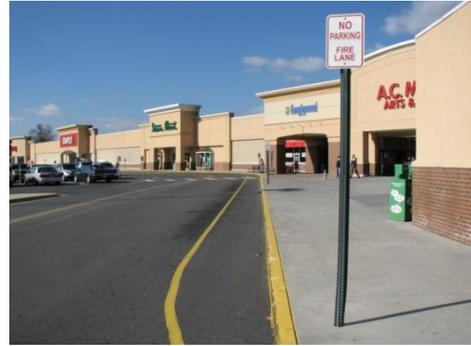
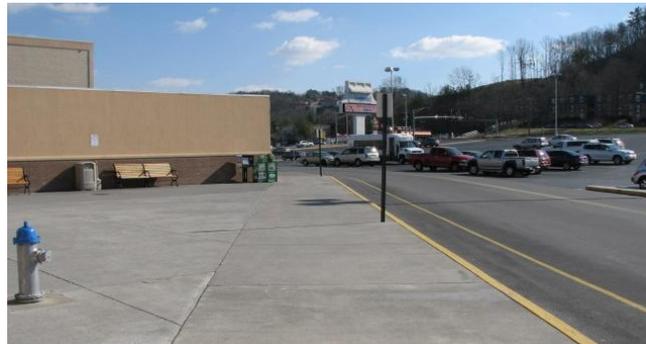
The Tanglewood Mall at AC Moore stop is convenient because it is located immediately adjacent to a primary mall entrance. Two buses fit easily in the space available and two-way traffic can pass even with the buses stopped. The “No Parking Fire Lane” signs that prohibit cars from parking along the curb also serve the dual purpose of providing a dedicated space for the buses. There is no bus stop sign here and one should be installed. The nearby benches shown in the picture above are part of the mall’s designated smoking area, yet the benches work well to also accommodate transit riders. The nearby building currently provides shelter as needed, but it is preferable to have a bus shelter closer to the bus stop.

<b>Stakeholders</b>	Valley Metro, Tanglewood Mall Management
<b>Recommendations</b>	Replace one of the benches with a large bus shelter.
<b>Estimated Costs</b>	Large bus shelter = \$9,450 Labor/Installation = \$3,395 Permits/Site plans = \$895

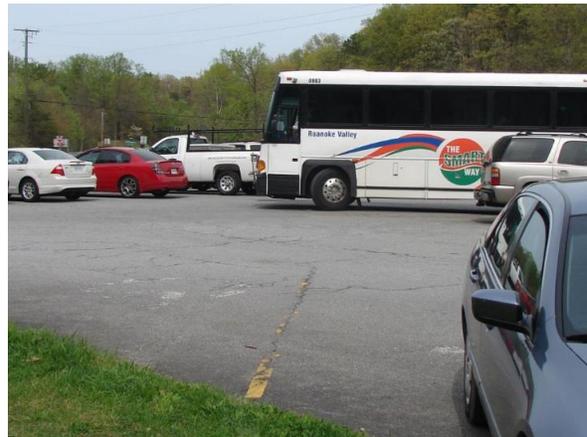
The Exit 140 Park and Ride lot was constructed in the 1970s as part of the I-81 Exit 140 construction. With the increase in gas prices, particularly since 2008, the lot has experienced consistent capacity and overflow use. The lot was expanded in 2009 when VDOT surface treated the adjacent overflow area. Recently, through the Regional Surface Transportation Program, the Exit 140 Park and Ride was selected for significant upgrades including repaving, the addition of curbs, lighting, trash receptacles, a bus shelter, bike rack, and stormwater measures. Currently, the regional Smart Way commuter bus is the only transit service at the Exit 140 Park and Ride lot. Improvements should be made with consideration of accommodating a connecting second bus or local transit service in the future. Additionally, the location of the bus shelter and bus turning radius should be coordinated with Valley Metro to ensure that the bus will be able to pull up flush with the curb. The current design, as shown, adequately connects handicap parking spaces with the shelter.

<b>Stakeholders</b>	Valley Metro, Roanoke County, VDOT
<b>Recommendations</b>	As the Exit 140 Park and Ride lot improvements are designed, stakeholders should coordinate to ensure that current and future transit services and amenities are adequately accommodated within the plan.
<b>Estimated Costs</b>	\$1,608,243.85 (per 2013 RSTP Project Application)

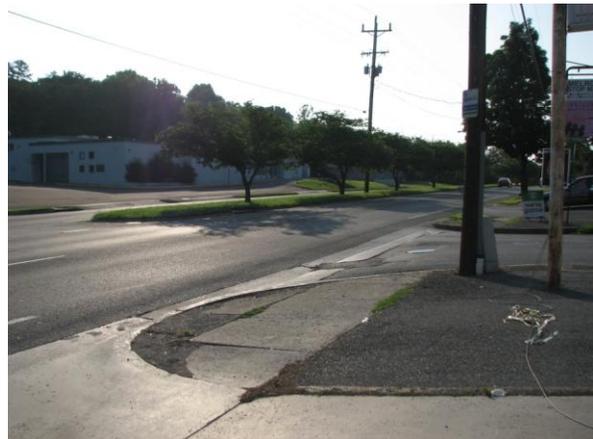
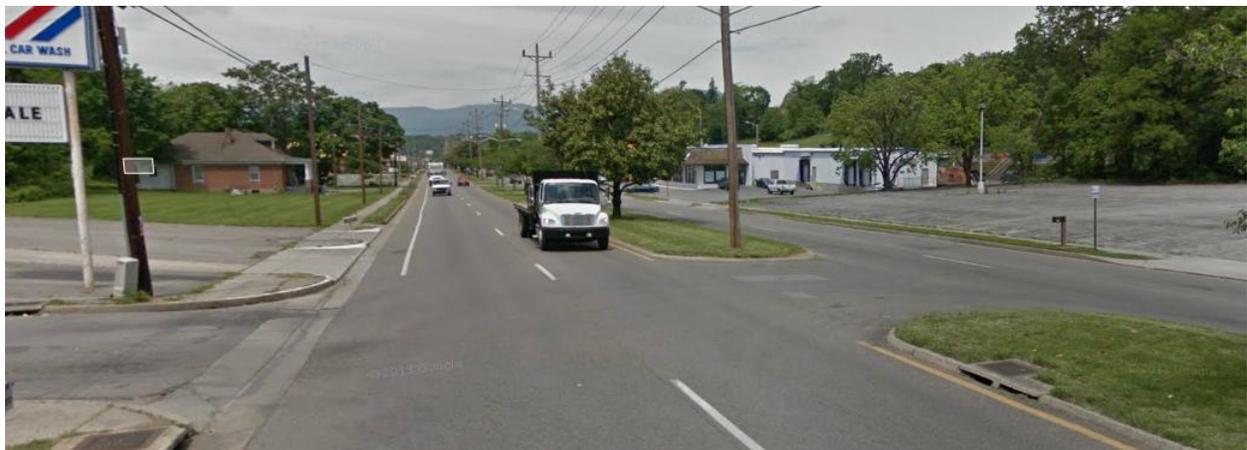
**30.) Melrose EB at 35th**

A large apartment complex is located up the hill off of 35<sup>th</sup> Street and is the main generator of activity at this stop and its companion stop, Melrose WB at 35<sup>th</sup> (which actually is #31 in the ranking of most active stops). Nearby driveways serve as curb ramps for riders crossing the street. The current landing area is not level and should be repaved.

Consideration should also be given to closing the driveway adjacent to the bus stop on Melrose Avenue. Two driveways next to each other currently serve the same building, which at the time of the site visit was vacant. A crosswalk on Melrose Avenue connecting the two bus stops along with signage and pedestrian activated flashing lights as well as a pedestrian refuge within the existing median would provide a safer crossing.

<b>Stakeholders</b>	Valley Metro, City of Roanoke, Adjacent property owner (The Clean Machine Car Wash)
<b>Recommendations</b>	Stripe a crosswalk across Melrose Avenue with signage and flashing lights, repave the landing area and close one driveway nearest the stop. Install a small bus shelter. Various ADA ramps at the intersection of Melrose Avenue and 35 <sup>th</sup> Street and at the pedestrian crossing.
<b>Estimated Costs</b>	Small bus shelter = \$6,620 Curb, gutter and sidewalk reconstruction at the driveway = \$4,000 Four ADA ramps = \$16,000 Crosswalk, flashing lights, tactile warning surfaces in the median refuge, signage = \$22,500 Labor/Installation = \$3,395 Permits/Site plans = \$1,790

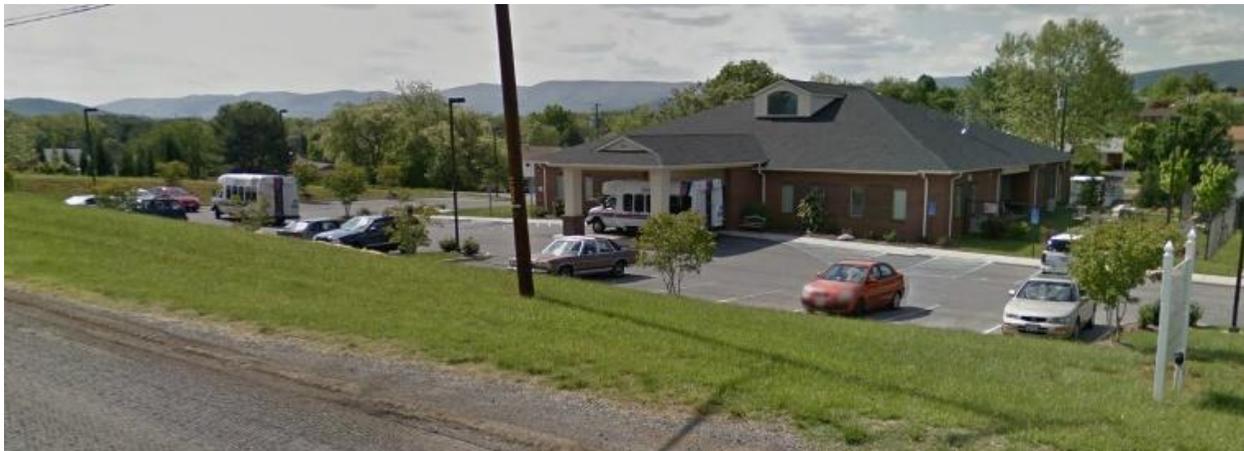
The nearest bus stop, Roanoke Blvd WB at Disabled Veterans Store, is not a high activity stop though the bus stops there about every other time it passes to either pick up or drop someone off. The current bus stop location is not ideal in that the bus blocks the adjacent driveway when stopping. It would be preferable to shift the stop in front of or directly adjacent to the Adult Day Care and construct a bus pull-off so that the bus does not impede traffic flow. Given that a rider who accesses this location may be a wheelchair, the bus may be stopped for an extended period to drop-off or pick-up a passenger. Certainly ADA improvements between the bus stop and the facility would make riding the fixed-route bus a better option for someone who is able to use the service and would like the opportunity. Given the high cost to local governments for each passenger transported on paratransit, any improvements that enable people to use the fixed-route bus is beneficial for everyone.

<b>Stakeholders</b>	Valley Metro, City of Salem, Adult Day Care management
<b>Recommendations</b>	Construct a bus pull-off on Roanoke Blvd. just east of the Adult Day Care driveway. Construct a landing pad, a large shelter, and a sidewalk connection to the Adult Day Care.
<b>Estimated Costs</b>	Large bus shelter = \$9,450 Labor/Installation = \$3,395 Permits/Site plans = \$895 Bus pull-off paving, curb, gutter = Sidewalk connection =

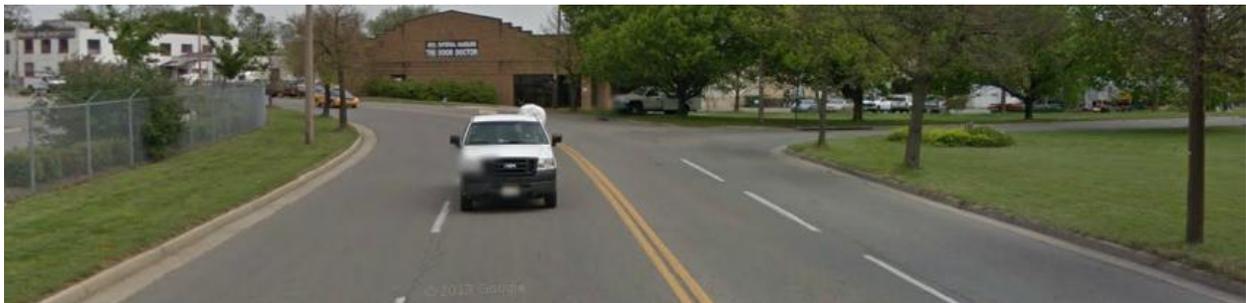
The Northwest Dialysis Center is about a quarter-mile from the closest bus stops at Orange Avenue and Plantation Road. There are no sidewalks from the bus stop to the Center, which is located in a cul-de-sac on 7<sup>th</sup> Street, up a small hill off of Plantation Road. The bus stops experienced very little to no activity during the NTD survey. In order for people to access the Northwest Dialysis Center, a pair of bus stops would need to be located at the Plantation Road and 7<sup>th</sup> Street intersection and involve placing bus service on Plantation Road, which does not exist currently. Dialysis patients are encouraged to exercise and walking a short distance to/from the bus stops would be a natural way to maintain physical activity. Providing a bus stop at the Plantation Road/7<sup>th</sup> Street intersection with sidewalks to the Center would make the option to take fixed-route bus service a possibility.

<b>Stakeholders</b>	Valley Metro, City of Roanoke
<b>Recommendations</b>	Provide fixed-route bus service on Plantation Road, construct a pair of bus stops with landing pads, a crosswalk across Plantation Road, and a sidewalk connecting the stops to the Dialysis Center.
<b>Estimated Costs</b>	Small bus shelter = \$6,620 Labor/Installation = \$3,395 Permits/Site plans = \$895 Crosswalk striping = \$1,000 Two driveway reconstructions = \$8,000 Three curb ramps = \$12,000 Sidewalk connection (approx. 700') = \$24,500
