# BUS STOP ACCESSIBILITY STUDY DRAFT REPORT

*Roanoke Valley Area Metropolitan Planning Organization*  
August 2013

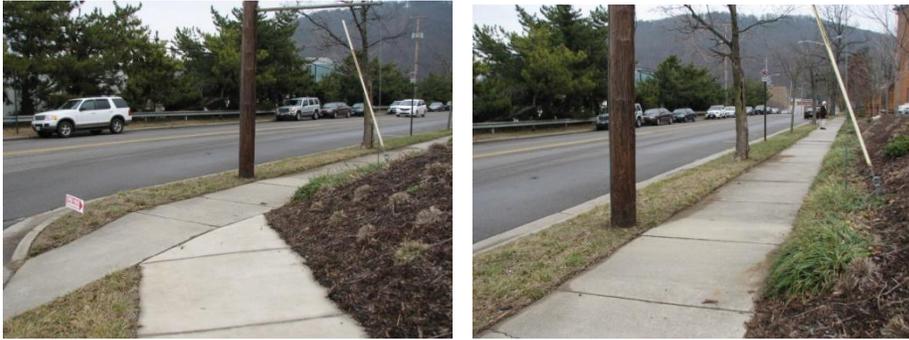
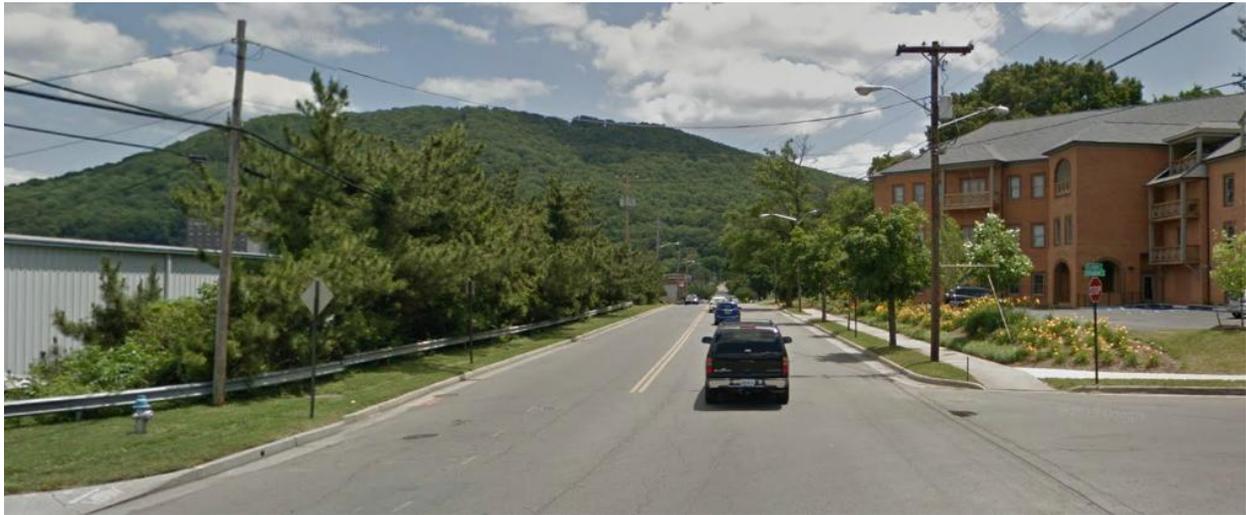
#### 4.) Crystal Spring Dialysis

The closest stops to the Crystal Spring Dialysis Center would be at McClanahan Street and Rosalind Avenue or on Franklin Road at the Pure Gas Station. Neither location is accessible for people getting to the Dialysis Center. There is a lack of sidewalk connections along McClanahan Street and no safe crossing across Franklin Road. The Franklin Road stops are more than a quarter-mile away and the McClanahan stops are just at a quarter-mile away. Neither are attractive options for dialysis patients, regardless of infrastructure deficiencies. In order to make the fixed-route bus an option for dialysis patients, the bus route would need to be evaluated to see if there is a way to route it past the building. Such a route and corresponding bus stops could be incorporated into an improved connection between Roanoke Carilion Memorial Hospital and Towers Shopping Center.

<b>Stakeholders</b>	Valley Metro, City of Roanoke
<b>Recommendations</b>	Consider options for routing a bus past the Crystal Spring Dialysis Center. If a route is possible, construct a small bus shelter, landing pad, and crosswalk across McClanahan Street to a companion stop that features the same amenities.
<b>Estimated Costs</b>	Two small bus shelters = \$6,620 Labor/Installation = \$6,790 Permits/Site plans = \$895 Crosswalk striping = \$1,000 Curb ramp = \$4,000

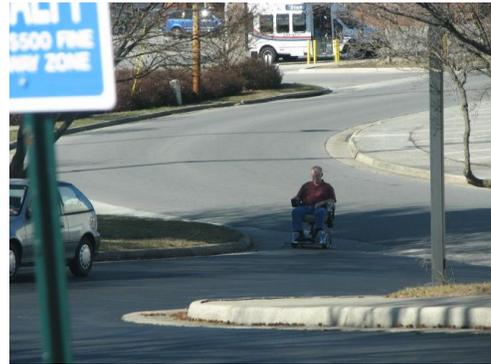
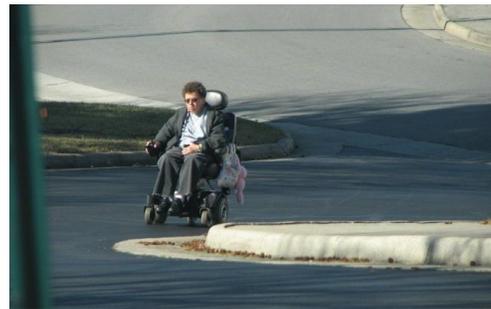
## 5.) Clearview Manor Apartments

Bus service at Clearview Manor is limited; the 36 bus stops there six times a day on its way into Campbell Court. For people to take the bus back to Clearview Manor, because service is not bi-directional, they must take the 31, which turns into the 36, and ride around most of Vinton before reaching Clearview Manor. The actual bus stop at Clearview Manor is missing a sign.

During the site visit, several people in wheelchairs were seen traveling on the road from the direction of the Lake Drive Plaza shopping center headed to the apartment building. They were clearly comfortable traveling in their wheelchair and able to get to nearby destinations on their own. They were using the street instead of the sidewalk due to missing curb ramps along their route which prevented them from using the sidewalk. Given an accessible route, some residents at Clearview Manor Apartments would probably feel comfortable traveling to Hardy Road to use the fixed-route bus service. The closest bus stops are Hardy EB at Vinyard (McDonalds) and Hardy WB at Bedford. If the latter is relocated as suggested previously, another stop near the Hardy Road/Vinyard Road intersection should be constructed to be the companion to Hardy EB at Vinyard (McDonalds).

One option for an accessible route between the Apartments and the Hardy Road bus stops would be to continue the sidewalk on the east side of Vinyard Road from the pool to the main shopping center driveway. Then stripe a crosswalk on the south side of the driveway leads to a new sidewalk connection on the west side of Vinyard Road continuing north to the existing McDonalds sidewalk. The Hardy Road/Vinyard Road intersection itself needs crosswalks striped and pedestrian signals.

<b>Stakeholders</b>	Valley Metro, Town of Vinton, Adjacent property owners
<b>Recommendations</b>	Provide a bus stop inbound near the Hardy Road/Vinyard Road intersection. Construct sidewalk connections and curb ramps between the Clearview Manor Apartments and the bus stops on Hardy Road. Install pedestrian signals at Hardy Road/Vinyard Road and crosswalks.
<b>Estimated Costs</b>	Small bus shelter for inbound stop = \$6,620 Labor/Installation = \$3,395 Permits/Site plans = \$895 Crosswalk striping = \$1,000 Eight curb ramps = \$32,000 Sidewalk connection (approx. 500') = \$17,500 Pedestrian signal = \$40,000

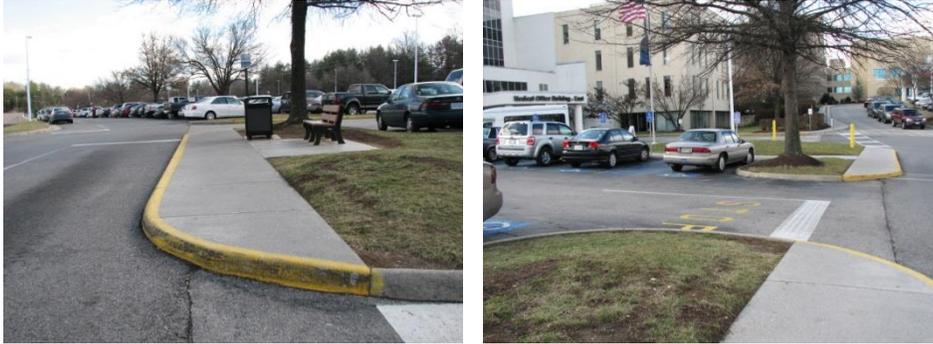
*Lewis Gale Medical Center sidewalks around the bus stop need ADA ramps*

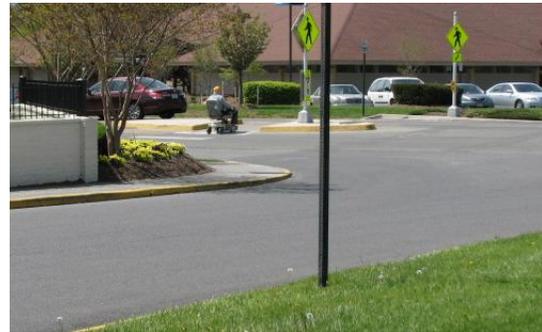
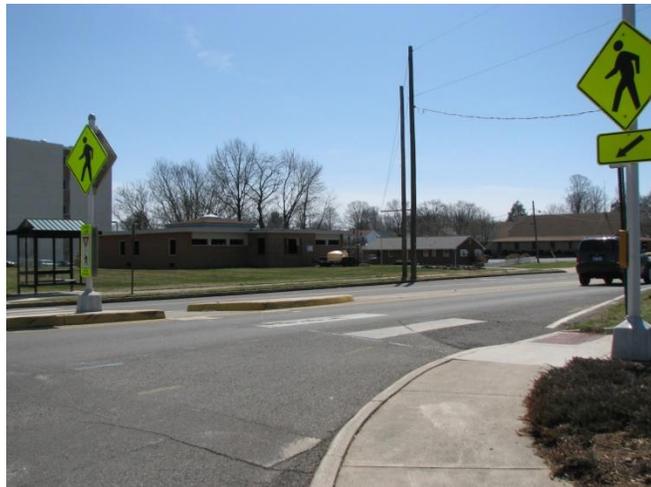
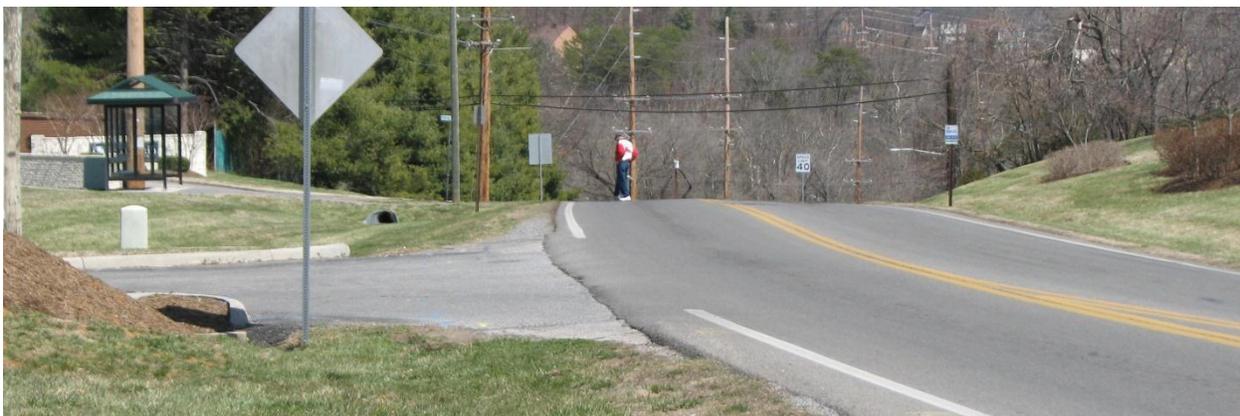
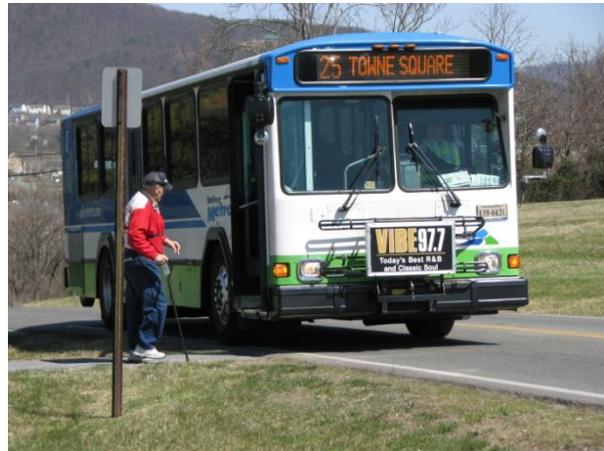
Friendship Manor Retirement Community provides many services to senior citizens including independent living. There are four bus stops available to the Community. At the time of this writing, Friendship Manor is undergoing plans to relocate the main driveway on the south side of Hershberger Road, which will affect the sheltered bus stop. The design consultant has been in contact with Valley Metro about how to incorporate the bus stop in the new configuration.

The current bus stop amenities are an example for the region on how to make bus stops safe, accessible, and easy to use. As shown in the pictures, when safe facilities are provided, senior citizens and people with disabilities will use them. There is a bus shelter, a marked crosswalk with pedestrian signage and a signal that when activated flashes warning lights on the signs. The bus stops are clearly companions, which make it easy for people to understand that they function together as boarding and alighting stops.

The four bus stops available to Friendship Manor should, for efficiency and minimization of financial resources, should be combined into two bus stops, one on either side of Hershberger Road. Upon visiting the location and reviewing the conceptual Friendship Manor renovation plans, the stops are recommended for the locations shown in the diagram below. At these locations, if possible, bus pull-offs should be constructed so as to not cause traffic to stop behind the bus. Each bus stop should feature a small bus shelter with an adequate landing pad and similar pedestrian crossing as is currently provided.

<b>Stakeholders</b>	Valley Metro, Friendship Manor Retirement Community management, VDOT, Roanoke County, City of Roanoke
<b>Recommendations</b>	Construct new bus stops with the Friendship Manor entrance reconstruction including a new pedestrian median and crosswalk, landing pads, and bus shelters.
<b>Estimated Costs</b>	Two small bus shelters = \$ Two curb ramps = \$8,000 Labor/Installation = \$3,395 Permits/Site plans = \$895

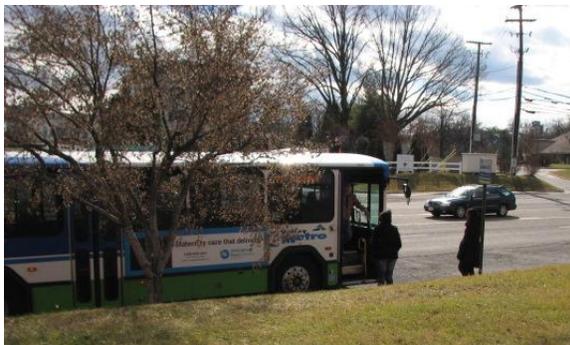
*Brandon WB at Stratford Park (Brandon Oaks)*

Stratford Park Residential Apartments are located up a small hill off of Brandon Avenue. The main building is a quarter-mile from the nearest bus stop. Sidewalks are lacking between the

bus stop and the building. People now walk along the Clear Channel Radio driveway and through the parking lot behind the building to travel between the bus stop and the residential building which while not ideal, works fairly well.

Of most difficulty, because the apartments are located on a bi-directional route, to use the bus efficiently, people must also use the bus stop on the opposite side of the road. This section of Brandon Avenue is a five-lane 35 mph roadway. In order to safely use the fixed-route bus people need to either ride to the route endpoint (Lewis Gale or Campbell Court) and loop around or get on/off at a farther stop where it is safer to cross. However, some people will

<b>Stakeholders</b>	Valley Metro, City of Roanoke, Brandon Oaks Retirement Community management
<b>Recommendations</b>	Construct a pedestrian refuge and install a traffic signal to be activated only by a pedestrian for crossing Brandon Avenue. Install small bus shelters at the bus stops and widen the landing area to the standard size.
<b>Estimated Costs</b>	Two small bus shelters = \$13,240 Two small retaining walls = \$10,000 Pedestrian island and crosswalk= \$22,500 Traffic signal = \$150,000 Two curb ramps = \$8,000 Labor/Installation = \$6,790 Permits/Site plans = \$895

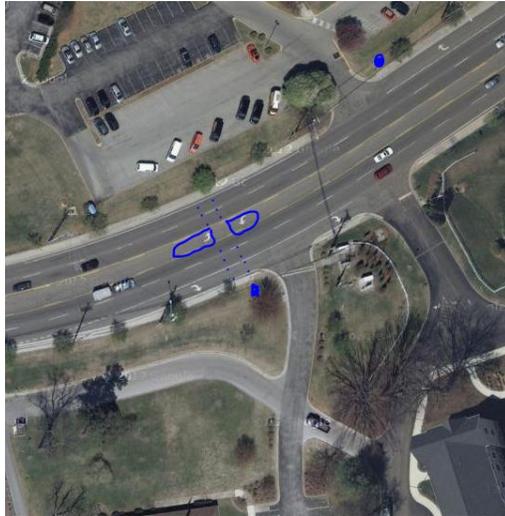
simply take their chances, like the woman in the picture above, and cross the road because the other options, although safer, are time-consuming and frustrating.

To make it safer for pedestrians to cross the street, a pedestrian island with crosswalks, flashing warning lights, and push buttons are recommended. With these accommodations, for example, a pedestrian crossing from the south to the north would push a button to activate flashing lights on sign posts and in the pavement along the crosswalk that would warn eastbound motorists to stop for the pedestrian crossing. Once in the median, the pedestrian would push another button to activate the second set of flashing lights, wait for westbound vehicles to stop, and

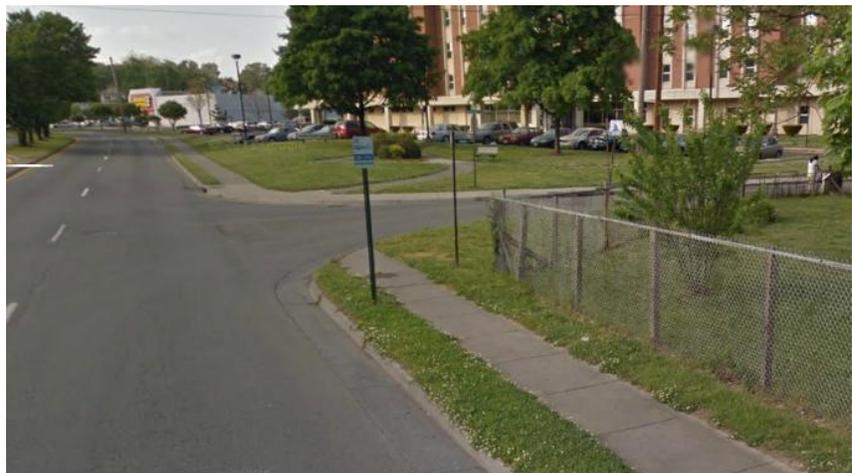
Morningside Manor is a residential facility for lower income or elderly people. The Montrose WB at 13<sup>th</sup> bus stop is part of the Kenwood Loop, which has transit service only a handful of times every day. The low activity index may be due to low sampling during the NTD survey and lower use than other stops on a regular route. This stop however does feature a bus shelter and adequate landing pad.

No other improvements are needed. The 13<sup>th</sup> NB at Montrose stop had a higher activity index, probably because it has service every hour. This stop however, does not have a bus shelter and one is needed. The route itself is inconvenient for residents because in order to get to Downtown Roanoke, they need to loop through Garden City. Residents also have the option of walking to Dale Avenue and catching a direct bus into Campbell Court, but are then faced

<b>Stakeholders</b>	Valley Metro, City of Roanoke
<b>Recommendations</b>	Install a bus shelter at the 13 <sup>th</sup> NB at Montrose stop with a landing pad and directional curb ramps across Montrose Avenue.
<b>Estimated Costs</b>	Small bus shelter = \$6,620 Two curb ramps = \$8,000 Labor/Installation = \$3,395 Permits/Site plans = \$895

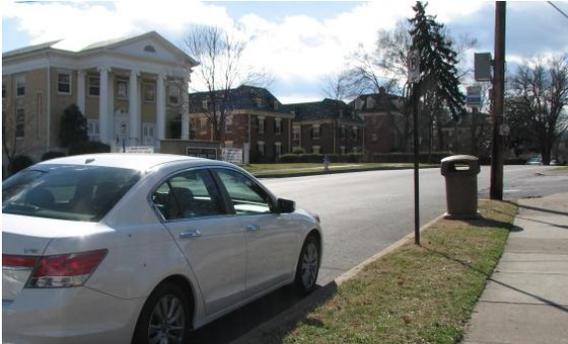
*Grandin SB at Windsor*

People traveling to Raleigh Court Health and Rehabilitation Center have good access to bus stops located at the intersection near the property. With few improvements, these stops will be easily accessible for people. At the Grandin SB at Windsor stop, the No Parking sign needs to be moved further north, away from Windsor Avenue, in order to allow room for the bus to pull up to the curb. The sidewalk also needs to be extended to the curb to better accommodate the wheelchair lift. The Grandin NB at Windsor bus stop is accessible in its current state. There are accessible ramps on each street corner and there is a landing pad that extends from the curb to the sidewalk. As opposed to its companion across the street, this bus stop is considered a “boarding” stop because most people who use it are getting on the bus rather than getting off. This bus stop would be a good candidate for a bus shelter with lighting.

<b>Stakeholders</b>	Valley Metro, City of Roanoke
<b>Recommendations</b>	Install a bus shelter at the Grandin NB at Windsor stop and a landing pad at the Grandin SB at Windsor stop. Remove parking at the bus stop on the southbound side of Grandin Road.
<b>Estimated Costs</b>	Small bus shelter = \$6,620 Landing pad = \$140 Labor/Installation = \$3,395 Permits/Site plans = \$895

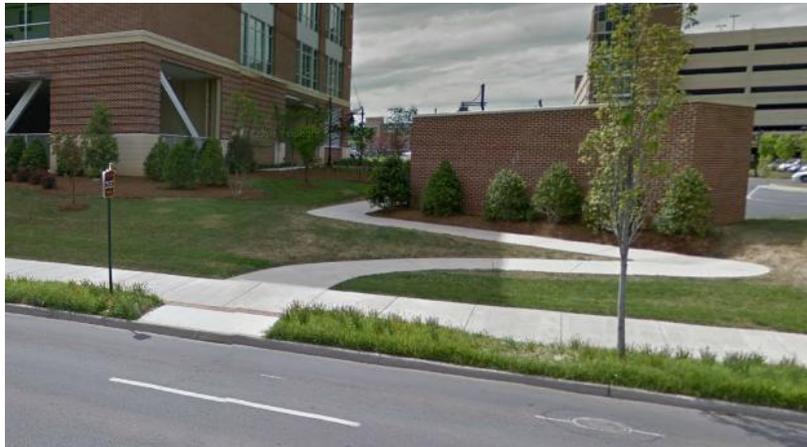
Carilion Clinic is located along the trolley line. The nearest Valley Metro fixed route is about a half-mile away at Walnut Avenue or Carilion Roanoke Memorial Hospital. People traveling to Carilion Clinic may alight at Campbell Court and walk a block to the nearest Star Line Trolley stop or take the fixed-route service to the Hospital and transfer to the trolley. The Jefferson SB at Reserve stop is likely

primarily an alighting stop. It is an accessible location with an adequate landing pad and pathway to the Clinic. A small shelter would be appropriate for people traveling southbound.

<b>Stakeholders</b>	Valley Metro, City of Roanoke
<b>Recommendations</b>	Install a small bus shelter at the stop.
<b>Estimated Costs</b>	Small bus shelter = \$6,620 Labor/Installation = \$3,395 Permits/Site plans = \$895

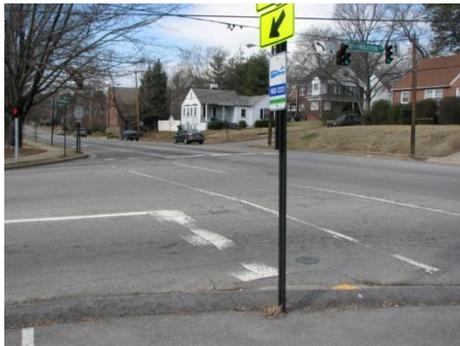
*Brambleton NB at Brandon*

This private residence is closest to the bus stops at Brambleton Avenue and Brandon Avenue. Accessibility at the Brambleton SB at Brandon stop would be improved by extending the sidewalk to the curb. Additionally, directional curb ramps need to be constructed on the southeast and southwest corners of the intersection to allow wheelchairs to cross Brandon Avenue and Brambleton Avenue. The Brambleton NB at Brandon stop should be relocated to Brandon Avenue just beyond the Oak Hill Commons shopping center. A sidewalk would need to be constructed to connect the bus stop to the shopping center. Given the low activity levels at both stops, neither would be a priority for a bus shelter.

<b>Stakeholders</b>	Valley Metro, City of Roanoke
<b>Recommendations</b>	Relocate Brambleton NB at Brandon to Brandon Avenue. Construct curb ramps on both sides of Brambleton Avenue at Brandon Avenue. Extend the sidewalk to the back of the curb on the southbound stop.
<b>Estimated Costs</b>	Two curb ramps = \$8,000 Sidewalk approx. 60' long = \$2,100 Landing pad = \$280 Labor/Installation = \$3,395 Permits/Site plans = \$895

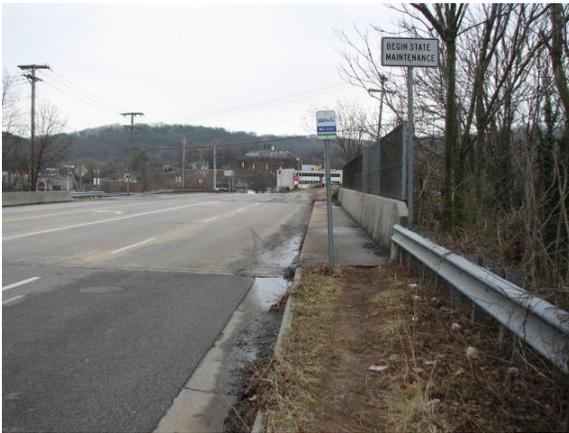
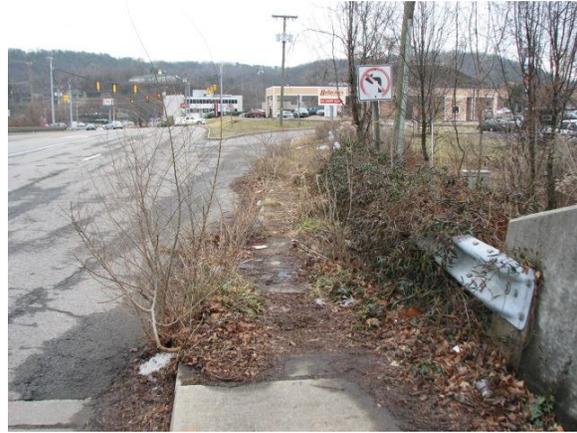
Pain Management is located off of Fallowater Lane, a half-mile from the nearest fixed-route bus stop on Ogden Lane. The path to travel from the stop to Pain Management is missing sidewalks both along the street and within the developments that exist between Ogden Road and the Pain Management facility. A bus route and stop should be considered for Starkey Road or Electric Road that would provide better access to this location.

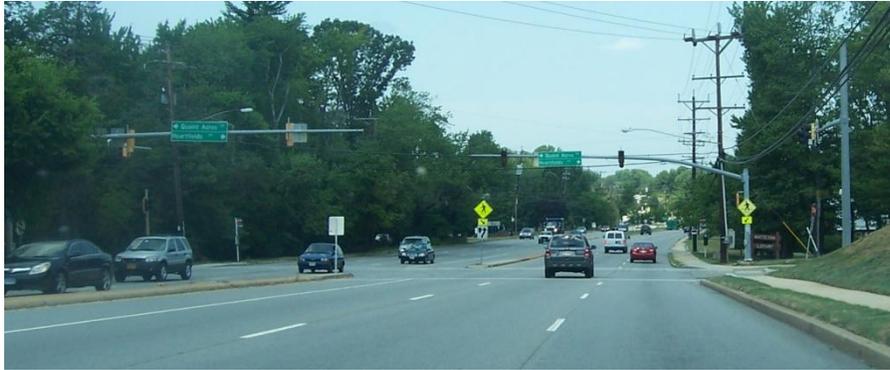
A pedestrian-activated signal is present on New Hampshire Avenue in Montgomery County Maryland. The bus stop is located on the left side of the picture; Sunrise Senior Living is located to the right. The signals on the mast arms are typically black and are only activated by a pedestrian pushing a button.

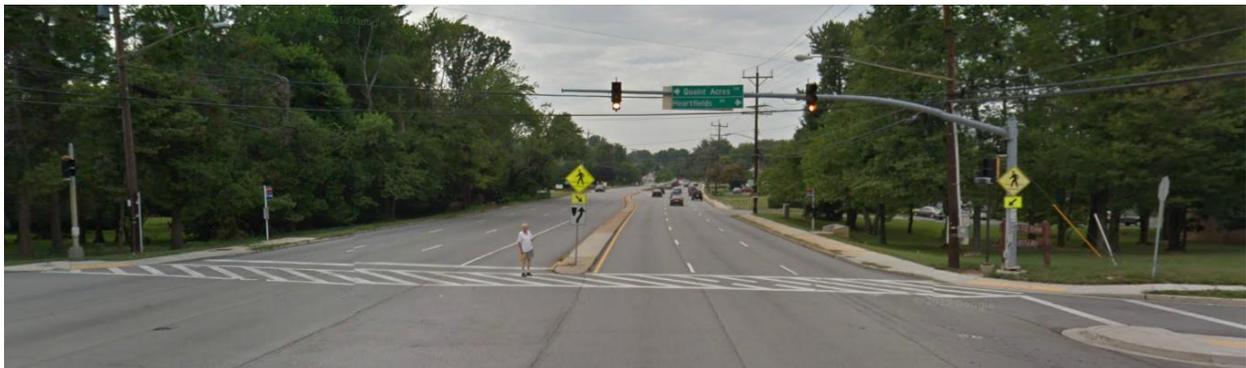
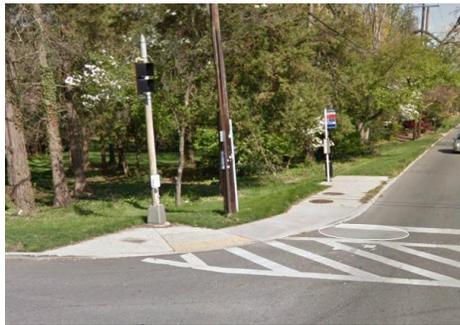
Google through Google Maps captured the image above of an elderly man crossing the street with the signal activated. With these accommodations, using public transit is made possible because walking across a six-lane highway to reach a destination can be accomplished safely.

Infrastructure costs can be minimized by focusing on the essential features. In this picture, sidewalks are provided only from the bus stop to the curb ramp on the corner.

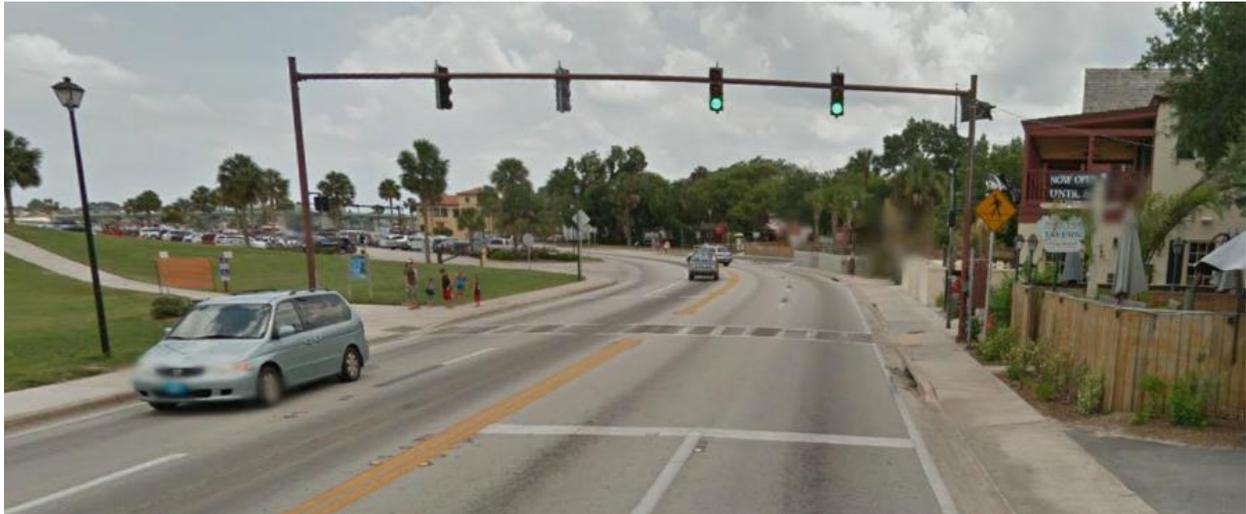
In St. Augustine, Florida, on S. Castillo Drive, a traffic signal was installed for the sole purpose of allowing a safe pedestrian crossing across a four-lane highway that separates the Castillo de San Marcos National Monument area from the St. Augustine tourist area. The traffic signal is green unless activated by a pedestrian which turns the light red.

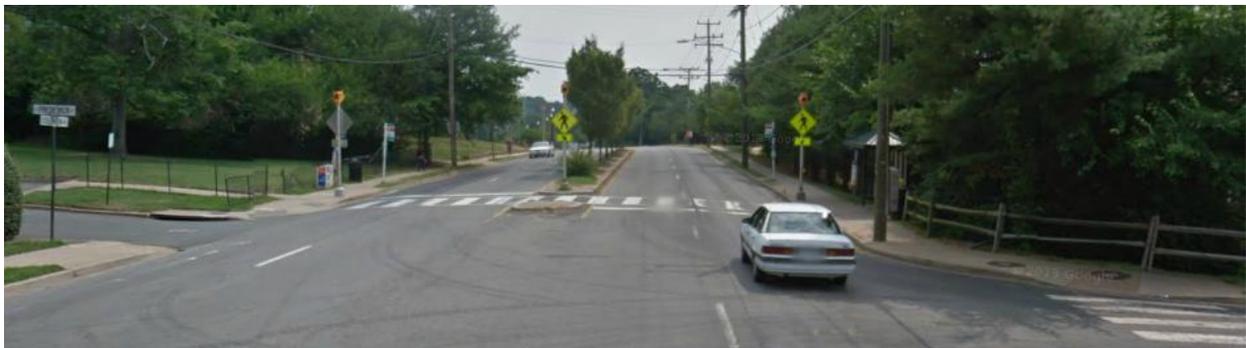
The picture below shows Columbia Pike, a four-lane arterial, featuring a pair of bus stops with a crosswalk connecting the two. The crosswalk is highlighted with pedestrian-activated flashing lights and signage, similar to the pedestrian crossing on Hershberger Road at Friendship Manor. In the picture, a bus shelter is placed on the inbound side where most riders board the bus. The companion stop does not have a shelter because it is used mainly for alighting.

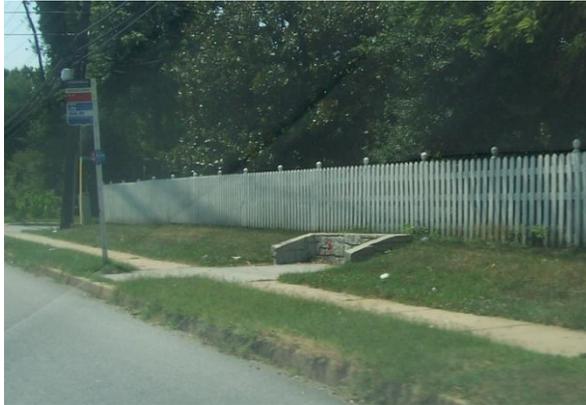
This bus stop features a landing pad from the back of the curb, 8' deep, bordered by a decorative wall used to separate the pad from the soil. The short wall serves as a retaining wall and a bench.

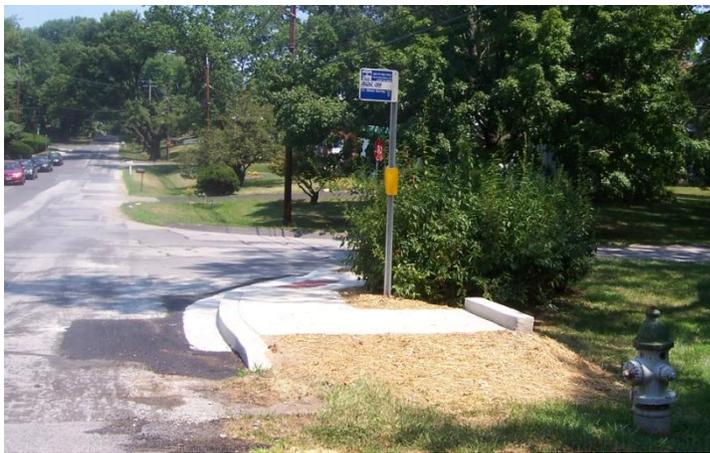
This is a basic bus stop that meets the needs of a person in a wheelchair. It is a 5' wide by 8' deep concrete pad with a curb along the backside for safety. The bus stop is connected to a short sidewalk and curb ramp. For an area in a local residential neighborhood, that does not have sidewalks and pedestrians are expected to walk on the low traffic streets, this bus stop does a nice job to provide a safe place for people to wait for the bus.

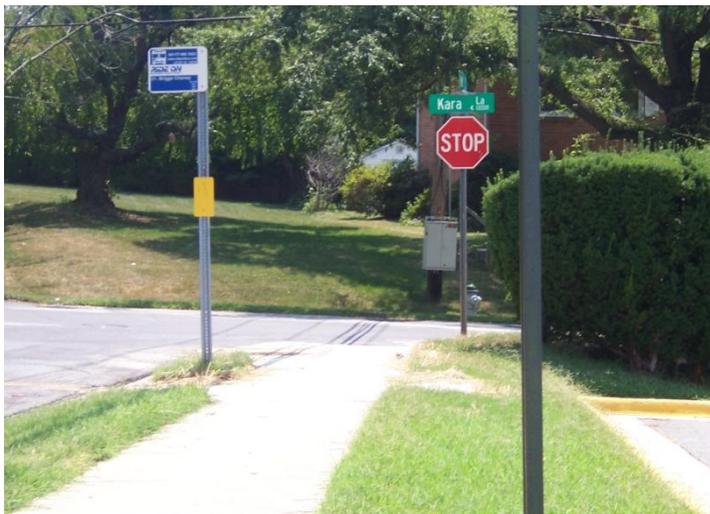
This bus stop is the most basic of accessible bus stops. The picture shows how the sidewalk has been extended to the back of the curb and out towards the adjacent parking lot, accomplishing the minimum 5' x 8' landing pad.

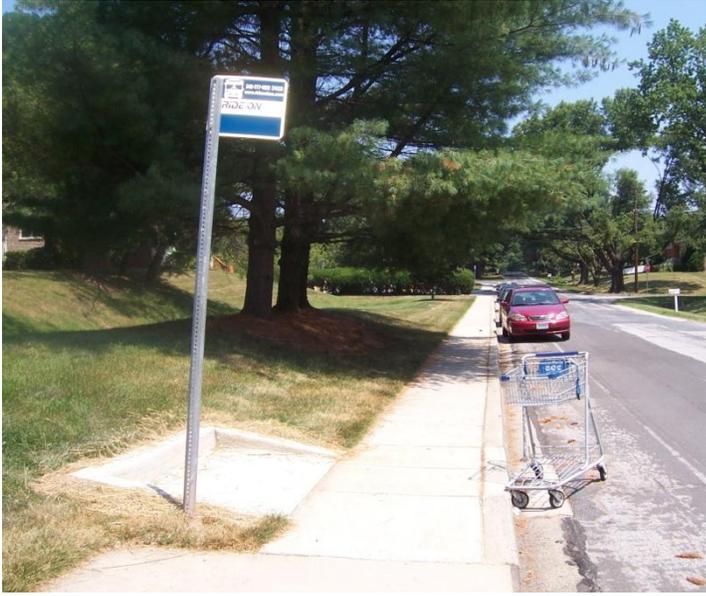
This bus stop features a landing pad bordered by a curb used to separate the pad from the hill. The curb also serves as a pseudo-bench.

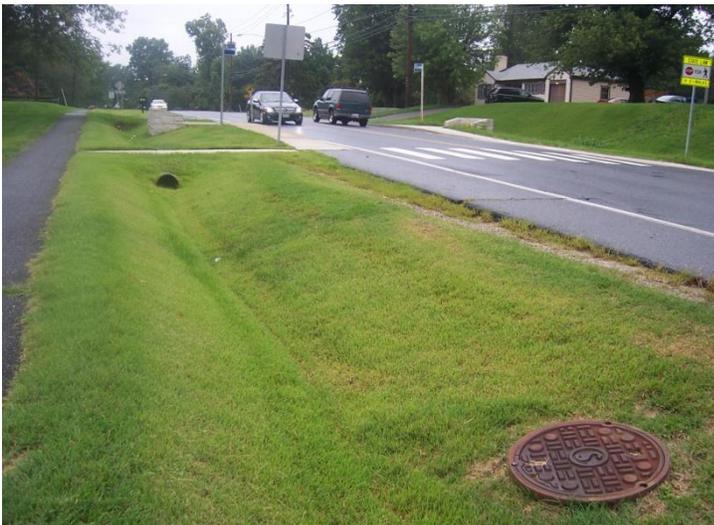
The adjacent pictures show an excellent example of how to accommodate multiple modes within a corridor in a low-density area. This two-lane road features on-street bike lanes, a pair of bus stops with simple built-in benches, a clearly marked crosswalk, a sidewalk leading from the crosswalk over the drainage ditch to a shared-use path. The bus stop features a raised concrete landing area that has also been incorporated into the bike lanes. The only additional recommendation may be a trash can; garbage seems to have accumulated in the ditch.

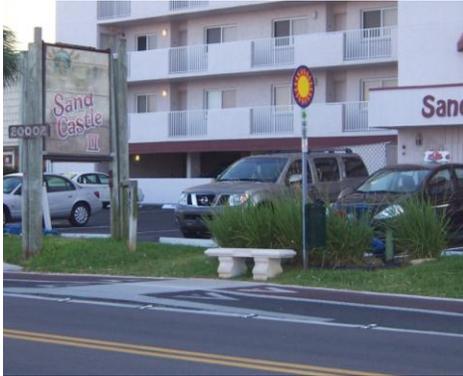
Gulf Boulevard is a two-lane street in Indian Shores, Florida. It features a bicycle lane in black, an on-street pedestrian lane in red, no curb, and a signed bus stop area. The bus stop features include a slightly raised concrete platform leading to a bench, schedule and route signage, and a small trash receptacle.

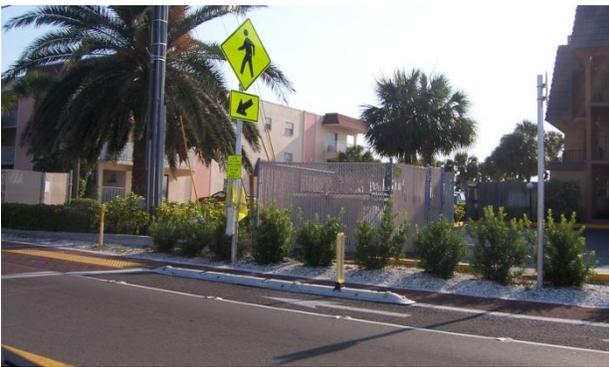
A person in a wheelchair can safely wait for a bus on the landing area within the red, pedestrian zone. In the picture below, on the right-hand side, a bus shelter is also shown. It is highlighted in the bottom picture.

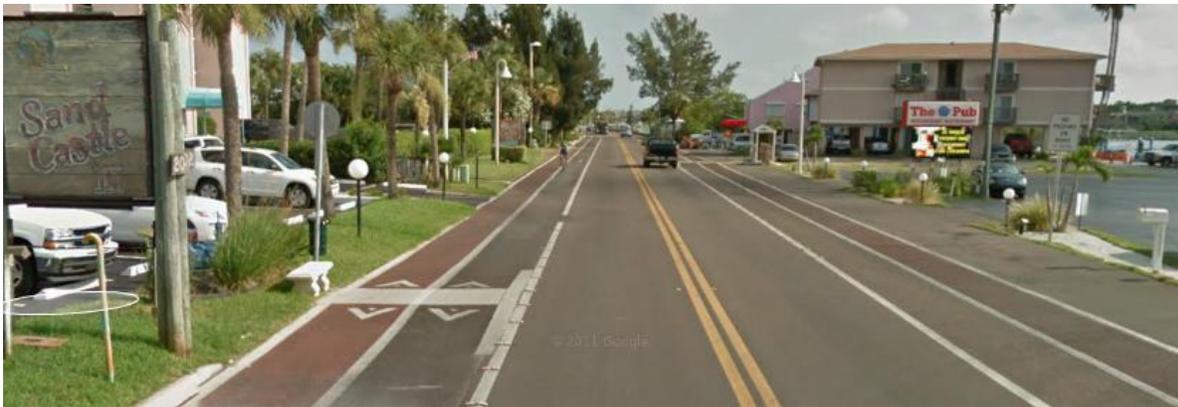
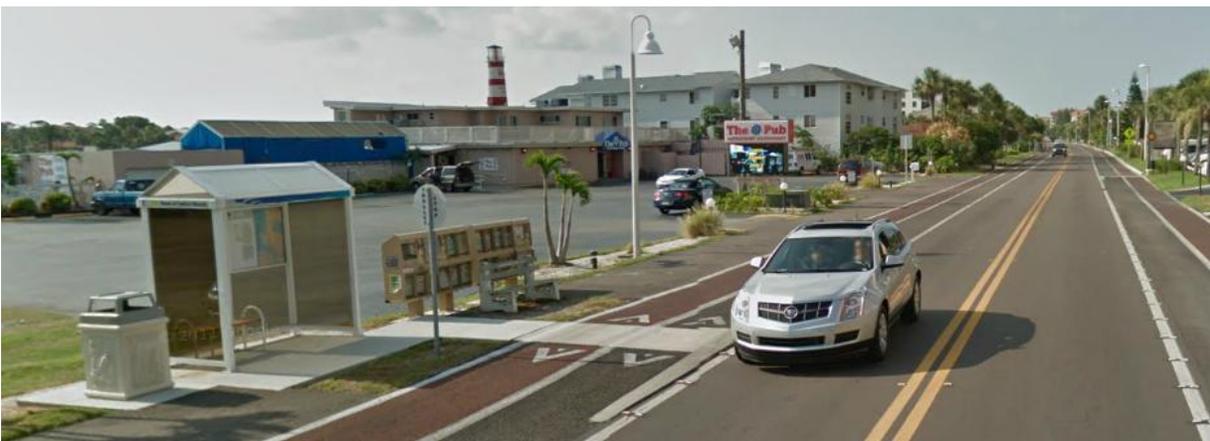
In the same area, a pedestrian crosswalk provides yellow flags for use in the dark. Pedestrians carry across a reflective flag to warn motorists of a pedestrian in the crosswalk. The flag is then deposited in a container on the opposite side of the street. The example shows strategic use of limited space within a right-of-way to provide a multimodal corridor which minimizes infrastructure and costs by using striping and colors instead of concrete.
