## BIKE/WALK/DISABILITY AUDIT: Pollard St

Date: 03 April 2019

Route: Bicycle – Pollard St from Washington Ave to Virginia Ave, turn right on Virginia Ave to Glade Creek, then return. Discussion of bicycle accommodations on Virginia Ave will be included in the next report with the walk & disability audit of Virginia Ave.

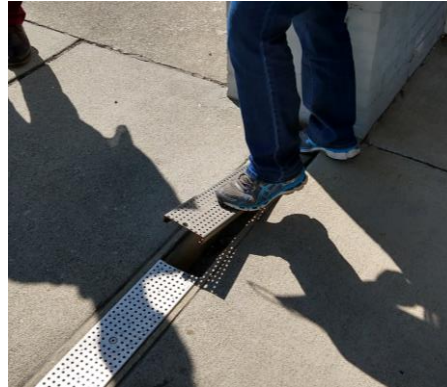
Loose drain cover

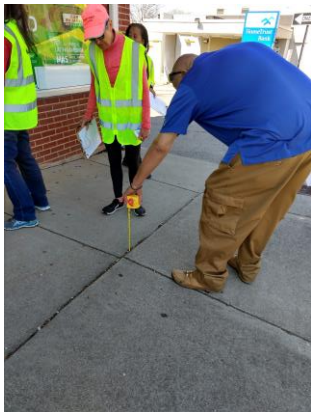
Settled sidewalk >1/4 inch

Disability: Some small actions would improve the 3-block section from Pollard to Blair for people with disabilities: grind down lips at storm drains and crosswalks, clean up debris. When pedestrian improvements are made at Pollard and Washington, consider high visibility crosswalks.

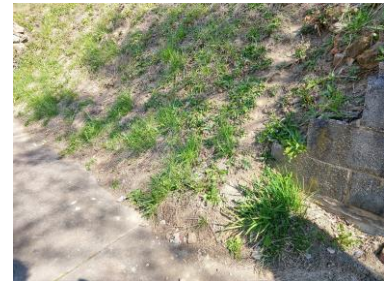
Collapsed retaining wall

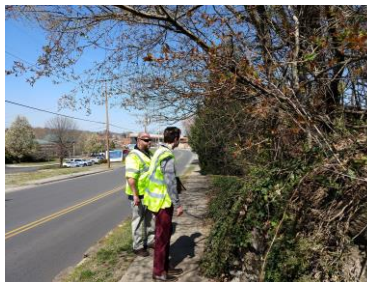
- Three entrances to Helado Bar could be combined, eliminating potential conflict points with pedestrians.
- Several metal grates have worked loose and need secured.
- Encroachment of vegetation, obstacles, and sidewalk disrepair constrain it to <4 feet in spots. Vegetation in particular on the east side along the parcel that is south of Jefferson Ave. Soil from a collapsed retaining wall encroaches on the sidewalk on the east side just north of Virginia Ave.
- Some uneven settling should be ground down.
- Rubber mat in front of Farmburguesa could be a trip hazard.
- A protruding square near a building downtown on the east side is a trip hazard.

Vegetation encroaching on sidewalk

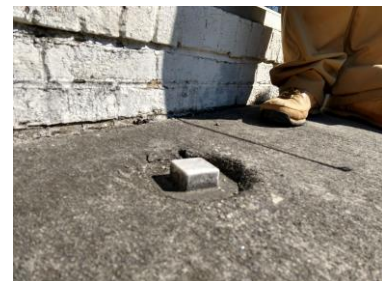
Protrusions like this are a trip hazard

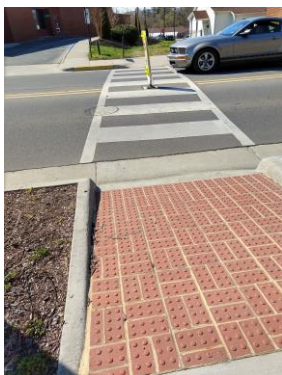
Crosswalks: The crosswalk at the library has extensive tactile surface on the east side, and none on the west. The latest guidance from Public Right-of-Way Access Guidelines recommends using exactly 24 inches of tactile surface, as the minimum and the maximum. The rationale is that tactile surfaces are necessary for blind people but pose an inconvenience to people in wheelchairs, so no more than the minimum should be used.

All the bumps ended up here. Only 24" of bumps, no more no less.

Curb ramps in the downtown area were improved more recently. However, at the time, there had not been a standard determined on tactile surfaces. These will be brought up to standard at the next opportunity.
