**Brandon Avenue Review of Safety and Pedestrian & Bicycle Accommodations**

Date: 13 August 2020

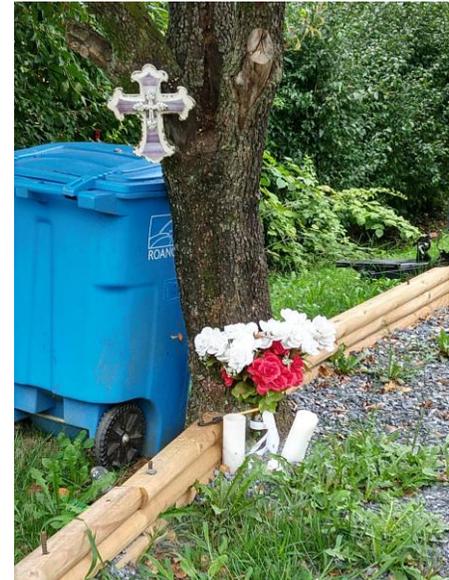
Figure 1. A memorial at the residence of the two victims of a fatal pedestrian crash near the site of the crash.

On May 15, 2020, a vehicle struck two pedestrians crossing Brandon Avenue at 7:11 pm, killing one and seriously injuring the other (Figure 1). Recognizing that Brandon Avenue is on the repaving schedule for 2020-2021, local advocates created the “[Build a Better Brandon Avenue](#)” Facebook page hoping to generate interest in using the repaving opportunity to improve safety. City staff delayed repaving Brandon Avenue in order to address community concerns. The Bike/Ped Committee and City staff met to observe and discuss options to improve

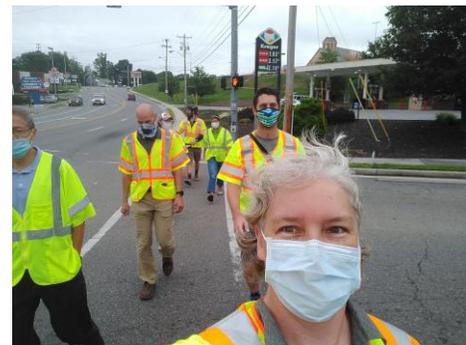
Figure 2. Crossing 23<sup>rd</sup> Street on Brandon Avenue.

safety and accommodations for pedestrians and bicyclists (Figure 2).

Crossing: The marked crosswalk at 23<sup>rd</sup> Street has pedestrian signals with push buttons. The push button on the north side is a few feet away from the marked crosswalk and there is no sidewalk connection between the push button and the crossing.

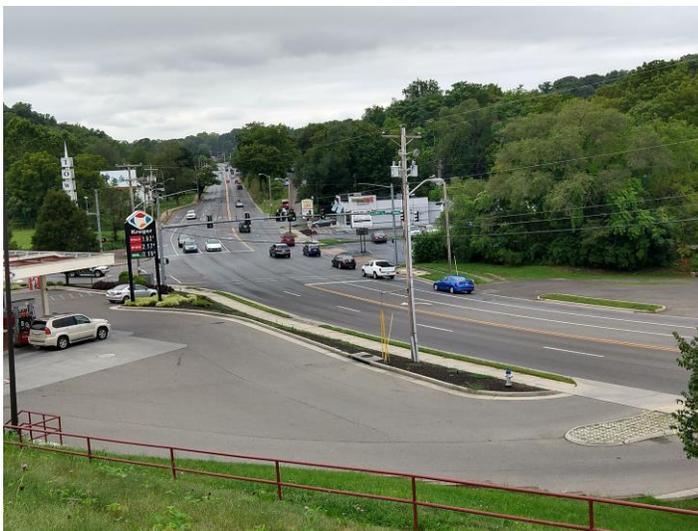
Figure 3. Brandon Avenue facing west

The south sidewalk is about five feet wide but encroaching grass covers the edges and trees grow over the sidewalk in places, effectively narrowing the width. Driveway ramps punctuate the sidewalk, also effectively narrowing the width. Several trash cans block the sidewalk partially or completely.

Repaving: Repaving is an opportunity to change the lane configuration to one that improves safety. A four-to-three lane conversion, or road diet, on Brandon Avenue would improve safety for all users. Pedestrians would be able to cross more safely with only one lane of traffic in each direction to contend with (the pedestrian fatality in May was a multiple-threat situation). However, a road diet may result in longer delays and extended backups at the signalized intersections. It is uncertain if this tradeoff would be understood or tolerated by drivers.

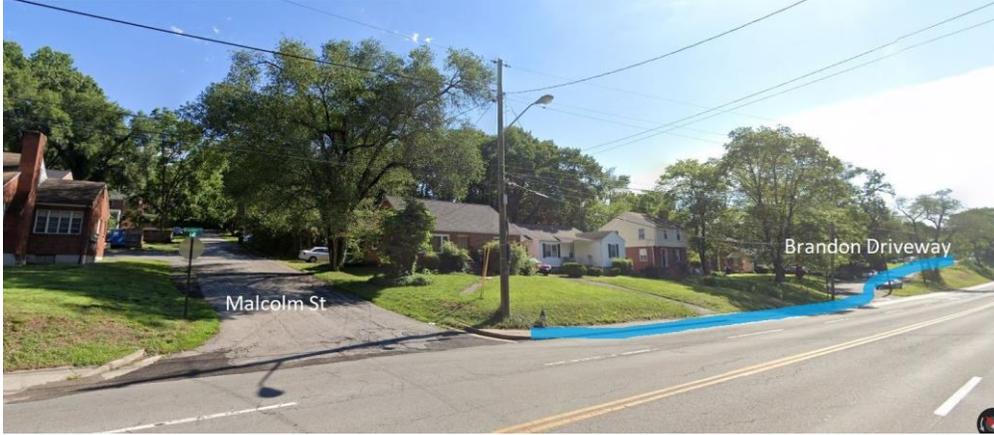
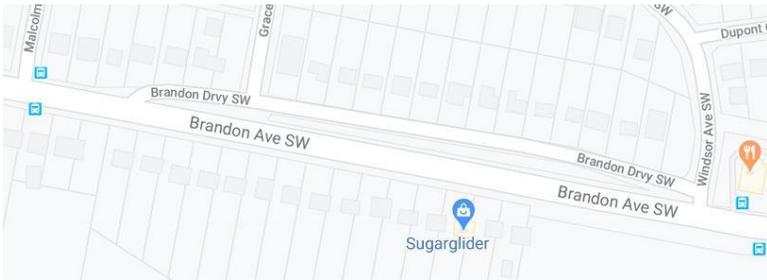
Figure 5. Brandon Driveway is a low-traffic parallel route on the north side of Brandon Avenue that is almost continuous with the north sidewalk of Brandon Avenue (blue line).

- Complete the sidewalk on the north side of Brandon Avenue, filling in gaps, noting the terrain challenges.
- Consider alternatives or interim measures to completing the north sidewalk, such as promoting pedestrian and bicycle use of Brandon Driveway (Figure 4) or Windsor Avenue with visual elements that call attention to these options, or converting a culvert into an underpass.
  - Brandon Driveway is steep, narrow, and in poor condition. Residents park on both sides and there are no sidewalks. The angle and terrain impede visibility of oncoming traffic. Consider interviewing residents about how they use the road and walk in the area.
- Install a pedestrian-actuated signal at Malcolm Street, consider a pedestrian refuge island. There are currently no pedestrian crossings between 23<sup>rd</sup> Street and Main Street, a distance of 2000 feet (and no crossing at Main Street either).

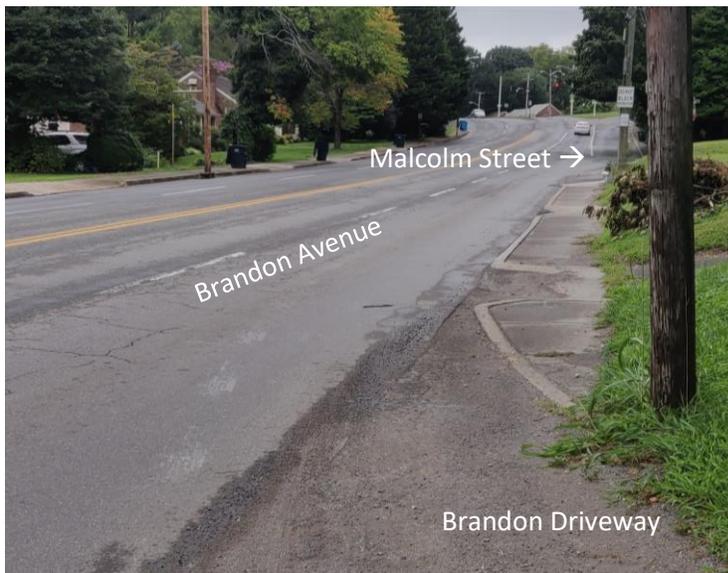
Figure 4. Another view of the sidewalk that almost connects Malcolm St to Brandon Driveway
