Belmont-Fallon Review of Pedestrian Accommodations

Date: 20 July 2021

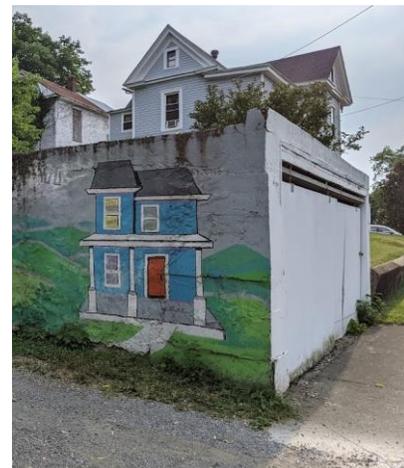
Many people were observed walking or being outside, giving the area a neighborly feel. Murals provide visual interest and City trash bins help keep trash contained. The Southeast Plawkers, many of whom participated in the walk, provide a huge service to the area by picking up visible litter.

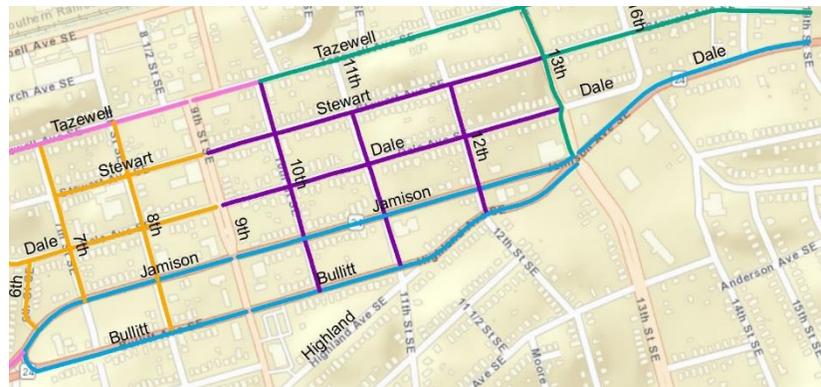
Jamison Avenue between 6th Street and 9th Street

Weeds along the sidewalk and private fence lines and overflowing trash cans create an unpleasant walking environment. The traffic calming berms have trash and dirt trapped between the berm the curb and overgrown weeds. Redundant driveways near Papa Johns create unnecessary potential conflict points between pedestrians and motor vehicles. Utility pole guy wires are trip hazards.

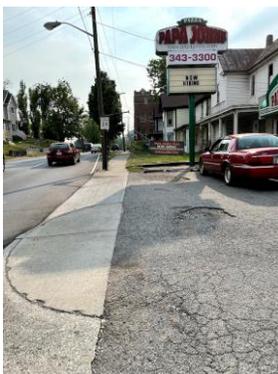
Opportunities for improvements at Jamison and 9th Street Intersection should prioritize pedestrians and people on bikes. The turning radius at Jamison Avenue and 9th Street is too tight for tractor trailers.

The 9th Street intersection will soon have audible pedestrian signals and curb ramps. Additional features that will make it safer for pedestrians include reducing the number of lanes on 9th Street, expanding the sidewalk, and building up landscape medians.

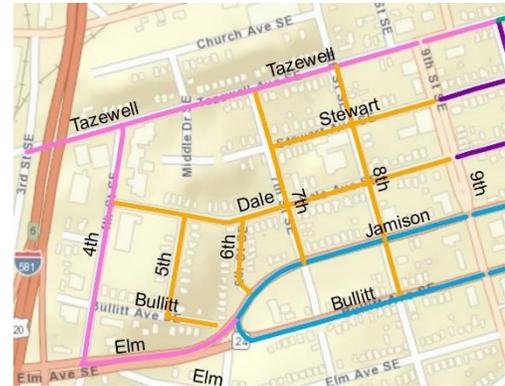
Dale Avenue between 8th Street and 6th Street

There is vegetative overgrowth in the planting strip. There is no sidewalk on 7th Street between Dale Avenue and Stewart Avenue.

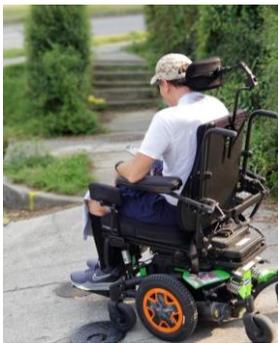
Elm Avenue between 4th Street and 6th Street

There are steps but no ramp access to Elm Ave from 6th Street. The sidewalk is obstructed by vegetative overgrowth. Sidewalk deterioration is a trip hazard and obstructs accessibility. A homeless encampment and trash on properties next to the P&N Citgo create an unpleasant walking environment. Few pedestrians were found in this area.

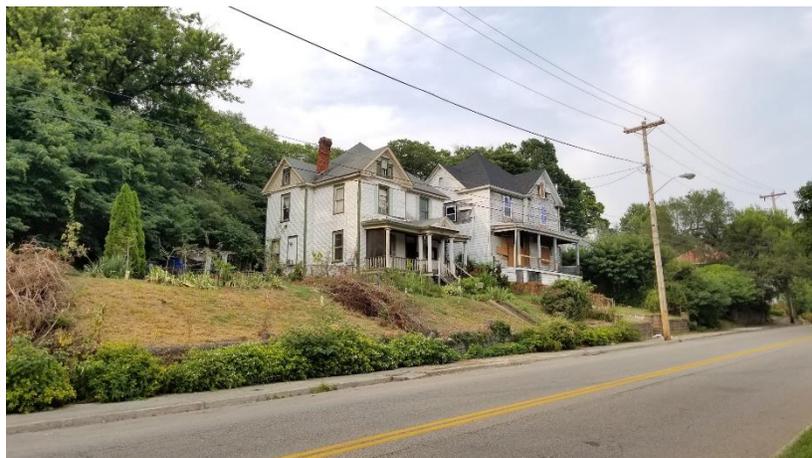
Uneven and broken sidewalks are a trip hazard. Sidewalks made of brick are attractive but as the bricks settle they can create an uneven surface if not properly maintained. Some streets lack sidewalks entirely. The pavement condition on some streets is poor, posing a trip hazard for pedestrians if there are no sidewalks. Drivers focused on potholes may not see pedestrians or may swerve unexpectedly into a pedestrian, and the potholes are unsightly. However, poor pavement condition can also have a traffic calming effect as drivers slow to avoid bumps.

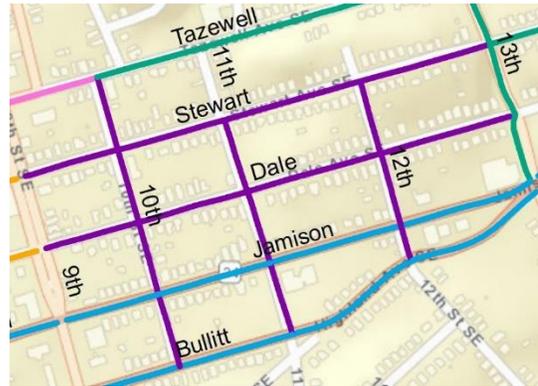
Trash, overgrown vegetation, crumbling retaining walls, and abandoned or inoperable vehicles create an unpleasant environment and block the sidewalk. Abandoned homes and buildings and loud music and engines create an unpleasant environment.

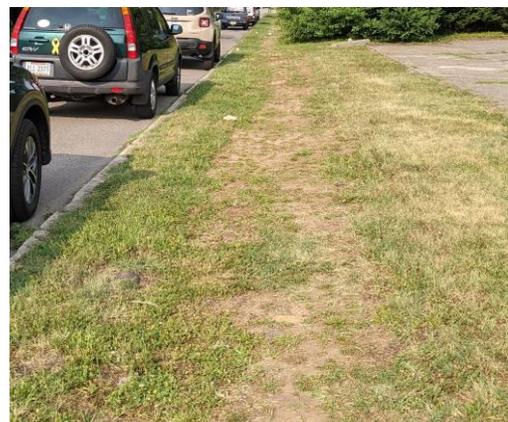
Some intersections do not have curb ramps or have inadequate curb ramps. Drainage issues create puddles, leave mud and debris blocking curb ramps, and accelerate wear. In cold weather, ice accumulation is a hazard for pedestrians. Broken asphalt at intersections is a trip hazard.

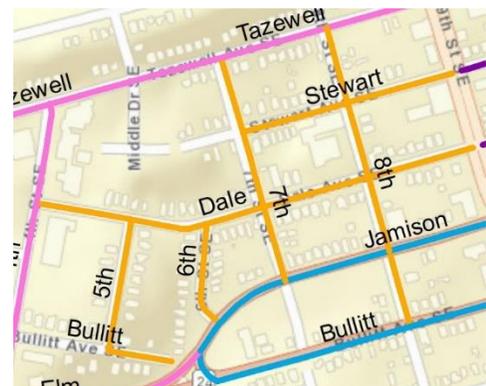
Dale Avenue between 7th Street and 9th Street

There was a lot of trash, particularly on the south. The brick sidewalk on the south side was completely overgrown in places.

At the intersection with 8th Street, there are no curb cuts.
