BUS STOP ACCESSIBILITY STUDY

*Roanoke Valley Area Metropolitan Planning Organization
September 2013*

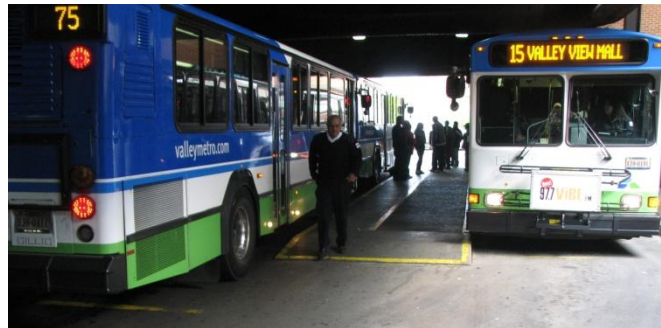
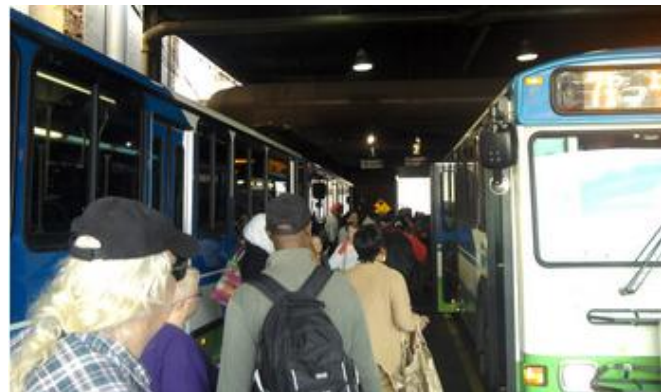
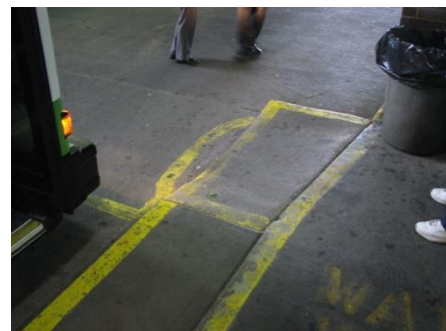
People generally have up to five minutes to transfer buses. Large numbers of people within this time alight one bus and board another bus. ADA accessibility and the resulting ease of transferring at this location is critical; it is a determining factor for people's decision to use the public transit system. If people do not feel they can successfully maneuver from one bus through the station to another bus, they will likely look for another way to get to their destination or not travel at all. The entire transit system depends on the ability to move easily through Campbell Court. While Campbell Court meets basic accessibility requirements, it is not an easy place to move around.

Landing areas can become very crowded at some times during the day making it a challenge for someone with a disability to maneuver from one bus to another. Signs indicating the drive aisle for buses are not easy to see or understand. Visually impaired riders would have an especially difficult time transferring buses. Announcements over a loudspeaker are made to notify people if a bus is in a different location than usual. However, the announcement may be difficult for some people to hear over the hum of buses. Tactile warning surfaces are not present on curb ramps. Several of the pedestrian walkways around the bus station are too narrow to accommodate a wheelchair. As such, people in wheelchairs must travel through the driveways to enter the station. Any pedestrian activity across the driveways causes potential conflicts and

significant safety concerns as buses enter and leave the station. Handicap push buttons are needed on the doors to enter the waiting area.

Stakeholders	Valley Metro, City of Roanoke, Downtown Roanoke Inc.
Recommendations	As part of the Downtown Roanoke Multimodal Transportation Study, develop options for reallocating space within Campbell Court to improve the ability for pedestrians to more easily transfer between buses including options for more clearly arranging buses within the station, better signage, ADA landings and ramps, and minimizing the need for pedestrians to walk in front of buses.
Estimated Costs	\$300,000 for the study

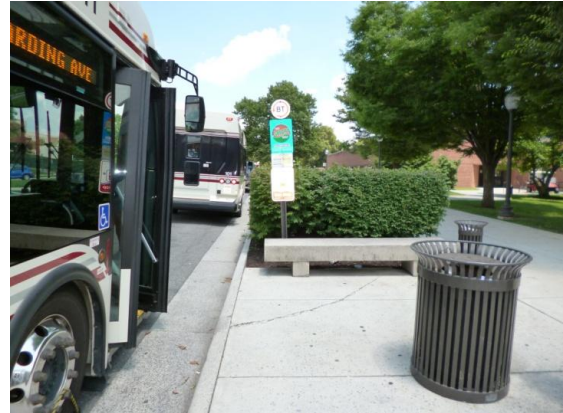
This bus stop is temporary as plans for a multi-modal transit center on the Virginia Tech campus at the corner of West Campus Drive and Perry Street are moving ahead. The project will incorporate the Smart Way commuter bus service. In light of this project, no improvements are recommended at the current location.

Stakeholders	Valley Metro, Blacksburg Transit, Virginia Tech
Recommendations	Coordinate the Smart Way service with the future multi-modal transit facility.
Estimated Costs	N/A

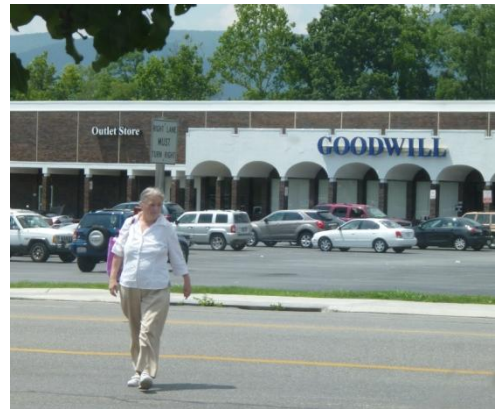
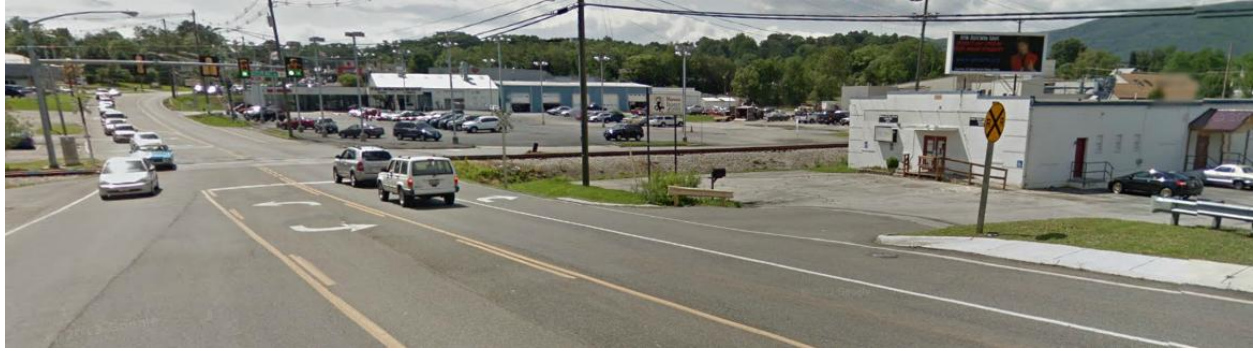
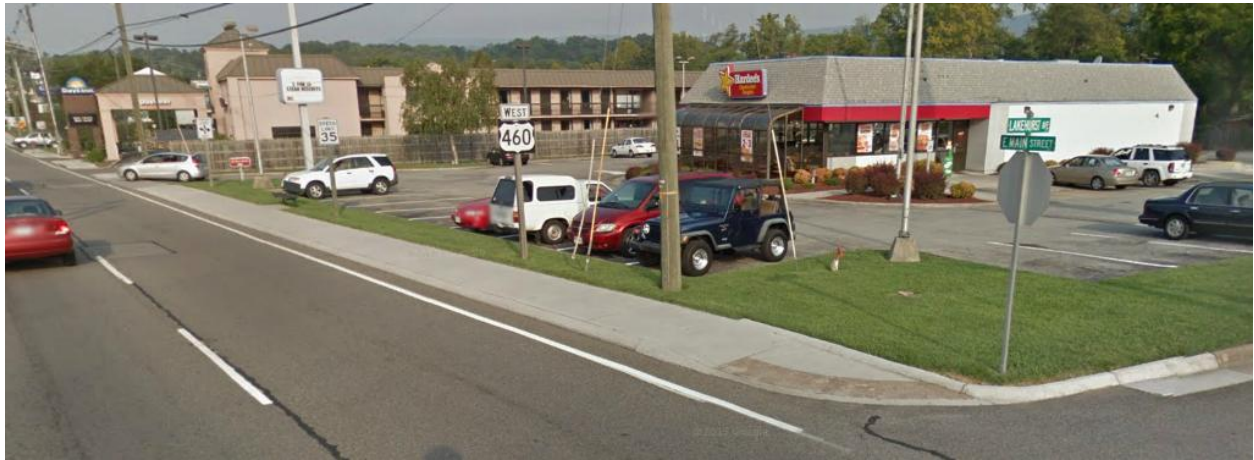
The current bus stop location on East Main Street should be reevaluated. Due to people's tendency to cross the street at an unsignalized location, if improvements at the current location cannot be accomplished, the bus stop should be relocated to a nearby signalized intersection.

Another option would be the Route 419/East Main Street intersection. Several activity generators exist near the Route 419/East Main Street intersection. If the stop is relocated closer to this intersection, one location to consider is west of Lakehurst Avenue in front of the Hardees. Curb ramps and pedestrian signals exist to enable users to cross the street safely at the traffic signal.

Stakeholders	Valley Metro, City of Salem, VDOT, Goodwill Industries
Recommendations	Consider options for relocating the East Main WB at Lakeside Plaza (Goodwill) bus stop closer to a signalized intersection. Install a small bus shelter and adequate landing area.
Estimated Costs	Small bus shelter = \$6,620 Labor/Installation = \$3,395 Permits/Site Plans = \$895

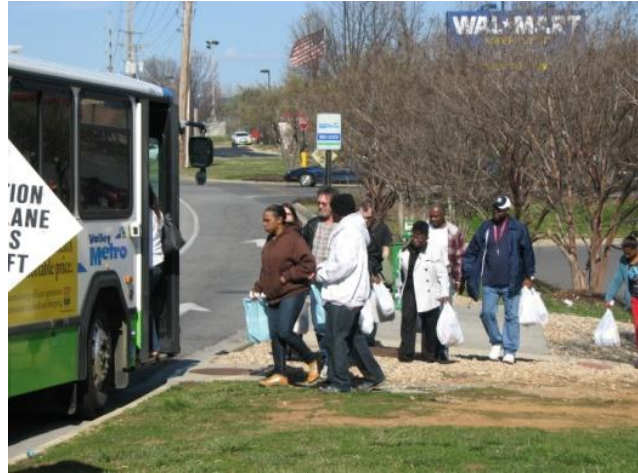
The Valley View Walmart stop has long been a location that has been recognized as needing accessibility improvements. Had it been simply a matter of installing a sidewalk and a bus shelter, conditions at this stop would have been improved years ago. The stop is located on private property at the boundary where the Walmart property meets the Sears property. Concerns from some of the private owners have kept officials struggling to find an adequate solution. The current stop location takes advantage of a concrete pad over a convergence of utilities. Improvements at the current location are limited due to the location of the utilities. The most recent concepts involve moving the bus stop slightly north, away from the utilities and completely on the Walmart property. Such a location requires a sidewalk ramp accessible for a wheelchair to accommodate the change in grade from the Walmart parking lot and Valley View Ring Road.

Stakeholders	Valley Metro, Valley View Mall management, Walmart
Recommendations	Construct a bus shelter with lighting and a pedestrian connection to the Walmart parking lot.
Estimated Costs	\$100,000

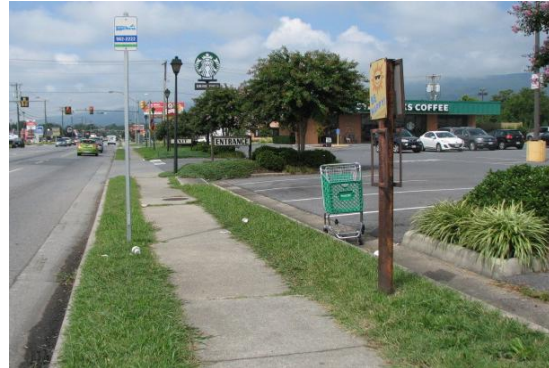
6.) Spartan Square Kroger/Salem Walmart

Since the NTD survey, route 91 has been modified in that it no longer stops within the Spartan Square shopping center. Instead the bus stop at Spartan Square Kroger is along the street. The level of bus stop activity may have decreased because this stop, at the time of the survey, was the furthest stop west on West Main Street and now there is one stop further west at Walmart. Regardless, it is recommended that the new bus stop location be improved because of the high activity generators located in the Spartan Square shopping center. The bus stop needs a shopping cart corral, a bus shelter, an adequate landing pad, and a trash can.

Stakeholders	Valley Metro, City of Salem, Spartan Square management, Kroger, Walmart
Recommendations	Determine long-term transit line location and associated bus stops. Install bus shelters, curb ramps, and shopping cart corrals at the final Kroger and Walmart stops. If the Walmart bus stop is to remain in the parking lot, discuss potential improvements with Walmart.
Estimated Costs	Two large shelters = \$18,900 Two curb ramps = \$8,000 Two shopping cart corrals = \$800 Labor/Installation = \$6,790 Permits/Site Plans = \$895

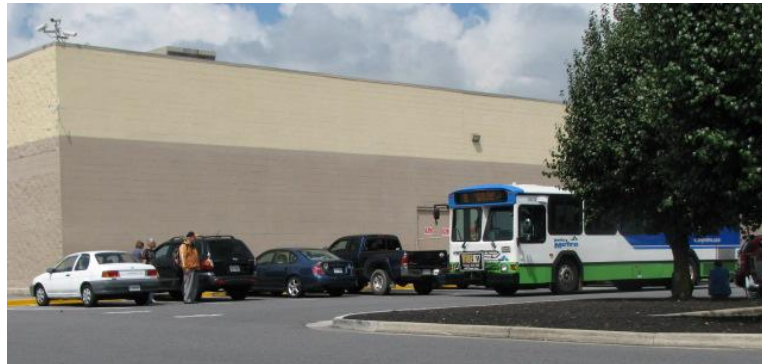
People at the current Walmart stop wait under nearby trees for the bus. Upon seeing the bus, people who use wheelchairs alight the sidewalk using a nearby curb ramp and wait in the driveway aisle, similar to the riders shown in the picture above. It is not preferable that the bus block parked cars. If this location remains a bus stop, parking should be removed (about five spaces) and a curb ramp, shopping car corral, and shelter be installed in their place.

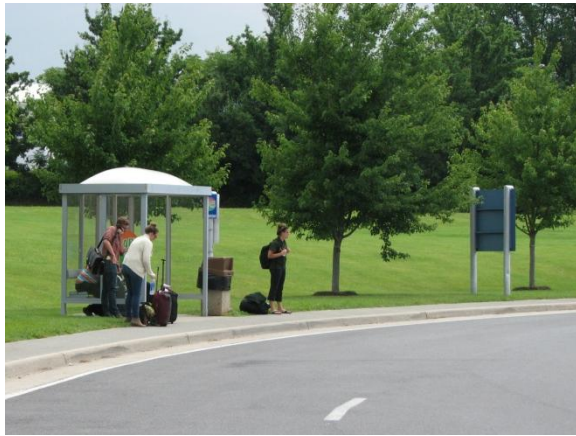
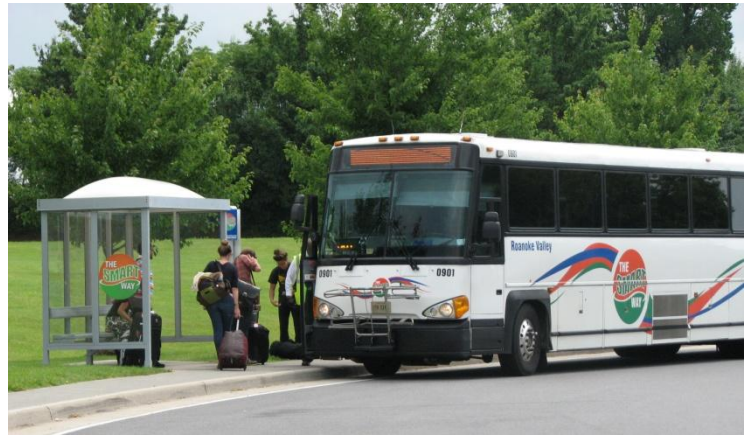
The Roanoke Regional Airport is currently served only by the Smartway Bus, which travels between Campbell Court and Virginia Tech Squires Student Center. The bus stop and shelter are overall in good condition and accessible. While a wheelchair could physically fit within the shelter, there is no specific location for a wheelchair as the bench spans the width of the shelter. The shelter appears undersized for the location since it can only hold only a few people. On the day of the field visit, several people were observed waiting outside the shelter. Fortunately the weather was pleasing to be outside, but on other days, when weather is not as pleasant, more covered space is recommended for this location. A posted bus schedule is also needed.

Stakeholders	Valley Metro, Roanoke Regional Airport
Recommendations	Upgrade the existing shelter to the current Valley Metro standard and add a second bus shelter, an additional concrete pad, and post the bus schedule.
Estimated Costs	Two Large Shelters = \$18,900 Labor/Installation = \$6,790 Permits/Site Plans = \$895

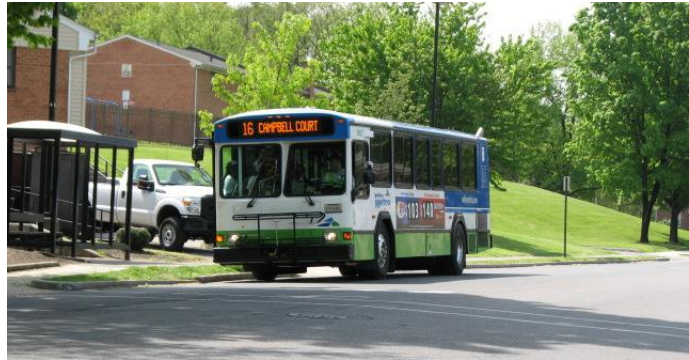
This is an inbound bus stop to Campbell Court that serves Hunt Manor and Afton Apartments. The existing bus shelter is in great disrepair with broken glass below missing windows. There is a crosswalk and curb ramps at the stop, but improvements are needed.

Stakeholders	Valley Metro, City of Roanoke
Recommendations	Install a new shelter and pave the landing pad between the sidewalk and curb, reconstruct two ramps with tactile surfaces on the north side of Hunt Avenue.
Estimated Costs	Two ramps = \$8,000 Small Shelter = \$6,620 Labor/Installation = \$3,395 Permits/Site Plans = \$895

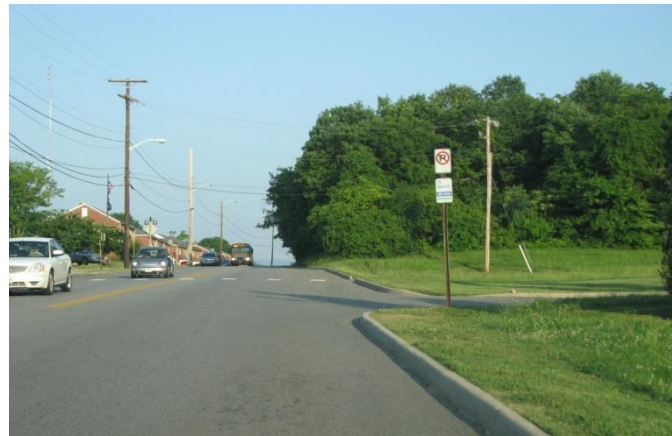
Horton Park, Melrose Library and Lansdowne Park public housing are the activity generators at this bus stop. During the NTD survey, more than 90% of the activity at this stop was from passengers being dropped off. There is no sidewalk at the bus stop, so riders are most likely let off in the street at the driveway entrance to the library. As seen in the picture, there is a crosswalk west of the bus stop. Given the activity at this stop, several improvements are needed.

Stakeholders	Valley Metro, City of Roanoke
Recommendations	Construct a landing pad, sidewalk between the bus stop and the crosswalk, curb ramps at each corner of the library driveway and at the crosswalk.
Estimated Costs	Three ramps = \$12,000 125' x 5' sidewalk = \$4,375 Labor/Installation = \$3,395 Permits/Site Plans = \$895

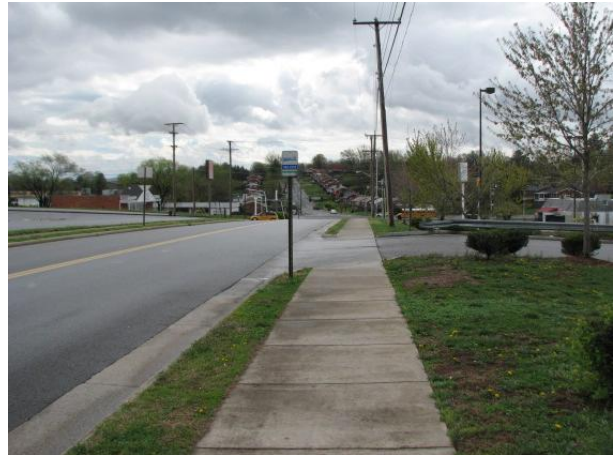
This bus stop is considered an outbound bus stop. It is located near several large retail stores. The bus from this stop travels to Valley View Mall. During the NTD survey, twice as many passengers alighted at the stop than boarded. Given that there are shopping destinations on both sides of the street, a crosswalk with ADA ramps in between the companion bus stops should be striped, and a small shelter installed.

Stakeholders	Valley Metro, City of Roanoke
Recommendations	Construct a landing pad, curb ramps at a new crosswalk, and install a bus shelter.
Estimated Costs	Two ramps = \$8,000 Crosswalk striping = \$1,000 Small shelter = \$6,620 Labor/Installation = \$3,395 Permits/Site Plans = \$895

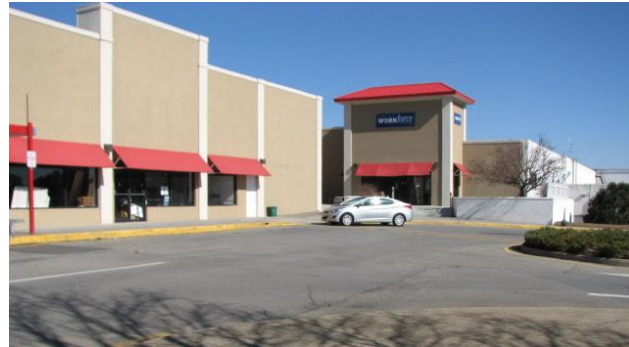
11.) Crossroads Shopping Center Driveway WB at Workforce/Kmart

The current location is accessible. It features a bus stop sign that is propped up in a window. Nearby deteriorating benches at Kmart provide riders a place to sit while waiting for the bus. Parking is prohibited at the stop through No Parking-Fire Lane signs. If this stop is moved to Hershberger Road, depending on the route alignment that would serve the stop, a bus shelter, landing pad, and other amenities may be needed.

Stakeholders	Valley Metro, City of Roanoke, Shopping Center management
Recommendations	Evaluate the long-term desired location of the stop. In the current location, relocate the sign on a post.
Estimated Costs	Minimal for the current location.

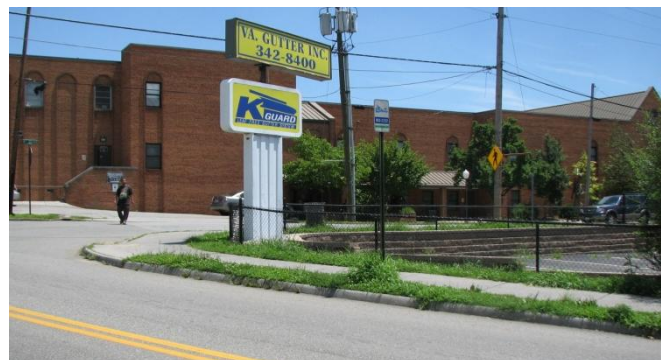
The main activity generator at this stop is the Rescue Mission. The bus at this location has traveled from Campbell Court on its way into Vinton. Most people during the NTD survey used this stop for alighting.

Stakeholders	Valley Metro, City of Roanoke
Recommendations	Pave a landing area 5'x8' wide by widening the sidewalk to the back of curb at the bus stop.
Estimated Costs	Sidewalk extension 40 sf = \$280 Labor/installation = to be done within a larger contract for ongoing sidewalk maintenance.

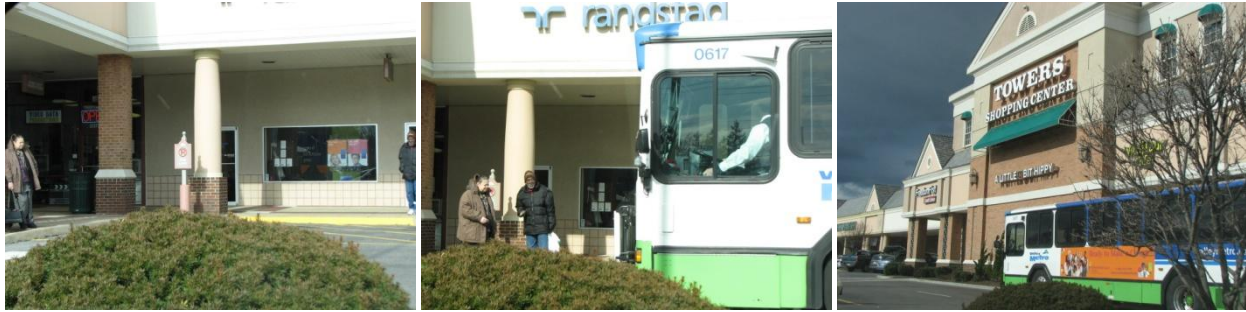
The bus stop in the upper lot of Towers Shopping Center is not currently signed though people who use the bus regularly know it will pick them up at the main entrance next to Randstad and McCallister's Deli. The building itself provides shelter. There are benches and a trash can available to riders. A person in a wheelchair would need to wait in the fire lane, which is unsheltered and accessible by using the ramp leading to the parking lot. In order to access the stop, the bus must use the drive aisles where at any moment a vehicle may attempt to back out, potentially causing a conflict with an oncoming bus. When one bus is at the stop, it blocks four parked vehicles from backing out of their spaces. If two buses arrive at the same time, many more parking spaces are blocked. The parking lot gets very crowded and driving to the current stop location can often be delayed by the congestion.

If the current stop remains, a sign is needed along with a ramp directly from the hatched area to the building entrance. However, it is preferable that this bus stop be moved to Colonial Avenue in order to avoid vehicle conflicts and delay in the parking lot. In order to accomplish this bus stop shift, the route would need to be modified. Additionally, because there are no elevators in Towers Shopping Center, and no safe pedestrian walkway to get from the upper and lower levels, each side of the shopping center must have a bus stop. It is recommended that any bus route that includes Towers Shopping Center provide service to both levels.

Stakeholders	Valley Metro, Towers Shopping Center management
Recommendations	Relocate the bus stop to Colonial Avenue, and install a shelter, landing pad, trash can, pedestrian ramps, and sidewalk connections to the shopping center and to the existing sidewalk front of CVS.
Estimated Costs	Large Shelter = \$9,450 Labor/Installation = \$10,185 Permits/Site Plans = \$895 700' x 5' sidewalk connection = \$24,500 Five ADA ramps = \$20,000

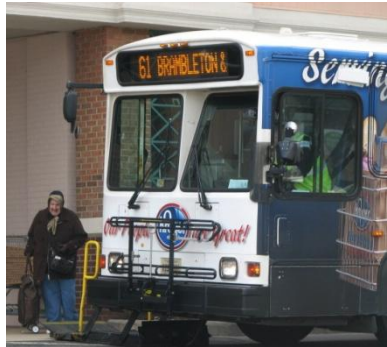
Existing Lower Level Stop Location

The current bus stop at Towers Shopping Center Kroger is conveniently located next to the building so that people can take advantage of the covered space, bench and trash can. This stop is missing a Valley Metro bus stop sign. The main concern with this location is that the back door of the bus opens up against a row of bushes next to the building, causing people to walk through the bushes. A possible location to relocate the stop would be in front of the Tuesday Morning store. The area in front of this store does not have parking as indicated by yellow striped lines. There is a blue marked handicap ramp to the sidewalk, a nearby bench and covered area for people to wait. If the stop were relocated here, because the sidewalk does not wrap around the building, pedestrians would need to walk through the building to access Kroger.

Due to the lack of an elevator within Towers Shopping Center, there is no opportunity for a person in a wheelchair to travel between the upper and lower level shops without going all the way around the building. There are no sidewalks to assist with this travel, so people would need to travel through the parking lots and driveway aisles. Unless conditions change at the Shopping Center, it is recommended that the routes that currently only serve the upper or lower levels be routed to serve both levels of the shopping center.

Stakeholders	Valley Metro, Towers Shopping Center management
Recommendations	Consider other locations to relocate the bus stop.
Estimated Costs	Depends on the final location selected.

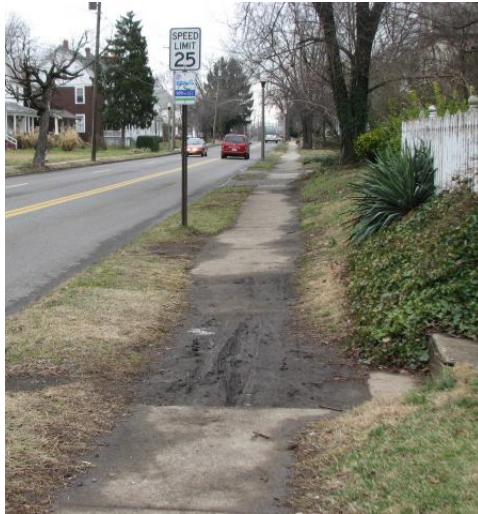
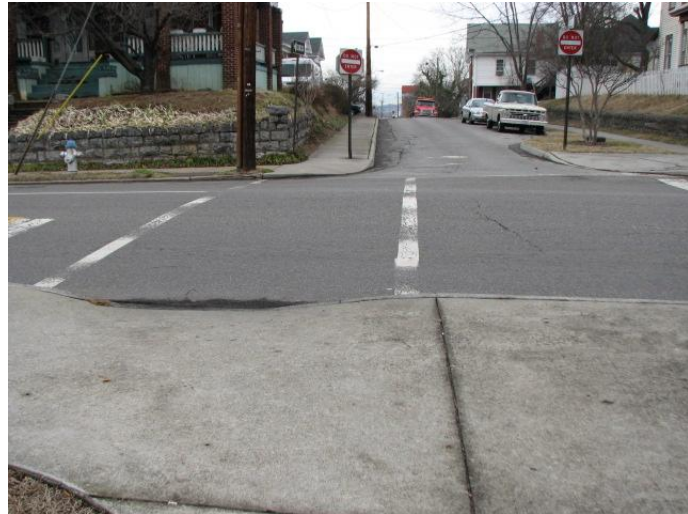
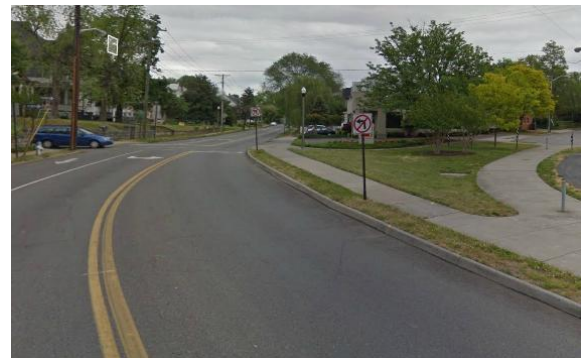
15.) Elm EB at 8th

This bus stop is located on an inbound route to Campbell Court. The surrounding area is mostly residential with private homes adjacent to the stop. The current bus stop location is limited in space but given its activity level would warrant a bus shelter. Locating a bus shelter at the current location should be explored fully before looking at relocation options. Locating a shelter at the current stop may be difficult because of the adjacent private homes and the potential for a shelter to cause sight distance limitations from vehicles emerging from driveways.

Another option to explore would be relocating the stop to the open space on the nearside of the Elm Avenue and 8th Street intersection. Due to the proximity to the Main Street and Ferdinand Avenue intersection, and the volume of traffic on this street at some times of the day, it may be desirable to provide a bus pull-off within the green open space. Drainage structures are evident within the open space which may make a bus pull-off more costly. In any location, at a minimum, a bench should be provided facing the sidewalk, a landing area paved between the sidewalk and curb, and a new sign installed.

Stakeholders	Valley Metro, City of Roanoke, adjacent property owners, Old Southwest neighborhood association.
Recommendations	Explore amenity improvement options at the current location. Explore a bus pull-off within the green open space between Ferdinand and 8 th Streets.
Estimated Costs	Varies depending on the option selected.

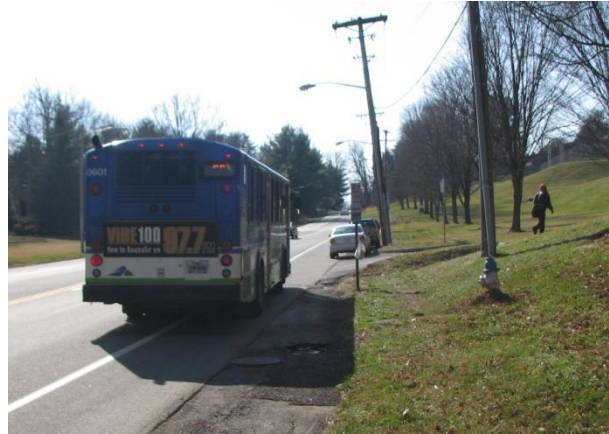
Virginia Western Community College is the attraction for this bus stop. The stop currently has no infrastructure or amenities. Able-bodied students walk up a nearby driveway to enter a side door to the building. Students cross the street using the overhead pedestrian walkway. Recently, a new building was constructed nearby. New sidewalks associated with the project did not extend to the bus stop. Additionally, it appears the new sidewalk is higher than the roadway, and no curbs were constructed with the sidewalks. This bus stop is mainly used for dropping off people coming from Campbell Court. However, a small shelter would still be appropriate for people waiting for the southbound bus.

Stakeholders	Valley Metro, City of Roanoke, VWCC
Recommendations	A small bus shelter, trash can, and paved landing area with connections to existing pedestrian facilities are recommended. Coordination with the College is necessary to determine the best location for the bus stop, and if it could be incorporated into the new section of sidewalk.
Estimated Costs	Small bus shelter = \$6,620 Labor/Installation = \$3,395 Permits/Site plans = \$895 Curb and sidewalk connections depending on the final location.

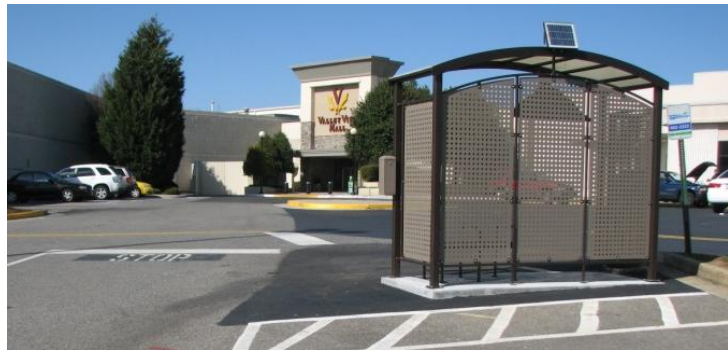
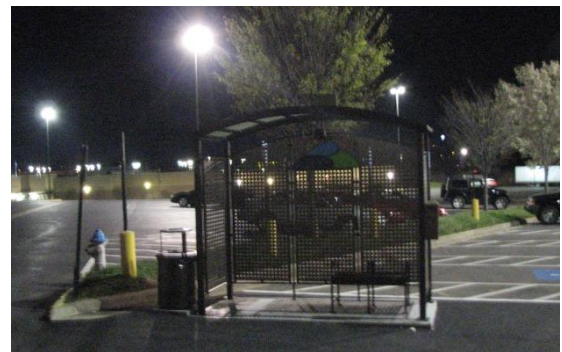
17.) Valley View Mall SB at Sears

Over the years, the main bus stop at Valley View Mall has been moved around due to concerns from nearby businesses. The current location places the bus stop in a parking lot near a main entrance of the mall. Functionally, the location works well. The buses have easy access into the lot through main drive aisles; as such, potential conflicts with vehicles are minimized.

The stop itself however is undersized given that it is the primary mall stop. There are seats for only two people and space for one wheelchair under the shelter. Additional riders would be waiting on the pavement next to the drive aisle intersection. At nighttime, the light inside the shelter does not work because of the lights in the surrounding parking lot. This makes the shelter itself dark.

Recommendations include creating a raised curb extension to separate the driving aisle from the passenger waiting space. This could be done by extending the median through some of the handicap parking spaces as shown in the adjacent concept. This concept would add an ADA ramp and an adequately sized ADA landing pad, as well as provide one additional large bus shelter. Pavement striping of stop bars would also be adjusted.

Stakeholders	Valley View Mall management, Valley Metro
Recommendations	Raise the bus stop to the sidewalk level, in line with the adjacent grass median. Enlarge the bus facility landing area to provide one more large bus shelter and one lamppost.
Estimated Costs	400 sq. ft. reinforced pedestrian area = \$5,600 Large shelter = \$9,450 Lighting/Lamppost = \$5,000 ADA ramp = \$4,000 Reuse existing small shelter and trashcan. Additional costs for demolition of existing curb/sidewalk.

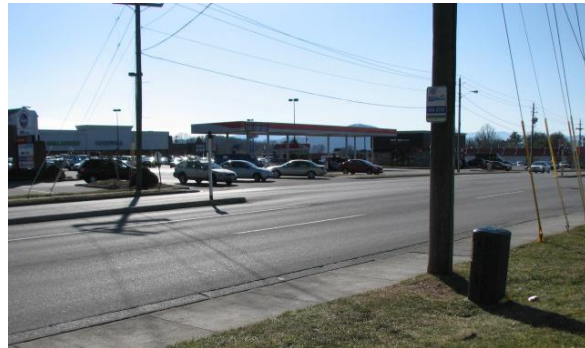
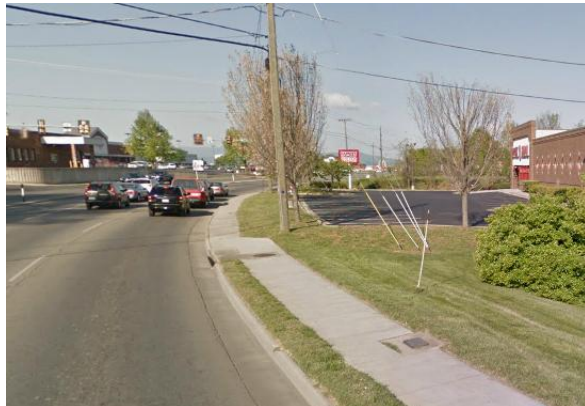
Instead of building a pedestrian crossing at the current location, it is recommended that the bus stop be moved to the nearside of the Hardy Road/Clearview Drive intersection near the Family Dollar as shown in the adjacent picture.

Stakeholders	Valley Metro, Town of Vinton, Adjacent property owners
Recommendations	Move bus stop to nearside Hardy Road/Clearview Drive; install a shelter and landing pad; stripe crosswalks on Hardy Road and Clearview Drive; construct a curb ramp on the existing sidewalk at the Clearview Drive driveway into the shopping center (behind Subway).
Estimated Costs	Large Shelter = \$9,450 ADA Ramp = \$4,000 Crosswalk Striping = \$800 Labor/Installation = \$3,395 Permits/Site plans = \$895

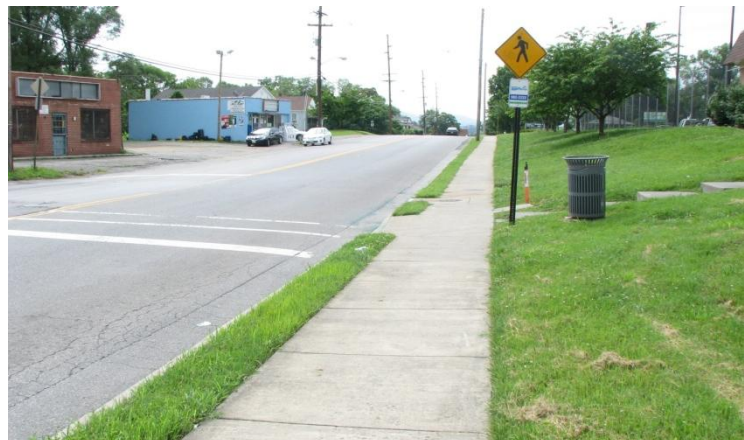
This bus stop serves route 16, which travels from Valley View Mall to Campbell Court. Many lower income residences are located near this stop, contributing to its high activity level. The stop is adjacent to Washington Park pool. The stop needs a small bus shelter and a repainted crosswalk. The trash receptacle should be moved to be more easily accessible from the sidewalk.

Stakeholders	Valley Metro, City of Roanoke Transportation and Parks and Recreation
Recommendations	Install a small shelter and landing pad with a short retaining wall, extend the sidewalk to the back of the curb at the bus stop, relocate the trash can.
Estimated Costs	Small bus shelter = \$6,620 Retaining wall = \$4,997 Crosswalk striping = \$400 Labor/Installation = \$3,395 Permits/Site plans = \$895

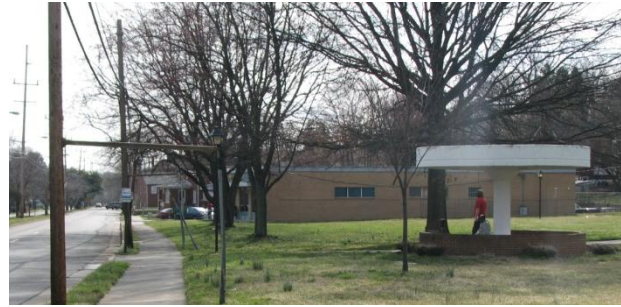
Melrose Towers, a residential building for lower income and elderly people, is the main trip generator at this bus stop. An adequate landing pad exists at the bus stop. Currently, a functional but dated shelter exists in the front lawn and serves as the bus shelter for the stop. The main concern with this shelter is the ability of the bus driver to see people waiting inside the shelter, due to its setback from the street. It is also not well lit at nighttime.

Stakeholders	Valley Metro, City of Roanoke, Melrose Towers management
Recommendations	Install a large shelter at the sidewalk.
Estimated Costs	Large bus shelter = \$9,450 Labor/Installation = \$3,395 Permits/Site plans = \$895

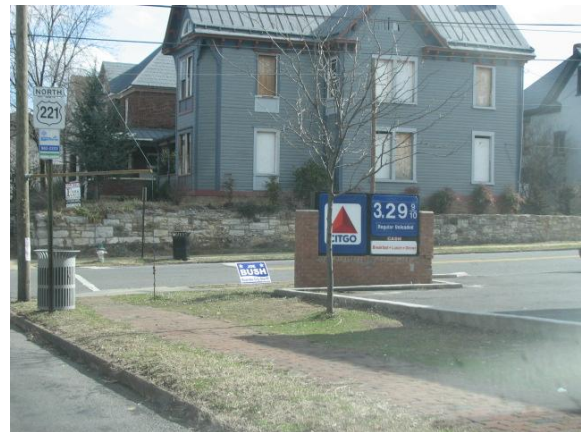
The bus stop at Elm Avenue and 5th Street is within the Old Southwest Village Center. While the activity at the stop is generated mostly from the nearby residences, there are some businesses that benefit from having a bus stop nearby. Valley Metro has been working with the Old Southwest Market (Citgo) property owners about installing a bus shelter on their property adjacent to the sidewalk. The sidewalk at the bus stop is brick. The landing pad, when extended from the back of the curb, should match the material and design of the existing sidewalk.

Stakeholders	Valley Metro, City of Roanoke, Citgo property owner
Recommendations	Install a small shelter and landing pad, extend the sidewalk to the back of the curb at the bus stop.
Estimated Costs	Small bus shelter = \$6,620 Labor/Installation = \$5,000 Permits/Site plans = \$895

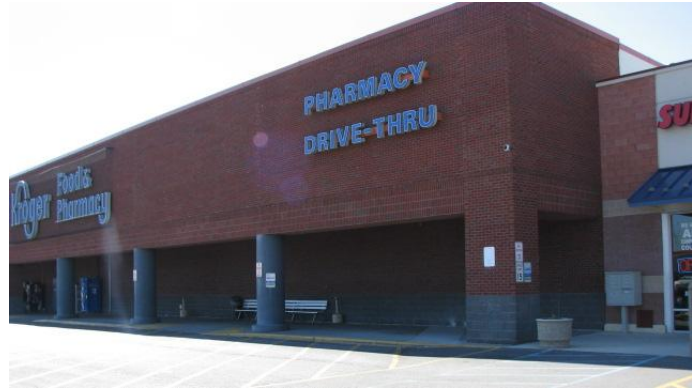
23.) Towne Square Kroger

The Towne Square Kroger bus stop exists as a place for the bus to turn around, and it is considered an end-of-the-line stop. The bus route was designed prior to the construction of the Aviation Drive/Towne Square Boulevard intersection. At the time this bus stop location was determined, the end-of-the-line location was logical. Now that the intersection exists, new opportunities arise to easily connect the Crossroads shopping area to the Valley View Mall shopping area. The routes serving Valley View and Towne Square Kroger should be reviewed to determine if a connection can be established. If a redesign of the routes is possible, the existing stop at Kroger could be removed. Bus stops, Towne Square EB at Rutgers and Towne Square WB at Rutgers (Golden Corral) exist nearby to accommodate riders traveling to the Kroger shopping center.

If the bus stop remains at Kroger, no improvements are needed. The building itself provides shelter, a bench is located nearby, and the wide sidewalk provides sufficient space to deploy the lift on the bus.

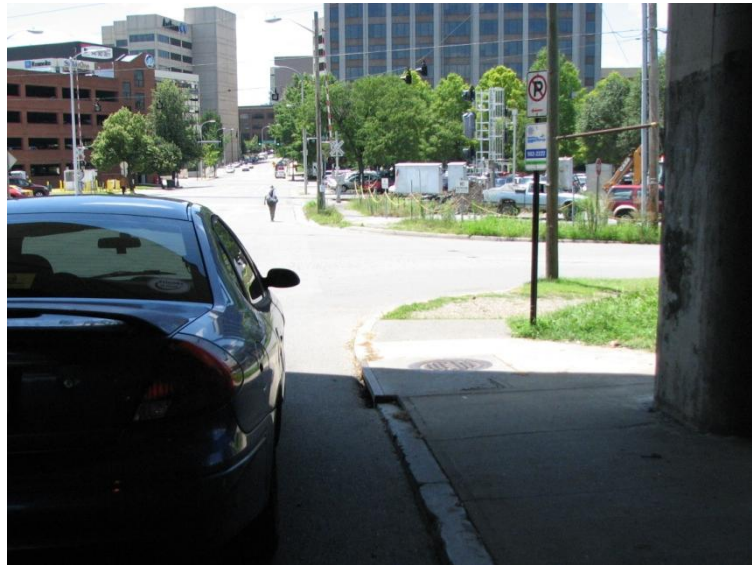
The Rescue Mission is the main activity generator at this bus stop. From this stop, the bus travels inbound to Campbell Court. The bus stop is located at a drainage inlet, as seen in the picture.

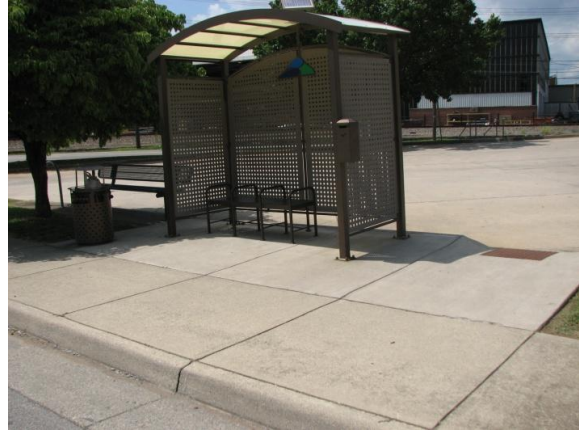
The Campbell WB at Norfolk stop at the Valley Metro Administration Building is a good example of an accessible bus stop. There is an access ramp leading from the stop toward the building. There is room under the shelter for a wheelchair. There is also an additional bench not associated with a shelter, a trash can, and a bike rack. While the stop itself is very accessible, getting to the bus stop could be improved by constructing a sidewalk on Campbell Avenue west of the Administration Building before it changes to Norfolk Avenue.

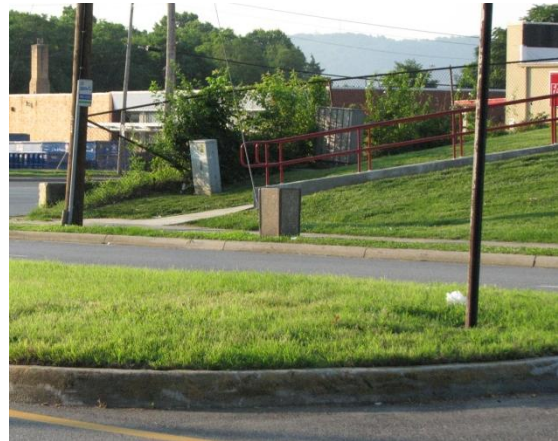
The Lansdowne Park apartments are the main activity generators at this bus stop. The bus route comes from the VA Hospital and heads inbound to Campbell Court. As such, most users are boarding the bus as opposed to alighting. The sidewalk needs to be extended to the curb to create an adequate landing area and a bus shelter installed.

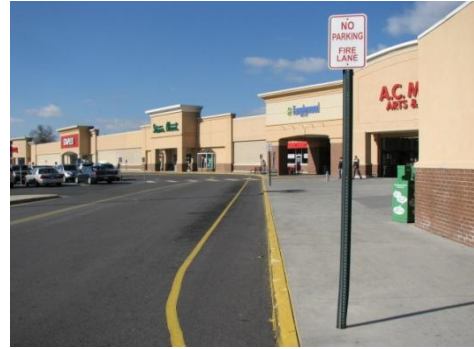
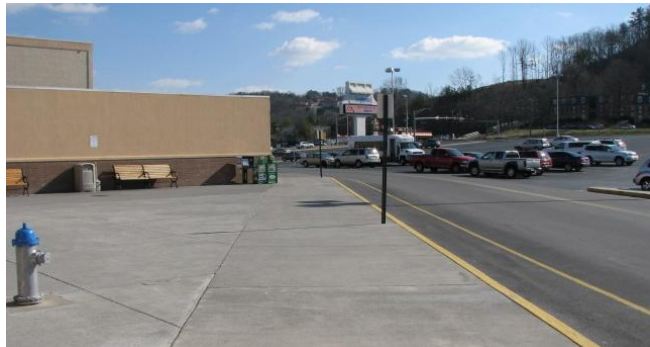
27.) Tanglewood Mall at AC Moore

The Tanglewood Mall at AC Moore stop is convenient because it is located adjacent to a primary mall entrance. Two buses fit easily in the space available and two-way traffic can pass even with the buses stopped. The “No Parking Fire Lane” signs that prohibit cars from parking along the curb also serve the dual purpose of providing a dedicated space for the buses. There is no bus stop sign here, and one should be installed. The nearby benches shown in the picture are part of the mall’s designated smoking area, yet the benches work well to also accommodate transit riders. The nearby building currently provides shelter as needed, but it is preferable to have a bus shelter closer to the bus stop.

Stakeholders	Valley Metro, Tanglewood Mall Management
Recommendations	Install a large bus shelter next to the bench closest to the driveway and install a bus stop sign.
Estimated Costs	Large bus shelter = \$9,450 Labor/Installation = \$3,395 Permits/Site plans = \$895

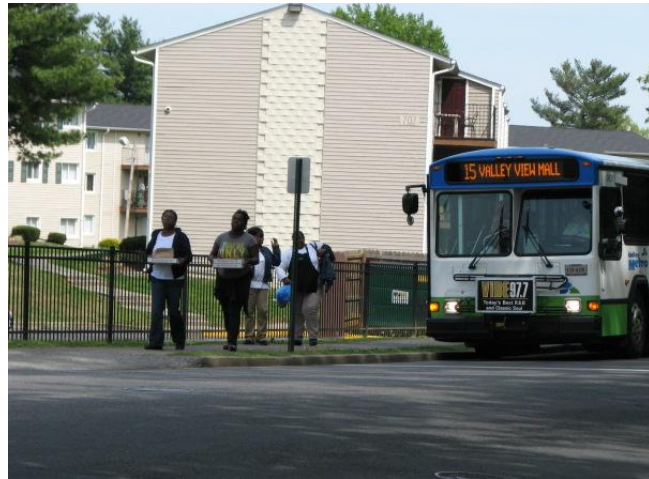
This bus stop serves Route 15, which travels outbound from Campbell Court to Valley View Mall. Several apartment complexes are located near the stop, which contribute to its high use. The stop is used more for alighting than boarding, but a shelter is still needed for people traveling to Valley View Mall. The nearby intersection at Hunt Avenue and 8th Street features a crosswalk across Hunt Avenue and ramps on each corner. The ramps, however, were constructed without tactile warning plates. As the City is able to replace older ramps with new ramps that feature tactile surfaces, it is recommended that all three ramps be upgraded.

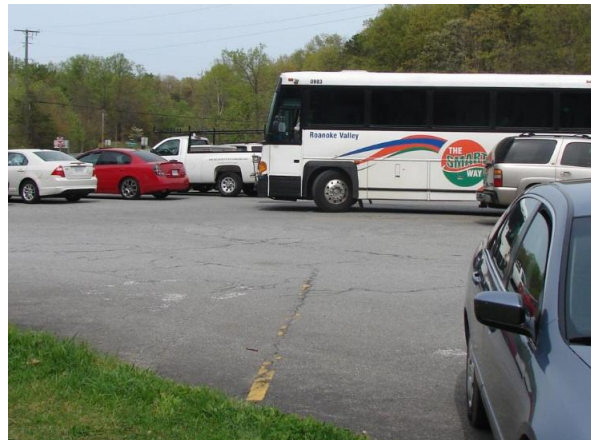
29.) Exit 140 Park and Ride

The Exit 140 Park and Ride lot was constructed in the 1970s as part of the I-81 Exit 140 construction. With the increase in gas prices, particularly since 2008, the lot has experienced consistent capacity and overflow use. The lot was expanded in 2009 when VDOT surface treated the adjacent overflow area. Recently, through the Regional Surface Transportation Program, the Exit 140 Park and Ride was selected for significant upgrades including repaving, the addition of curbs, lighting, trash receptacles, a bus shelter, bike rack, and stormwater measures. While most people drive to this stop, it is possible that some folks will also be dropped off. The bus shelter should be large enough to accommodate several people waiting for the bus.

Currently, the regional Smart Way commuter bus is the only transit service at the Exit 140 Park and Ride lot. Improvements should be made with consideration of accommodating a connecting second bus or local transit service in the future. Additionally, the location of the bus shelter and bus turning radius should be coordinated with Valley Metro to ensure that the bus will be able to pull up flush with the curb. The current design, as shown, adequately connects handicap parking spaces with the shelter.

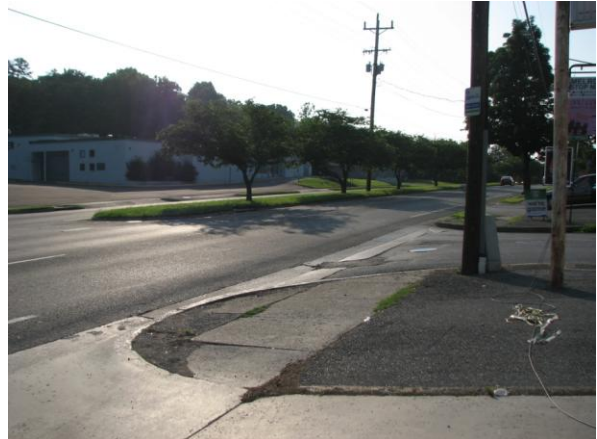
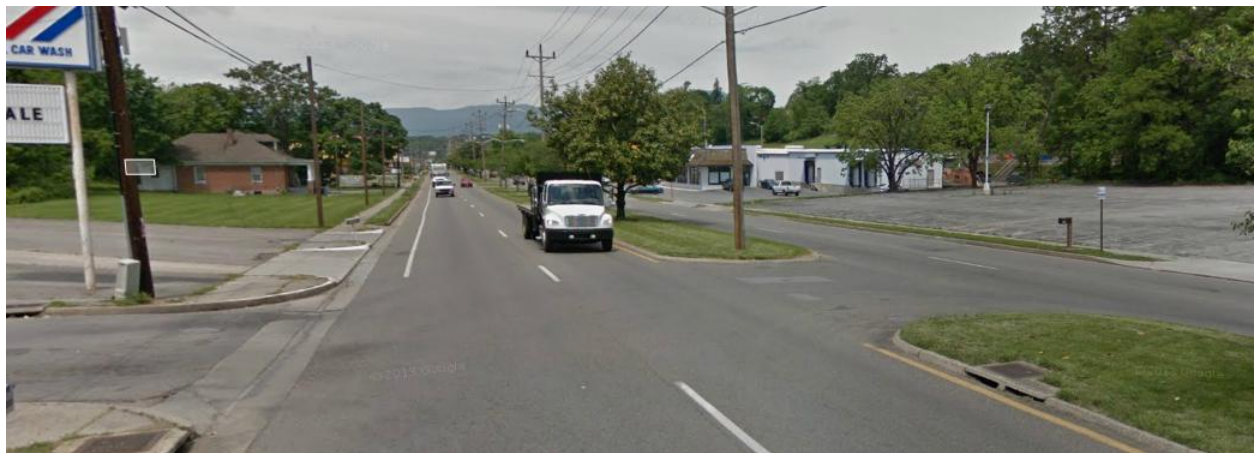
30.) Melrose EB at 35th

A large apartment complex is located up the hill off of 35th Street and is the main activity generator of activity at this stop and its companion stop, Melrose WB at 35th (which is #31 in the ranking of most active stops). Nearby driveways serve as curb ramps for riders crossing the street. The current landing area is not level and needs to be repaved.

Consideration should be given to closing the driveway adjacent to the bus stop on Melrose Avenue. Two driveways next to each other currently serve the same building which was vacant at the time of the site visit. A crosswalk on Melrose Avenue connecting the two bus stops along with signage and pedestrian activated flashing lights as well as a pedestrian refuge within the existing median would provide a safer crossing.

Stakeholders	Valley Metro, City of Roanoke, Adjacent property owner (The Clean Machine Car Wash)
Recommendations	Stripe a crosswalk across Melrose Avenue with signage and flashing lights, repave the landing area and close one driveway nearest the stop. Install a small bus shelter. Construct curb ramps on both sides of 35 th Street and at the pedestrian crossing.
Estimated Costs	Small bus shelter = \$6,620 Curb, gutter and sidewalk reconstruction at the driveway = \$4,000 Four curb ramps = \$16,000 Crosswalk, flashing lights, tactile warning surfaces in the median refuge, signage = \$22,500 Labor/Installation = \$3,395 Permits/Site plans = \$1,790

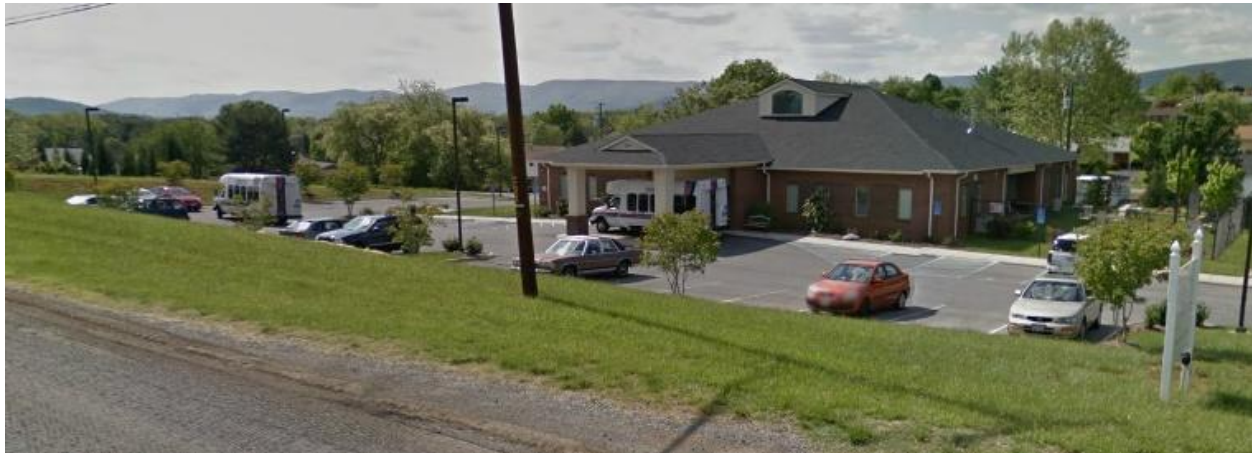
The nearest bus stop, Roanoke Blvd WB at Disabled Veterans Store, is not a high activity stop though the bus stops there about every other time it passes to either pick up or drop someone off. The current bus stop location is not ideal in that the bus blocks the adjacent driveway when stopped. It would be preferable to shift the bus stop in front of or directly adjacent to the Adult Day Care and construct a bus pull-off so that the bus does not impede traffic flow on the two-lane road. Given that a rider who accesses this location may be in a wheelchair, the bus may be stopped for an extended period to drop-off or pick-up a passenger. Certainly accessibility improvements between the bus stop and the facility would make riding the fixed-route bus a better option for someone who is able to use the service and would like the opportunity.

Stakeholders	Valley Metro, City of Salem, Adult Day Care management
Recommendations	Construct a bus pull-off on Roanoke Blvd. just east of the Adult Day Care driveway. Construct a landing pad, a large shelter, and a sidewalk connection to the Adult Day Care.
Estimated Costs	Large bus shelter = \$9,450 Labor/Installation = \$3,395 Permits/Site plans = \$895 Bus pull-off paving = \$30,000 Sidewalk connection approximately 150' long = \$5,250

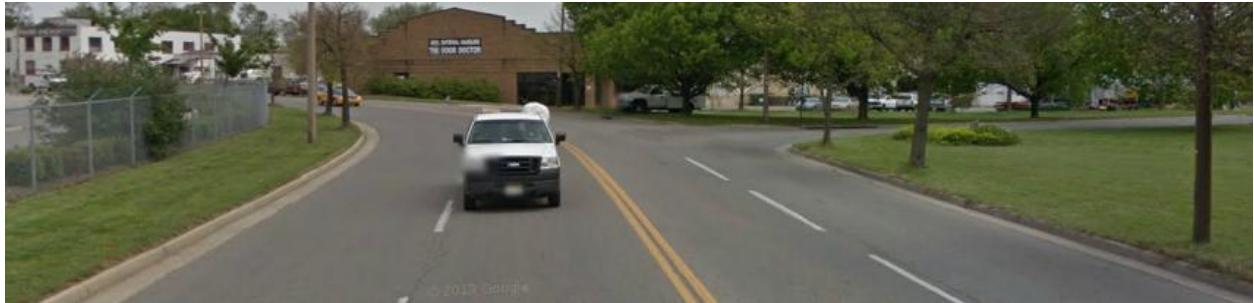
The Northwest Dialysis Center is about a quarter-mile from the closest bus stops at Orange Avenue and Kimball Avenue/Plantation Road. There are no sidewalks from the bus stop to the Center, which is located in a cul-de-sac on 7th Street, up a small hill off of Plantation Road. These bus stops experienced very little to no activity during the NTD survey.

In order for people to access the Northwest Dialysis Center, a pair of bus stops should be located at the Plantation Road and 7th Street intersection. Doing this would involve placing bus service on Plantation Road, which does not currently exist. Dialysis patients are encouraged to exercise, and walking a short distance to/from the bus stops would be a natural way to maintain physical activity. Providing a bus stop at the Plantation Road/7th Street intersection with sidewalks to the Center would make the option to take fixed-route bus service a possibility.

Stakeholders	Valley Metro, City of Roanoke
Recommendations	Provide fixed-route bus service on Plantation Road, construct a pair of bus stops with landing pads, a crosswalk across Plantation Road, and a sidewalk connecting the stops to the Dialysis Center.
Estimated Costs	One small bus shelter for the southbound (inbound) stop = \$6,620 Landing pad for the outbound stop = \$280 Labor/Installation = \$3,395 Permits/Site plans = \$895 Crosswalk striping = \$1,000 Sidewalk connection (approx. 700') = \$24,500 Two driveway reconstructions = \$8,000 Three curb ramps = \$12,000

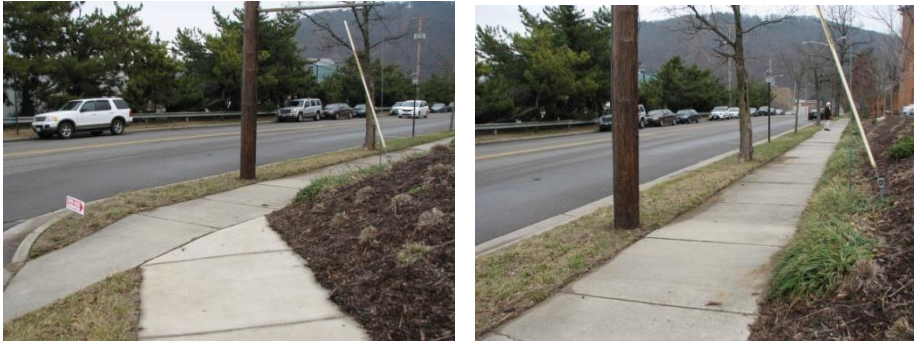
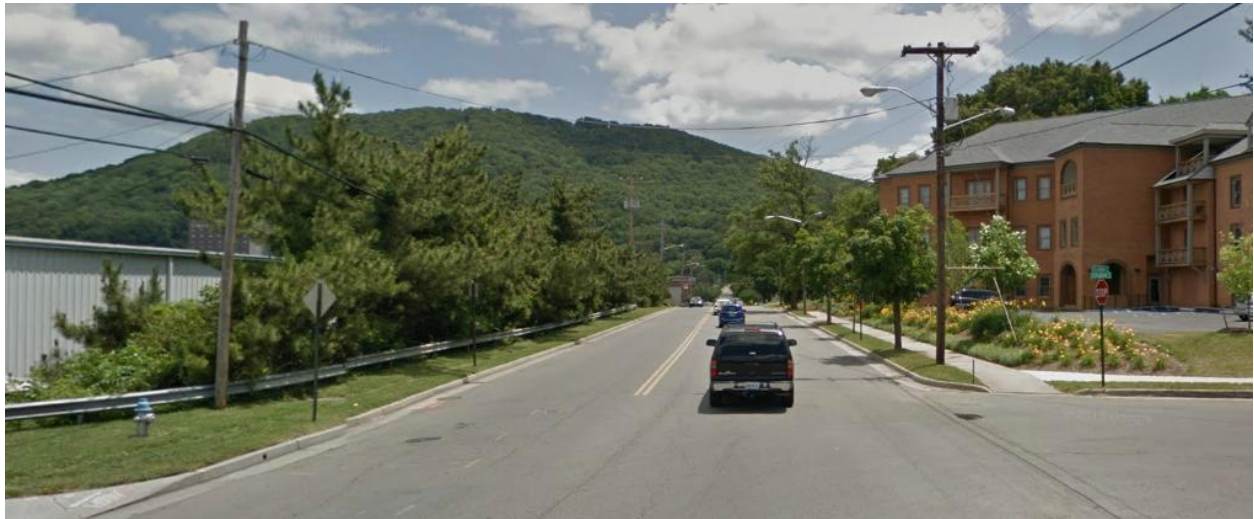
The closest stops to the Crystal Spring Dialysis Center are at McClanahan Street and Rosalind Avenue and on Franklin Road at the Pure Gas Station. Neither location is accessible for people getting to the Dialysis Center. Sidewalk connections along McClanahan Street are lacking, and there is no safe pedestrian crossing across Franklin Road. The Franklin Road stops are more than a quarter-mile away and the McClanahan stops are just at a quarter-mile away. Neither are attractive options for dialysis patients, regardless of infrastructure deficiencies. In order to make fixed-route transit service an option for dialysis patients, the bus route would need to be evaluated to see if there is a way to route the bus past the building. Such a route and corresponding bus stops could be incorporated into an improved connection between Roanoke Carilion Memorial Hospital and Towers Shopping Center.

Stakeholders	Valley Metro, City of Roanoke
Recommendations	Consider options for routing a bus past the Crystal Spring Dialysis Center. If a route is possible, construct a small bus shelter, landing pad, and crosswalk across McClanahan Street to a companion stop that features the same amenities.
Estimated Costs	Two small bus shelters = \$6,620 Labor/Installation = \$6,790 Permits/Site plans = \$895 Crosswalk striping = \$1,000 Curb ramp = \$4,000
