BUS STOP ACCESSIBILITY STUDY

*Roanoke Valley Area Metropolitan Planning Organization
September 2013*

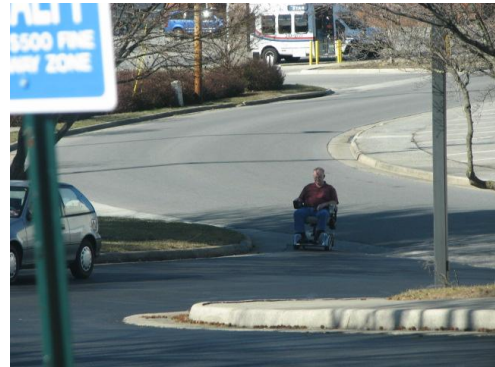
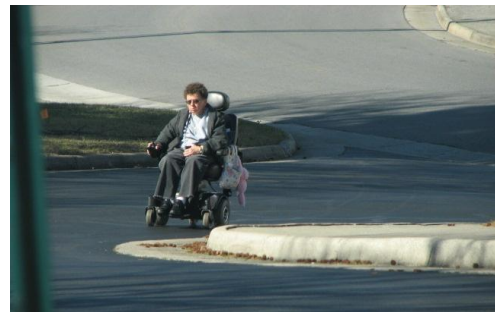
Bus service at Clearview Manor is limited; the 36 bus stops there six times a day on its way into Campbell Court. For people to take the bus back to Clearview Manor, because service is not bi-directional, they must take the 31, which turns into the 36, and ride around most of Vinton before reaching Clearview Manor. The actual bus stop at Clearview Manor is missing a sign.

During the site visit, several people in wheelchairs were seen traveling on the road from the direction of the Lake Drive Plaza shopping center headed to the apartment building. They were clearly comfortable traveling in their wheelchair and able to get to nearby destinations on their own. They were riding on the street instead of the sidewalk due to missing curb ramps along their route which prevented them from using the sidewalk. Given an accessible route, some residents at Clearview Manor Apartments would probably feel comfortable traveling to Hardy Road to use the fixed-route bus service. The closest bus stops are Hardy EB at Vinyard (McDonalds) and Hardy WB at Bedford. If the latter is relocated as suggested in the previous section, another stop near the Hardy Road/Vinyard Road intersection should be constructed to be the companion to Hardy EB at Vinyard (McDonalds).

One option for an accessible route between the Apartments and the Hardy Road bus stops would be to continue the sidewalk on the east side of Vinyard Road from the pool to the main shopping center driveway. Then stripe a crosswalk on the south side of the driveway, which would lead to a new sidewalk connection on the west side of Vinyard Road continuing north to the existing McDonalds sidewalk. The Hardy Road/Vinyard Road intersection itself needs crosswalks striped and pedestrian signals.

Stakeholders	Valley Metro, Town of Vinton, Adjacent property owners
Recommendations	Provide a bus stop inbound near the Hardy Road/Vinyard Road intersection. Construct sidewalk connections and curb ramps between the Clearview Manor Apartments and the bus stops on Hardy Road. Install pedestrian signals and crosswalks at the Hardy Road/Vinyard Road intersection.
Estimated Costs	Small bus shelter for inbound stop = \$6,620 Labor/Installation = \$3,395 Permits/Site plans = \$895 Crosswalk striping = \$1,000 Eight curb ramps = \$32,000 Sidewalk connection (approx. 500') = \$17,500 Pedestrian signal = \$40,000

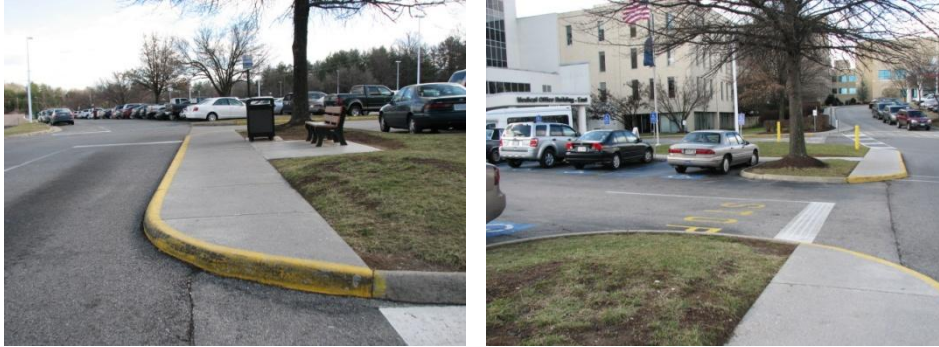
Lewis Gale Medical Center sidewalks around the bus stop need ADA ramps

Lewis Gale Medical Center is well-served by multiple bus routes both from the City of Roanoke and the City of Salem. It has an adequate landing area to deploy the wheelchair lift and amenities including a bench and trash can. This bus stop, however, is not accessible in that the sidewalks lack curb ramps. Therefore a person in a wheelchair cannot get to the bus stop. Rather, they would need to wait nearby in the travel lane or driveway aisle. Likewise, a person in a wheelchair alighting the bus would also need to be let off in the travel lane or driveway aisle. Two ramps are needed to make a seamless wheelchair accessible pathway to the Medical Center. A bus shelter is also needed.

Stakeholders	Valley Metro, Lewis Gale Medical Center
Recommendations	Discuss potential improvements with Lewis-Gale to improve accessibility including, but not limited to constructing curb ramps to make an accessible path from the Medical Center entrance to the bus stop, and replacing the bench with a bus shelter.
Estimated Costs	Large bus shelter = \$9,450 Two curb ramps = \$8,000 Labor/Installation = \$3,395 Permits/Site plans = \$895

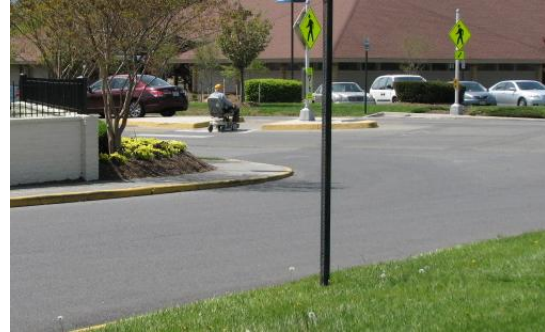
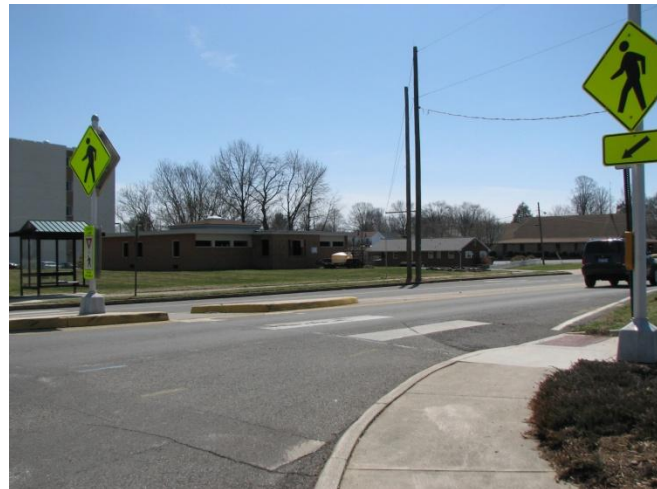
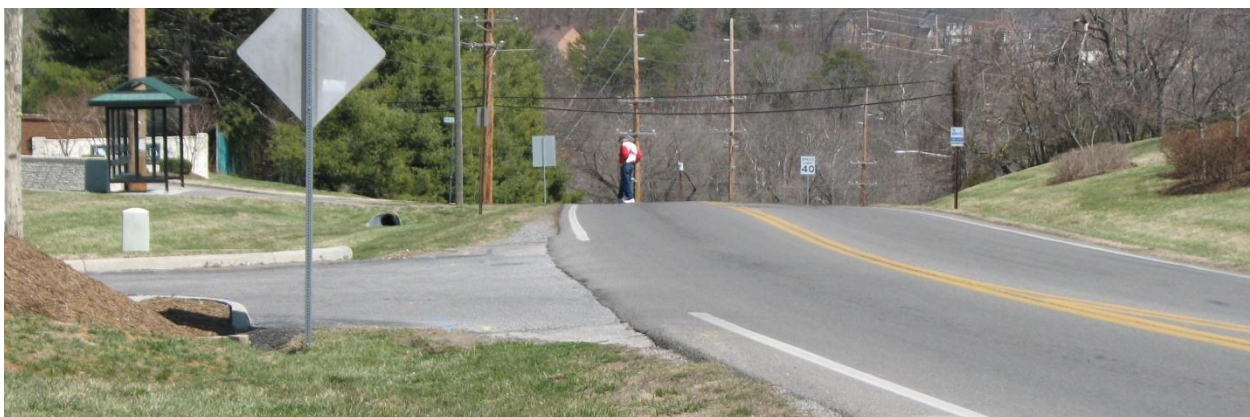
Friendship Manor Retirement Community provides many services to senior citizens including independent living. There are four bus stops available to the Community. At the time of this writing, Friendship Manor is undergoing plans to relocate the main driveway on the south side of Hershberger Road, which will remove the sheltered bus stop and pedestrian crossing. The design consultant has been in contact with Valley Metro about how to incorporate the bus stop in the new configuration.

The current bus stop amenities are excellent examples for the region on how to make bus stops safe, accessible, and easy to use. As shown in the pictures, when safe facilities are provided, senior citizens and people with disabilities will use them. There is a bus shelter, a marked crosswalk with pedestrian signage and a signal that when activated flashes warning lights on the signs. The bus stops are clearly companions, which make it easy for people to understand that they function together as boarding and alighting stops.

Stakeholders	Valley Metro, Friendship Manor Retirement Community management, VDOT, Roanoke County, City of Roanoke
Recommendations	Construct new bus stops concurrent with the Friendship Manor entrance reconstruction including a new pedestrian median and crosswalk, landing pads, bus pull-offs and bus shelters.
Estimated Costs	Two small bus shelters = \$13,240 Pedestrian crossing and four curb ramps = \$36,000 Sidewalk connections approximately 700' = \$24,500 Bus pull-offs = \$180,000 Labor/Installation = \$6,790 Permits/Site plans = \$895

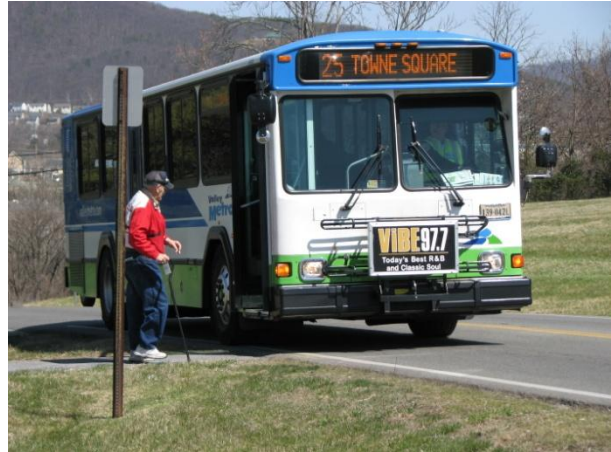
The four bus stops available to Friendship Manor should, for efficiency and minimization of financial resources, be combined into two bus stops, one on either side of Hershberger Road. Upon visiting the location and reviewing the conceptual Friendship Manor renovation plans, bus stops are recommended for the locations approximately shown in red in the diagram below. At these locations, bus pull-offs should be constructed so as to not cause traffic to stack behind the bus. Each bus stop should feature a small bus shelter with an adequate landing pad and similar pedestrian crossing as is currently provided across Hershberger Road. Sidewalks along Hershberger Road should lead from the bus stops to the entrances of nearby buildings.

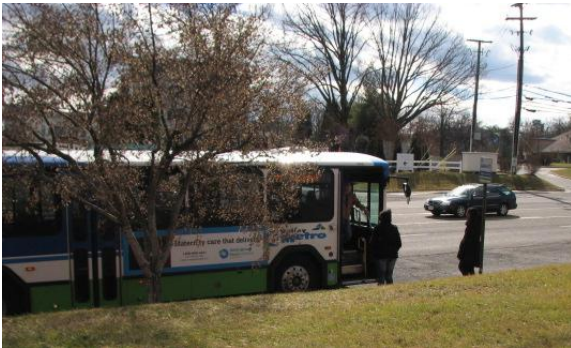
Brandon WB at Stratford Park (Brandon Oaks)

Stratford Park Residential Apartments are located up a small hill off of Brandon Avenue. The main building is a quarter-mile from the nearest bus stop. Sidewalks are lacking between the bus stop and the building. People now walk along the Clear Channel Radio driveway and through the parking lot behind the building to travel between the bus stop and the residential building which, while not ideal, works fairly well.

Stakeholders	Valley Metro, City of Roanoke, Brandon Oaks Retirement Community management
Recommendations	Construct a pedestrian refuge and install a traffic signal to be activated only by a pedestrian for crossing Brandon Avenue. Install small bus shelters at the bus stops and widen the landing area to the standard size.
Estimated Costs	Two small bus shelters = \$13,240 Two small retaining walls = \$10,000 Pedestrian island and crosswalk= \$22,500 Traffic signal = \$150,000 Two curb ramps = \$8,000 Labor/Installation = \$6,790 Permits/Site plans = \$895

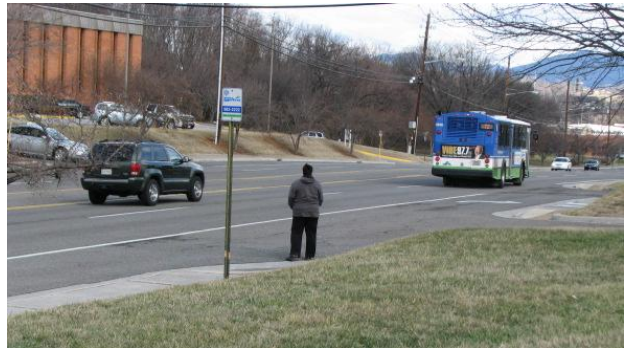
Brandon EB at Stratford Park (Brandon Oaks)

Of most difficulty, because the apartments are located on a bi-directional bus route, to use the bus efficiently, people must also use the bus stop on the opposite side of the road. The bus stops are located on Brandon Avenue, which is a five-lane 35 mph roadway and no pedestrian crossing facilities near the bus stops. In order to safely use the fixed-route bus people need to either ride to the route endpoint (Lewis Gale or Campbell Court) and loop around or get on/off at a farther stop where it is safer to cross. However, some people will simply take their chances, like the woman in the picture above, and cross the street because the other options, although safer, are time-consuming and frustrating.

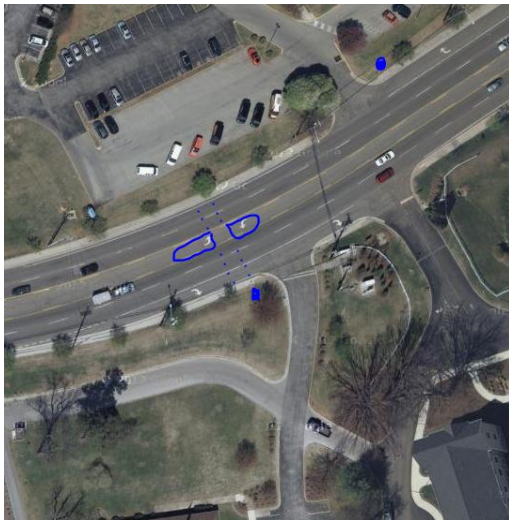
To make it safer for pedestrians to cross the street, a pedestrian island with crosswalks, a pedestrian traffic signal, and pedestrian push buttons are recommended. With these accommodations, a pedestrian crossing the street would push a button to activate the traffic signal, which would turn red, stopping traffic on Brandon Avenue to allow the pedestrian to cross safely. Such improvements could enable residents at Brandon Oaks Retirement Community and Stratford Park to travel independently and more safely without a car.

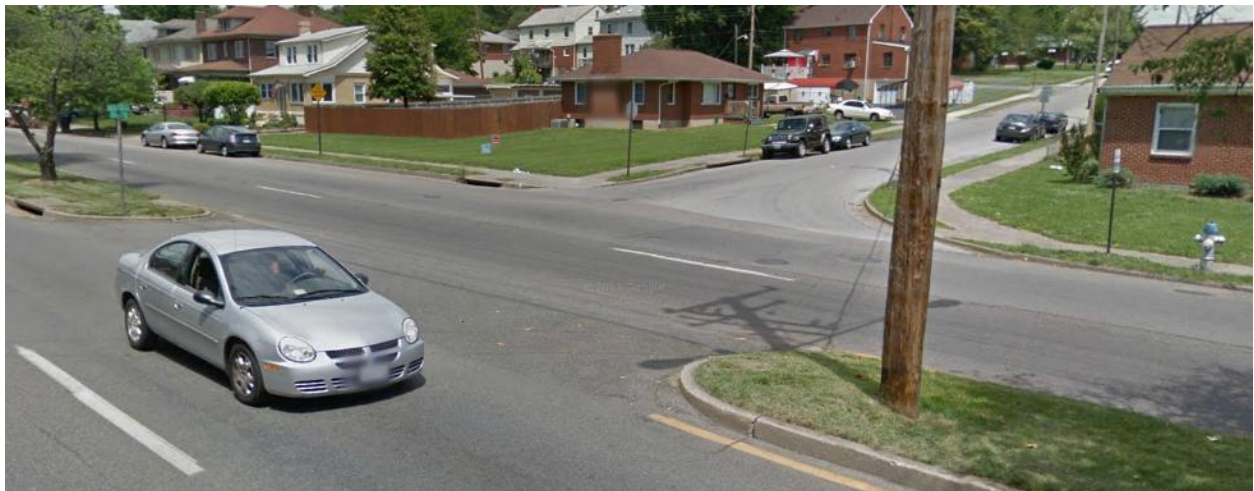
A bus shelter is also needed at the eastbound bus stop shown in the picture below. The shelter could be installed in the grass area just beyond the bus stop.

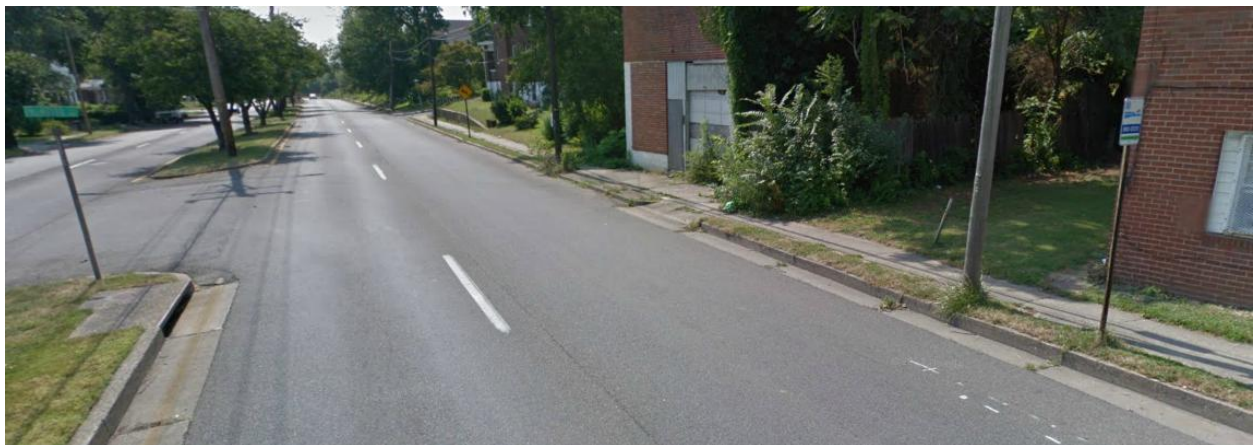
Curb ramps are needed in conjunction with the pedestrian crosswalk as well as on the corners at Palmetto Street and at 29th Street. Residents should be educated on which bus stops should be used and crossing the street safely.

Stakeholders	Valley Metro, City of Roanoke
Recommendations	Install pedestrian flashing lights and crosswalks, curb ramps and relocate the westbound bus stop. Install small bus shelters at the bus stops and widen the landing area to the standard size.
Estimated Costs	Two small bus shelters = \$13,240 Pedestrian signs with flashing lights and crosswalk= \$22,500 Three curb ramps = \$12,000 Labor/Installation = \$6,790 Permits/Site plans = \$895

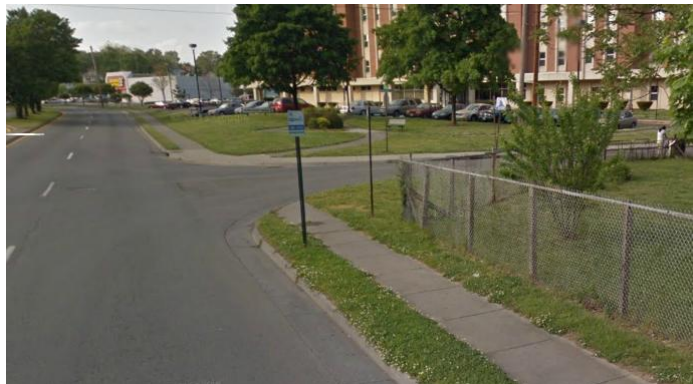
The 13th NB at Montrose stop had a higher activity index, probably because it has service every hour. This stop however, does not have a bus shelter and one is needed. The bus route itself is inconvenient for residents because in order to get to Downtown Roanoke, they need to loop through Garden City. Residents also have the option of walking to Jamison Avenue and catching a direct bus into Campbell Court. The intersection of Jamison Avenue and 13th Street has pedestrian signals and most corners have curb ramps. One location that needs a ramp is in the island on the northeast corner of the intersection.

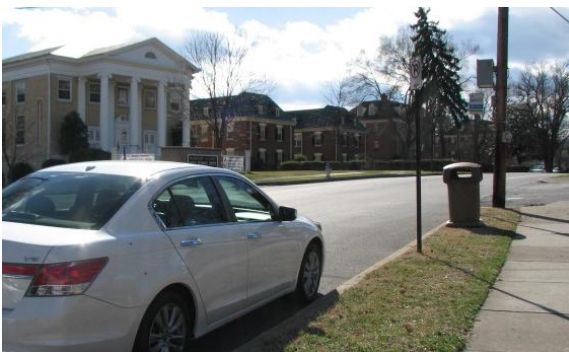
People traveling to Raleigh Court Health and Rehabilitation Center have good access to bus stops located at the Grandin Road/Windsor Avenue intersection near the property. With few improvements, these stops will be easily accessible for people. At the Grandin SB at Windsor stop, the No Parking sign needs to be moved further north, away from Windsor Avenue, in order to allow room for the bus to pull up to the curb. The sidewalk also needs to be extended to the curb to better accommodate the wheelchair lift. The Grandin NB at Windsor bus stop is accessible in its current state. There are accessible ramps on each street corner and there is a landing pad that extends from the curb to the sidewalk. As opposed to its companion across the

Stakeholders	Valley Metro, City of Roanoke
Recommendations	Install a bus shelter at the Grandin NB at Windsor stop and a landing pad at the Grandin SB at Windsor stop. Remove parking at the bus stop on the southbound side of Grandin Road.
Estimated Costs	Small bus shelter = \$6,620 Landing pad = \$140 Labor/Installation = \$3,395 Permits/Site plans = \$895

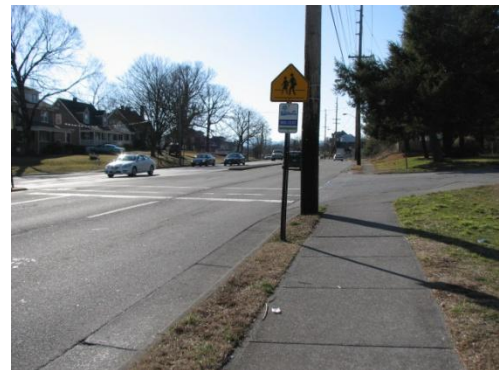
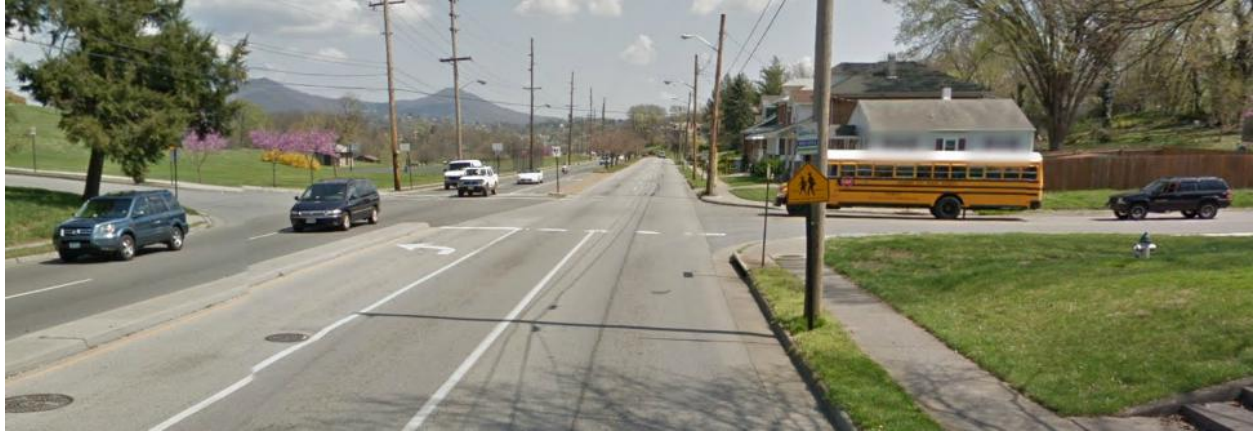
The bus stop activity at these stops was low during the NTD survey. Certainly the need to cross Dale Avenue may deter some people from attempting to use the bus. Consideration should be given to a pedestrian activated traffic signal as shown in section 7.1. Such a signal may also be beneficial to students who want to walk to school.

Stakeholders	Valley Metro, City of Roanoke
Recommendations	Provide a more prominent pedestrian crossing through flashing lights or a traffic signal. Extend the sidewalk to the back of the curb.
Estimated Costs	Landing pads = \$280 Additional cost for safer pedestrian crossing various depending on technology chosen.

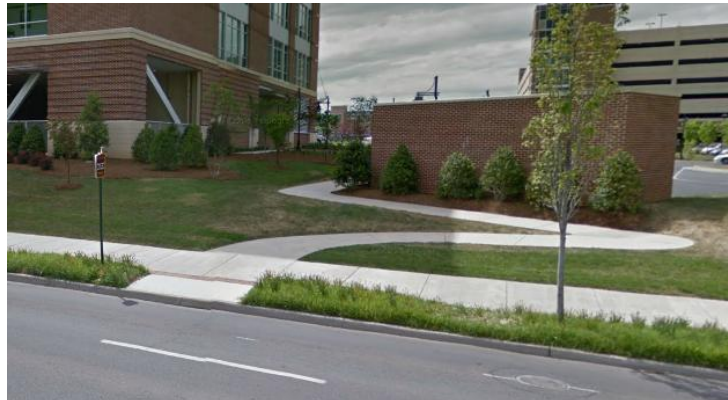
Carilion Clinic is located along the trolley line. The nearest Valley Metro route is about a half-mile away at Walnut Avenue or Carilion Roanoke Memorial Hospital. People traveling to Carilion Clinic may alight at Campbell Court and walk a block to the nearest Star Line Trolley stop or take the fixed-route service to the Hospital and transfer to the trolley. The Jefferson SB at Reserve stop is primarily an alighting stop. It is an accessible location with an adequate landing pad and pathway to the Clinic. A small shelter would be appropriate for people traveling southbound.

Stakeholders	Valley Metro, City of Roanoke
Recommendations	Install a small bus shelter at the stop.
Estimated Costs	Small bus shelter = \$6,620 Labor/Installation = \$3,395 Permits/Site plans = \$895

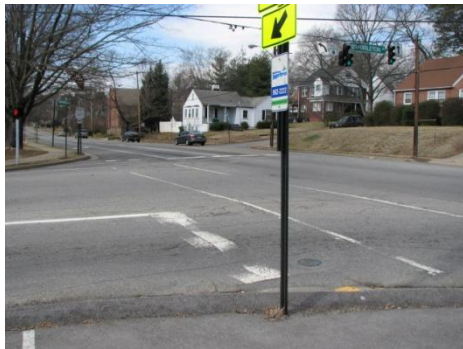
Brambleton NB at Brandon

This private residence is closest to the bus stops at Brambleton Avenue and Brandon Avenue. Accessibility at the Brambleton SB at Brandon stop would be improved by extending the sidewalk to the curb. Additionally, directional curb ramps need to be constructed on the southeast and southwest corners of the intersection to allow wheelchairs to cross Brandon Avenue and Brambleton Avenue.

Stakeholders	Valley Metro, City of Roanoke
Recommendations	Construct curb ramps on both sides of Brambleton Avenue at Brandon Avenue. Extend the sidewalk to the back of the curb on the southbound stop.
Estimated Costs	Two curb ramps = \$8,000 Landing pad = \$280

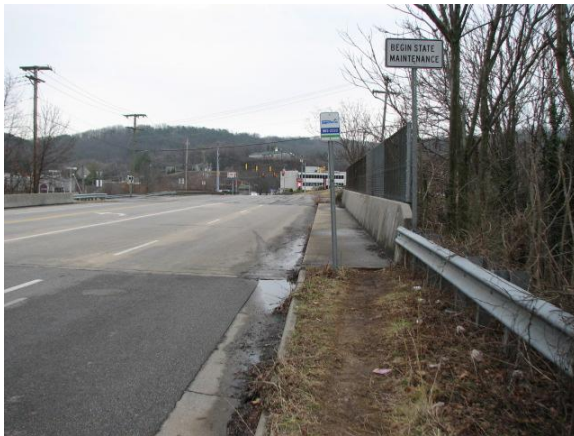
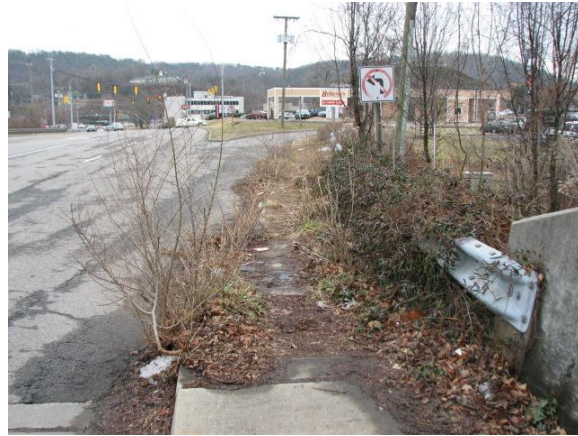
Pain Management is located off of Fallowater Lane, a half-mile from the nearest fixed-route bus stop on Ogden Lane. The path to travel from the stop to Pain Management is missing sidewalks both along the street and within the developments that exist between Ogden Road and the Pain Management facility. A bus route and stop should be considered for Starkey Road or Electric Road that would provide better access to this location, as well as the many other businesses nearby. As a minimum, a sidewalk should be constructed from the bus stop to Starkey Road. The intersection of Ogden Road at Starkey Road is inclined at the northwest corner and a short retaining wall may be needed.

Stakeholders	Valley Metro, Roanoke County
Recommendations	Construct a sidewalk from the bus stop to Starkey Road. Consider bus routes for Starkey Road or Electric Road in future transit plans.
Estimated Costs	Three curb ramps = \$12,000 Retaining wall = \$5,000 Sidewalk connection approximately 350' = \$12,250 Labor/Installation = \$3,395 Permits/Site plans = \$895

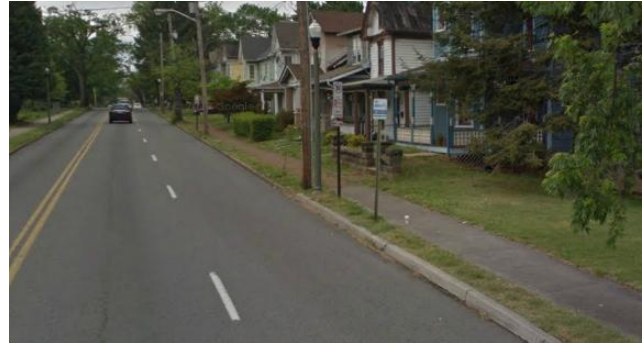
Recommendations for the Elm WB at 5th stop include extending the sidewalk to the back of the curb to create an adequately-sized landing area, installing a bench, and replacing the existing ramps at the intersection of Elm Avenue and 5th Street with directional curb ramps with tactile warning plates.

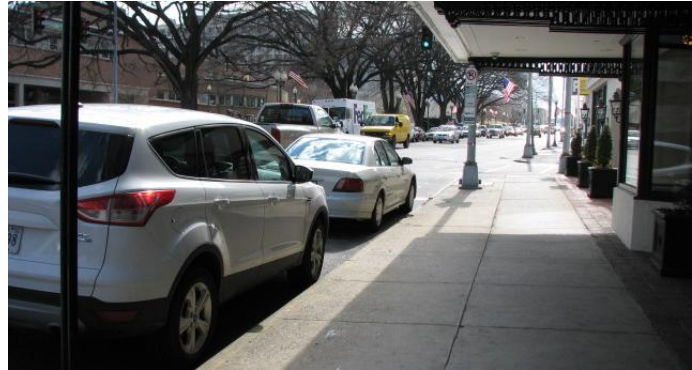
The Water Authority is located in Downtown Roanoke and has several bus stops within a block of the building that are accessible. The two bus stops reviewed are at the intersection of Jefferson Street and Bullitt Avenue. The Jefferson SB at Bullitt stop is located near the Patrick Henry, a residential building that extends over the sidewalk, providing shelter for transit riders when necessary. As such a bus shelter is not needed at this location. However, on-street parking prohibits the bus from pulling up next to the curb, making it difficult for pedestrians with disabilities to get onto the bus. Parking should be prohibited during transit hours to allow the bus to properly service the stop and enable riders with disabilities the opportunity to safely board the bus.

The Jefferson NB at Bullitt stop is located in front of the Downtown Roanoke Main Library. This bus stop is served by inbound buses to Campbell Court. Given its location within the system, more people would alight at this stop than board. As such a bus shelter is not needed at this location, and a nearby brick wall around the patio serves as a makeshift bench for riders. One of the standard black backless benches used in downtown could be installed near this stop to provide a better accommodation for riders.

Stakeholders	Valley Metro, City of Roanoke
Recommendations	Remove on-street parking during transit service hours at the bus stops. Install a bench near the northbound stop.
Estimated Costs	Bench = \$1,700

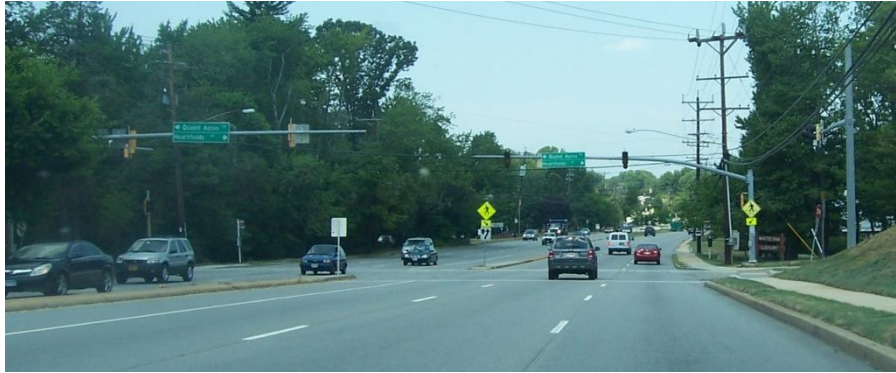
A pedestrian-activated signal is present on New Hampshire Avenue in Montgomery County Maryland. The bus stop is located on the left side of the picture; Sunrise Senior Living is located to the right. The signals on the mast arms are typically black and are only activated by a pedestrian pushing a button.

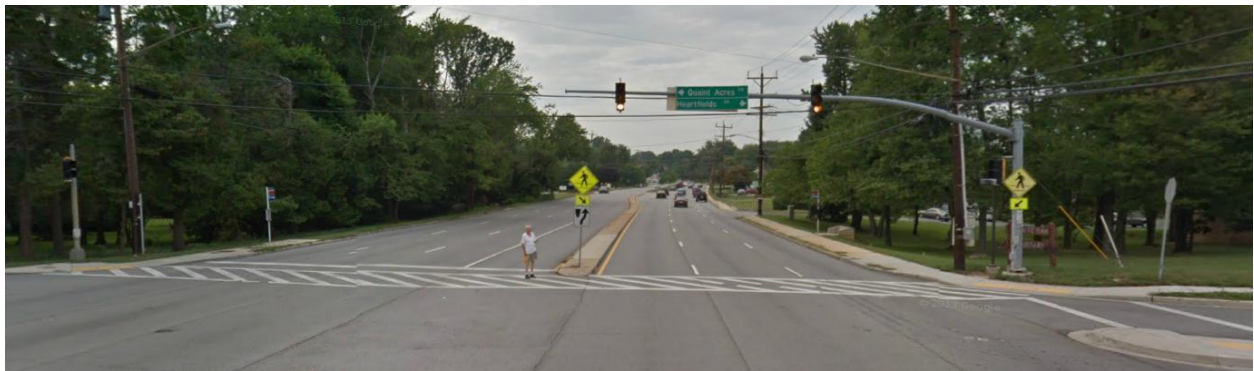
Google through Google Maps captured the image above of an elderly man crossing the street with the signal activated. With these accommodations, using public transit is made possible because walking across a six-lane highway to reach a destination can be accomplished safely.

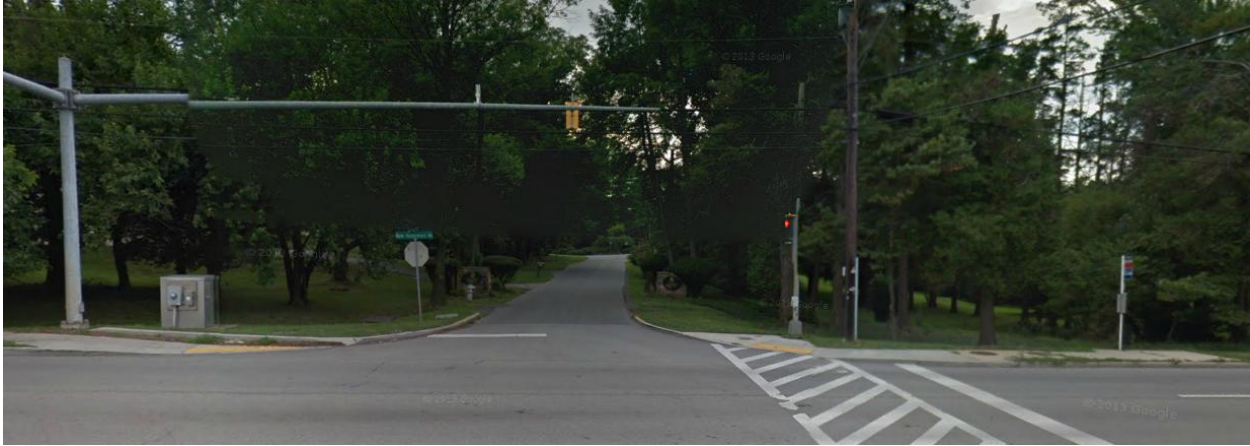
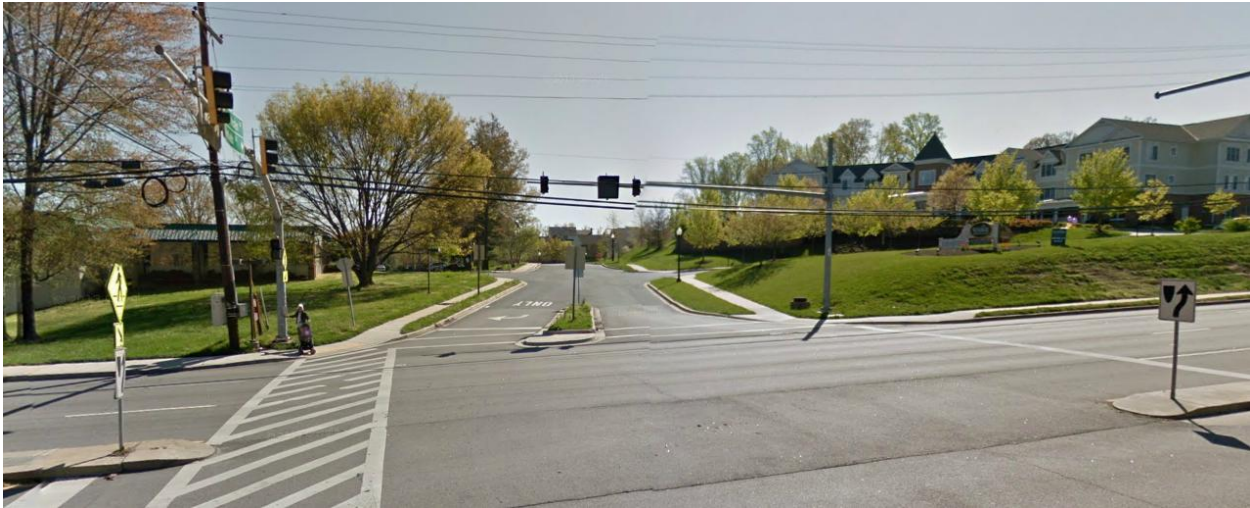
Infrastructure costs can be minimized by focusing on the essential features. In this picture, sidewalks are provided only from the bus stop to the curb ramp on the corner.

The side streets feature a stop sign and stop bar along with a signal that turns red when it is not permissible to proceed. In the second picture below, the traffic pattern was designed to only allow right turns due to conflicts turning left onto a six-lane highway. Drivers wanting to turn left are expected to turn right and then make a U-turn at the next intersection.

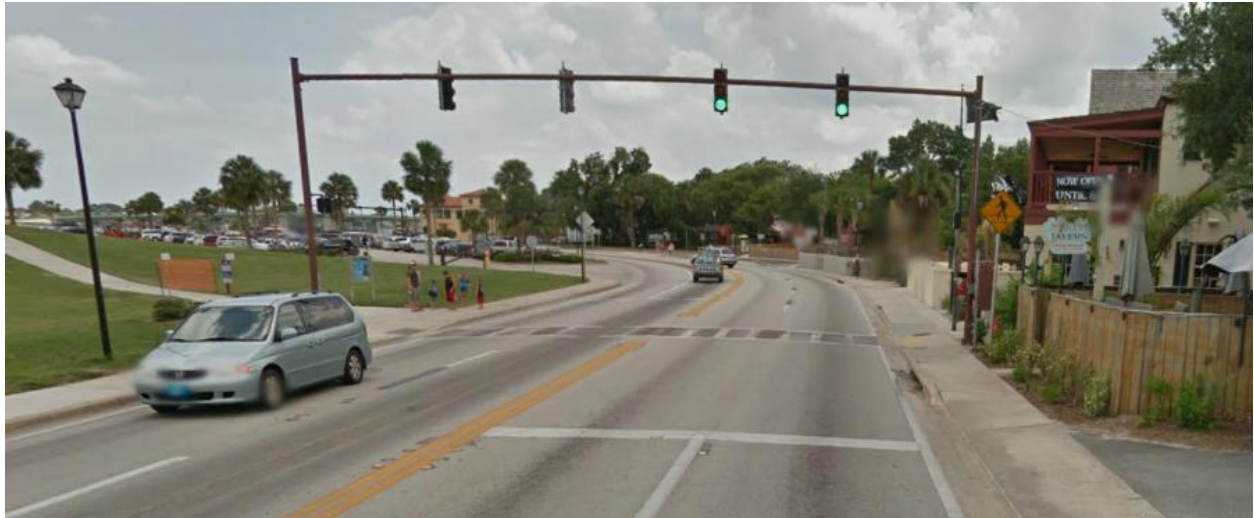
7.1.2 St. Augustine, Florida

In St. Augustine, Florida, on S. Castillo Drive, a traffic signal was installed for the sole purpose of allowing a safe pedestrian crossing across a four-lane highway that separates the Castillo de San Marcos National Monument area from the St. Augustine tourist area. The traffic signal is green unless activated by a pedestrian which turns the light red.

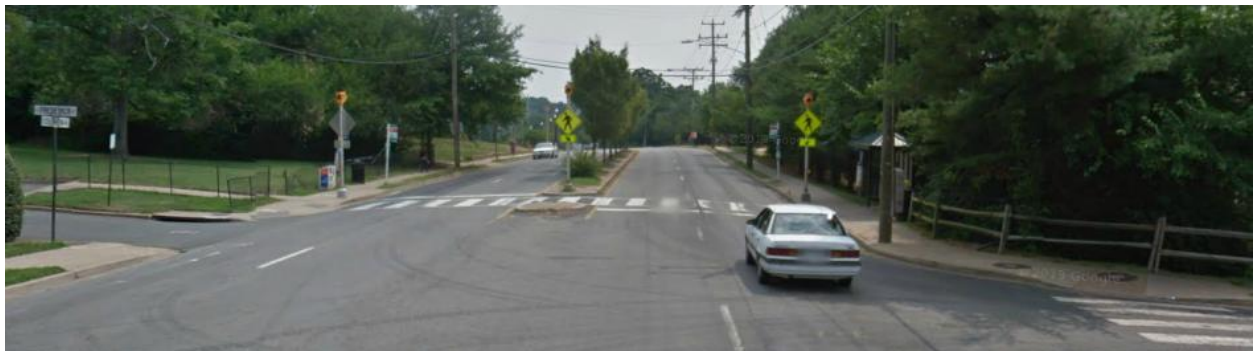
7.1.3 Arlington, Virginia

The picture below shows Columbia Pike, a four-lane arterial, featuring a pair of bus stops with a crosswalk connecting the two. The crosswalk is highlighted with pedestrian-activated flashing lights and signage, similar to the pedestrian crossing on Hershberger Road at Friendship Manor. In the picture, a bus shelter is placed on the inbound side where most riders board the bus. The companion stop does not have a shelter because it is used mainly for alighting.

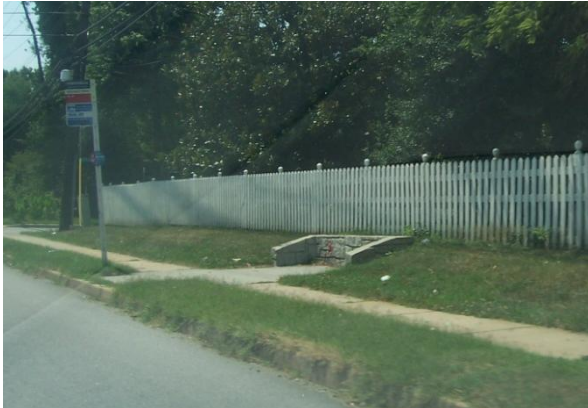
7.2 Bus Stops in Low-Density Areas in Montgomery County, MD

This bus stop features a landing pad from the back of the curb, 8' deep, bordered by a decorative wall used to separate the pad from the soil. The short wall serves as a retaining wall and a bench.

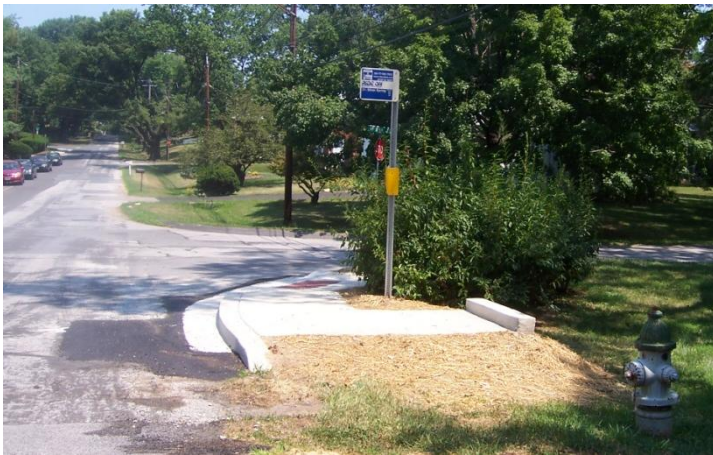
This is a basic bus stop that meets the needs of a person in a wheelchair. It is a 5' wide by 8' deep concrete pad with a curb along the backside for safety. The bus stop is connected to a short sidewalk and curb ramp. For an area in a local residential neighborhood, that does not have sidewalks and pedestrians are expected to walk on the low traffic streets, this bus stop does a nice job to provide a safe place for people to wait for the bus.

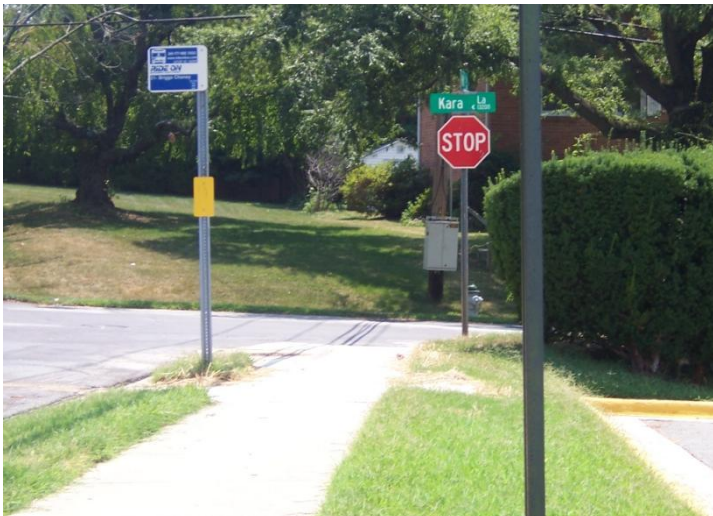
This bus stop is the most basic of accessible bus stops. The picture shows how the sidewalk has been extended to the back of the curb and out towards the adjacent parking lot, accomplishing the minimum 5' x 8' landing pad.

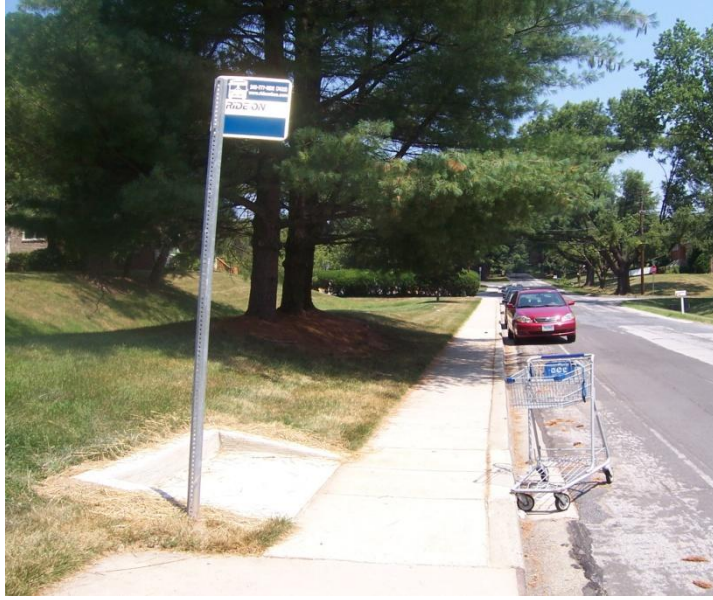
This bus stop features a landing pad bordered by a curb used to separate the pad from the hill. The curb also serves as a pseudo-bench.

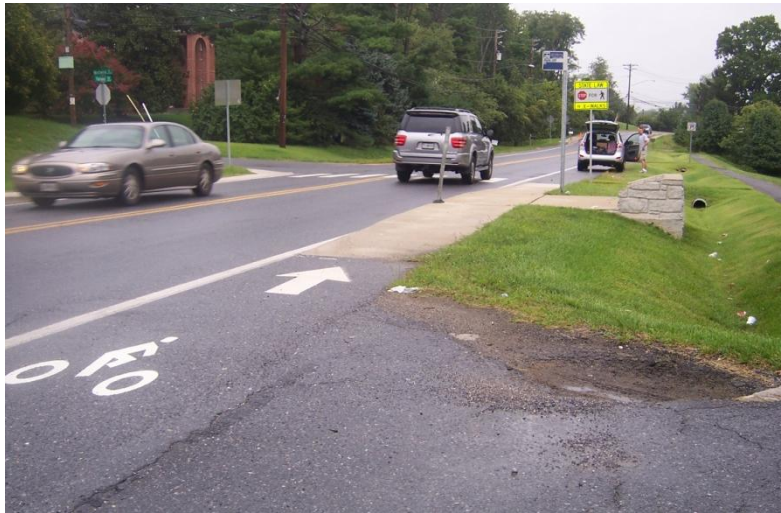
The adjacent pictures show an excellent example of how to accommodate multiple modes within a corridor in a low-density area. This two-lane road features on-street bike lanes, a pair of bus stops with simple built-in benches, a clearly marked crosswalk, a sidewalk leading from the crosswalk over the drainage ditch to a shared-use path. The bus stop features a raised concrete landing area that has also been incorporated into the bike lanes. An additional recommendation may be a trash can; garbage seems to have accumulated in the ditch.

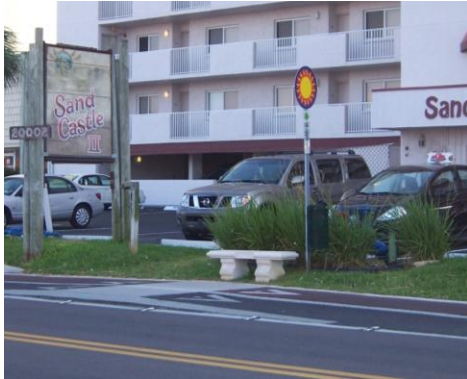
7.3 Street-level Accommodations for All Modes in FL

Gulf Boulevard is a two-lane street in Indian Shores, Florida. It features a bicycle lane in black, an on-street pedestrian lane in red, no curb, and a signed bus stop area. The bus stop features include a slightly raised concrete platform leading to a bench, schedule and route signage, and a small trash receptacle.

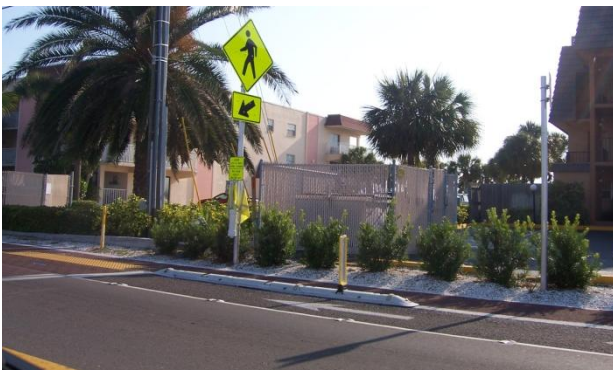
A person in a wheelchair can safely wait for a bus on the landing area within the red, pedestrian zone. In the picture below, on the right-hand side, a bus shelter is also shown. It is highlighted in the bottom picture.
