WALK/DISABILITY AUDIT: Main St in Salem

Date: 7 February 2019

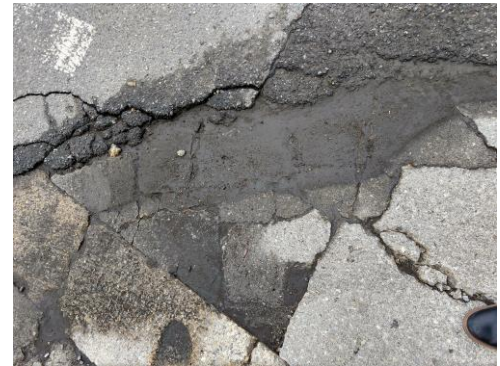
Pavement condition: The pavement is in reasonable condition, and it is assumed that after construction it will be in excellent condition. There are minor pavement issues west of Academy (the western limit of the Downtown Plan) that could be addressed to improve access for people with disabilities, where pavement offsets are greater than ¼ inch. Where curb ramps meet the street can be particularly bumpy.

Figure 2. Uneven surfaces challenge people with disabilities and are common at the interface of curb ramps and street

While the Downtown Plan is being implemented, consider grinding down offsets in the sidewalk or the interface of the curb ramp and street to less than ¼ inch, especially on segments that do not yet have allocated funding.

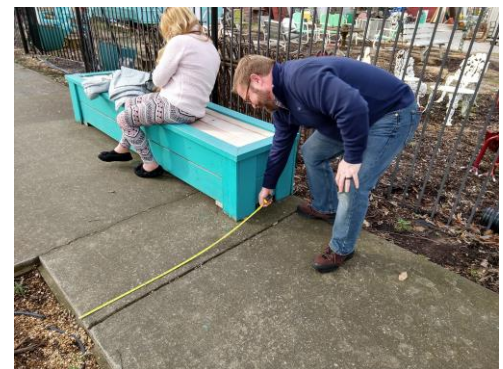
Sidewalks: The sidewalk is comfortably wide. Auditors discussed the importance of ensuring that 4 feet of sidewalk space is protected from encroachment by street furniture with fencing or different colors or

Figure 3. As the Downtown Plan is implemented, care should be taken to protect the 4-foot walkway from encroachment by street furniture

patterns of pavement. The Allstate office building on the northeast corner of Main and Academy has a parking lot that is continuous with the sidewalk. The parking lot is very short and vehicles encroach on the sidewalk, which is not delineated from the parking lot.

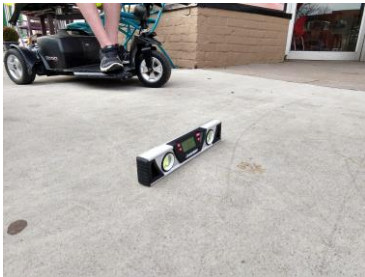
Cross elevations: Building entrances are not at the same level as the sidewalk. Auditors viewed examples of buildings with entry steps that are not accessible to wheelchairs and examples of sidewalk ramped up to be even with the entrance of the building. These ramps provide wheelchair access to the building but can cause steep slopes that are difficult to navigate.

Figure 5. The sidewalk has been ramped up to the entrance, so that the entrance is accessible, but this can result in a steep cross slope difficult to navigate.

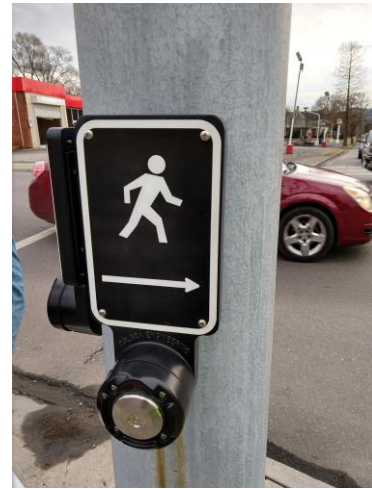
Crosswalks: Midblock crosswalks are extremely well respected by motorists. Crosswalks should be better aligned with curb ramps. Any new pedestrian signals will be audible.

Figure 4. Audible pedestrian signals are standard practice and make the street usable for people who are visually impaired.
